The Dalles Dam Fishway Status Report

01/10/2021

Inspection Period: 01/03-01/09

THE DALLES DAM

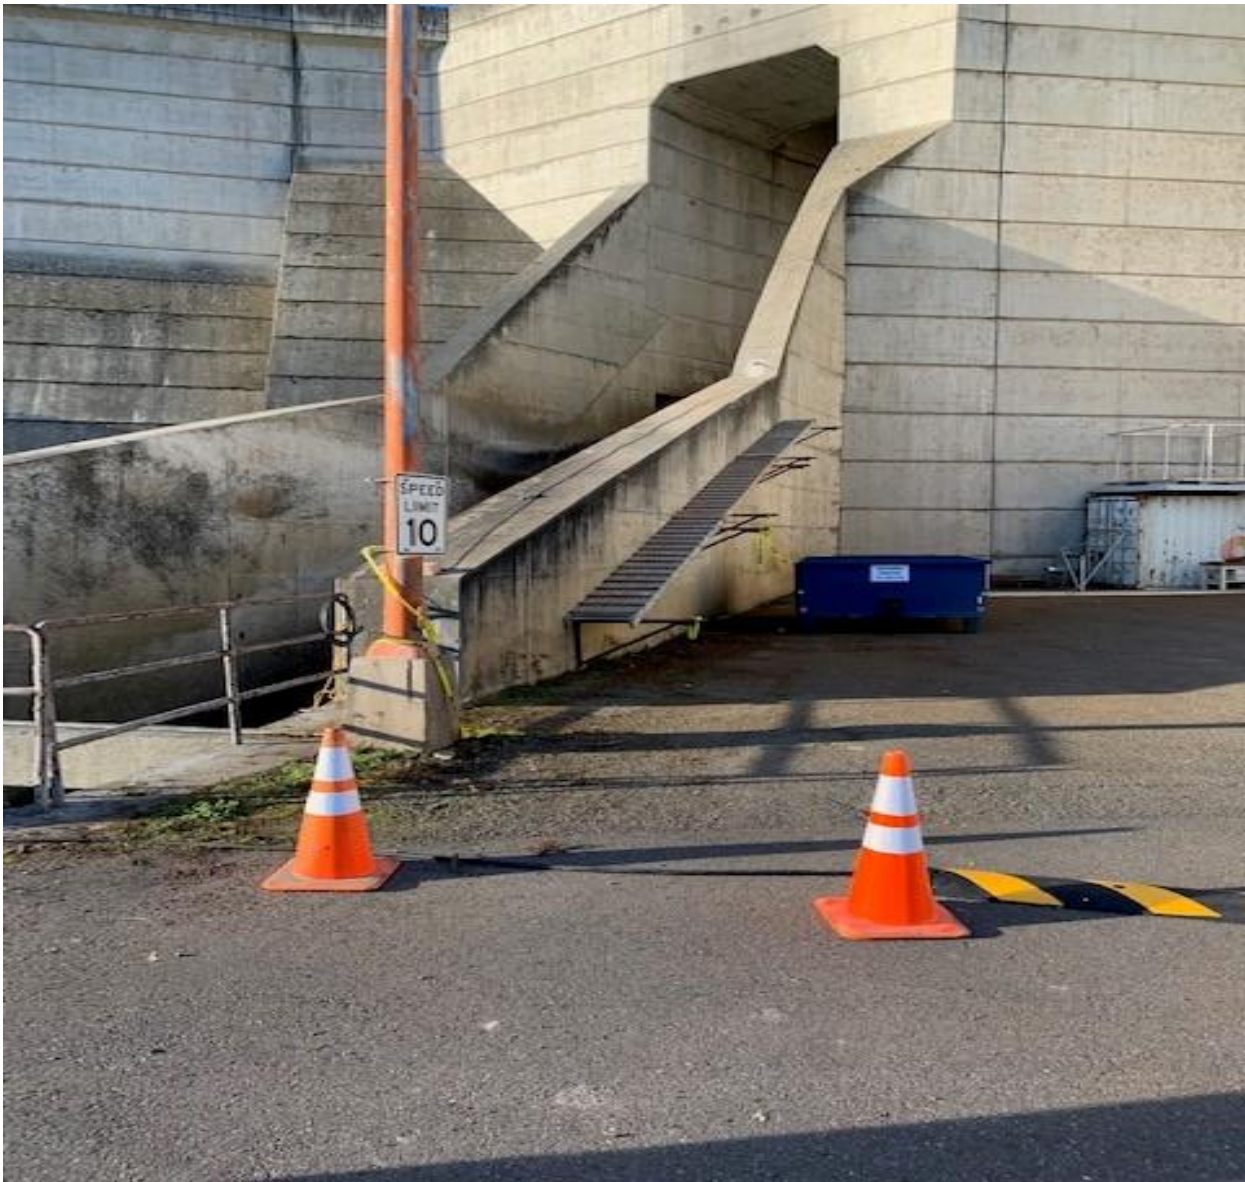
Contractor preparing work site for sluiceway cover
