The Dalles Dam Fishway Status Report

01/17/2021

Inspection Period: 01/10-01/16

THE DALLES DAM

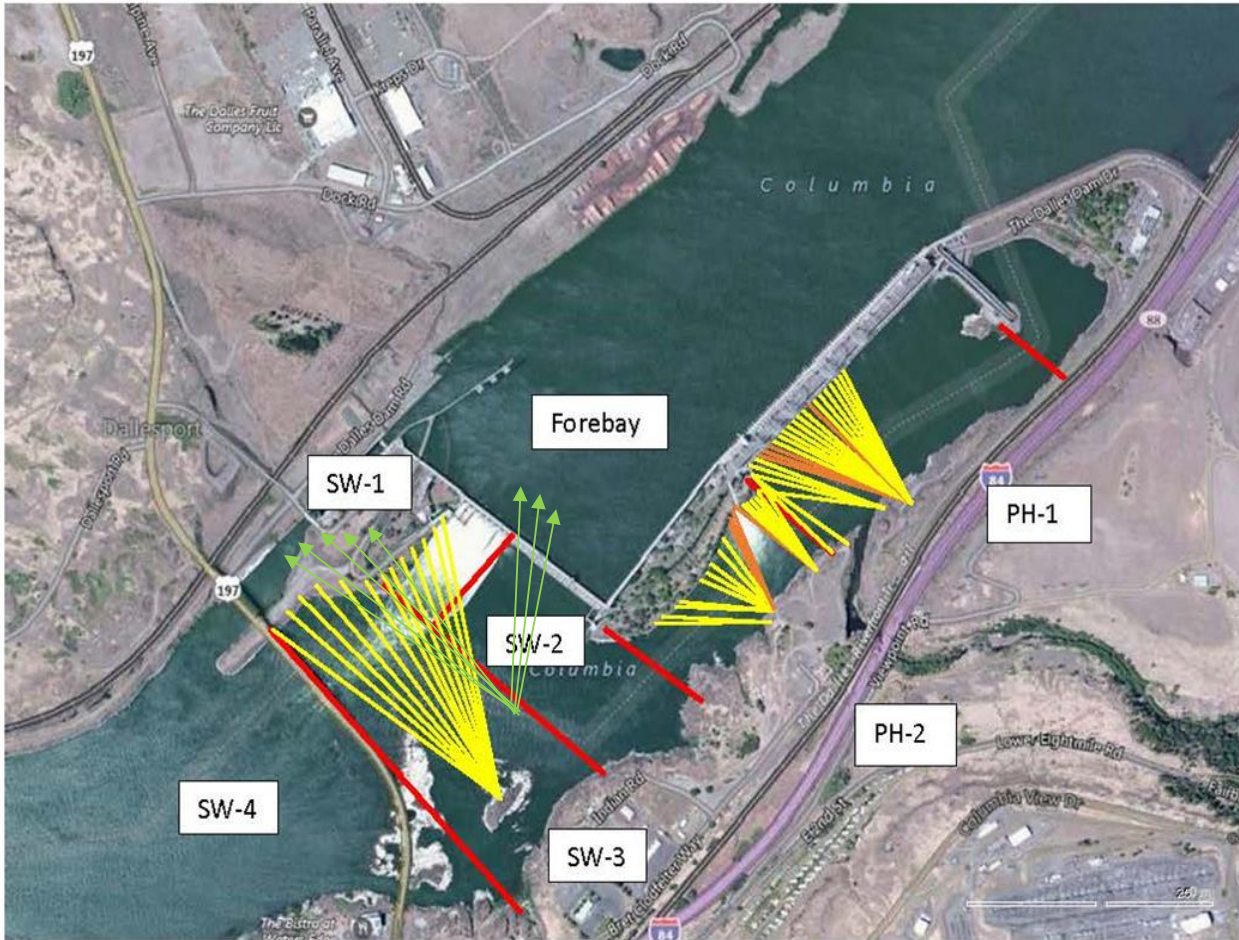
New Avian Lines and laser deterrent zones

Red lines = avian zones Yellow lines = current wires Orange lines = down or missing wires

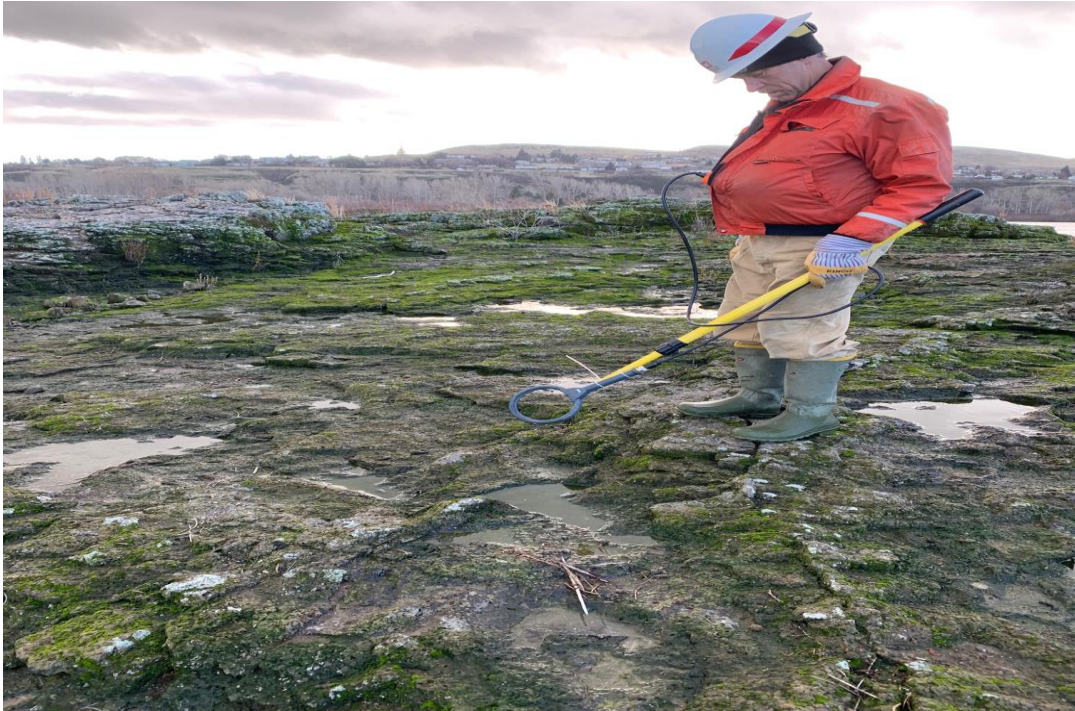
Cordie caught actually working. Scanning for PITs.

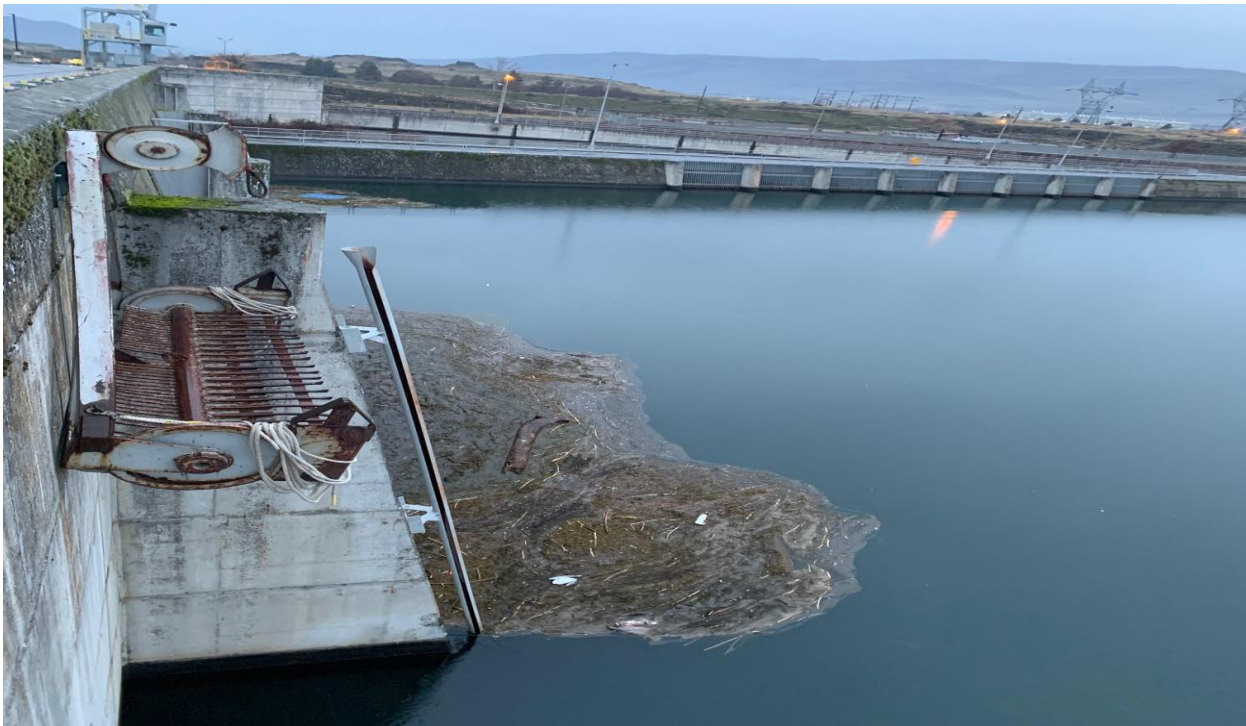
Exit differential	0	≤ 0.5'	
Count station differential	0	≤ 0.3'	
Weir crest depth	0	1.0' ± 0.1'	
Entrance differential	0	1.0' - 2.0'	1.3
Entrance weir N1	0	depth (≥ 8')	9.6
Entrance weir N2	0	Closed	
PUD Intake differential	7	≤ 0.5'	TDM unable to remove significant floating weeds buildup. North FB index data unreliable.

North PUD intake with high debris loading. Rake system out of commission.

- Repairing wind damaged debris guard for north fishladder exit.
- PUD intake rake out of service due to power track damage. Exploring repair options. Temporary repair planned for 2021 season.
- Five of 6 east fishway collection channel dewatering pumps removed for repair/rehab. Work to resume FY21.
- East and north fishway automation (SCADA) near complete for east exit and east entrance. Commission next week.
- Spillway assessment (MRER); Spillgate 9 trunnion pin included.
- Calibration checks on North fishway entrance and exits 12/25/2020, all within criteria.
- Diffuser grating panel missing at east entrance. Dive repair completed.
