# The Dalles Dam Fishway Status Report

01/31/2021

Inspection Period: 01/24-01/30

## THE DALLES DAM

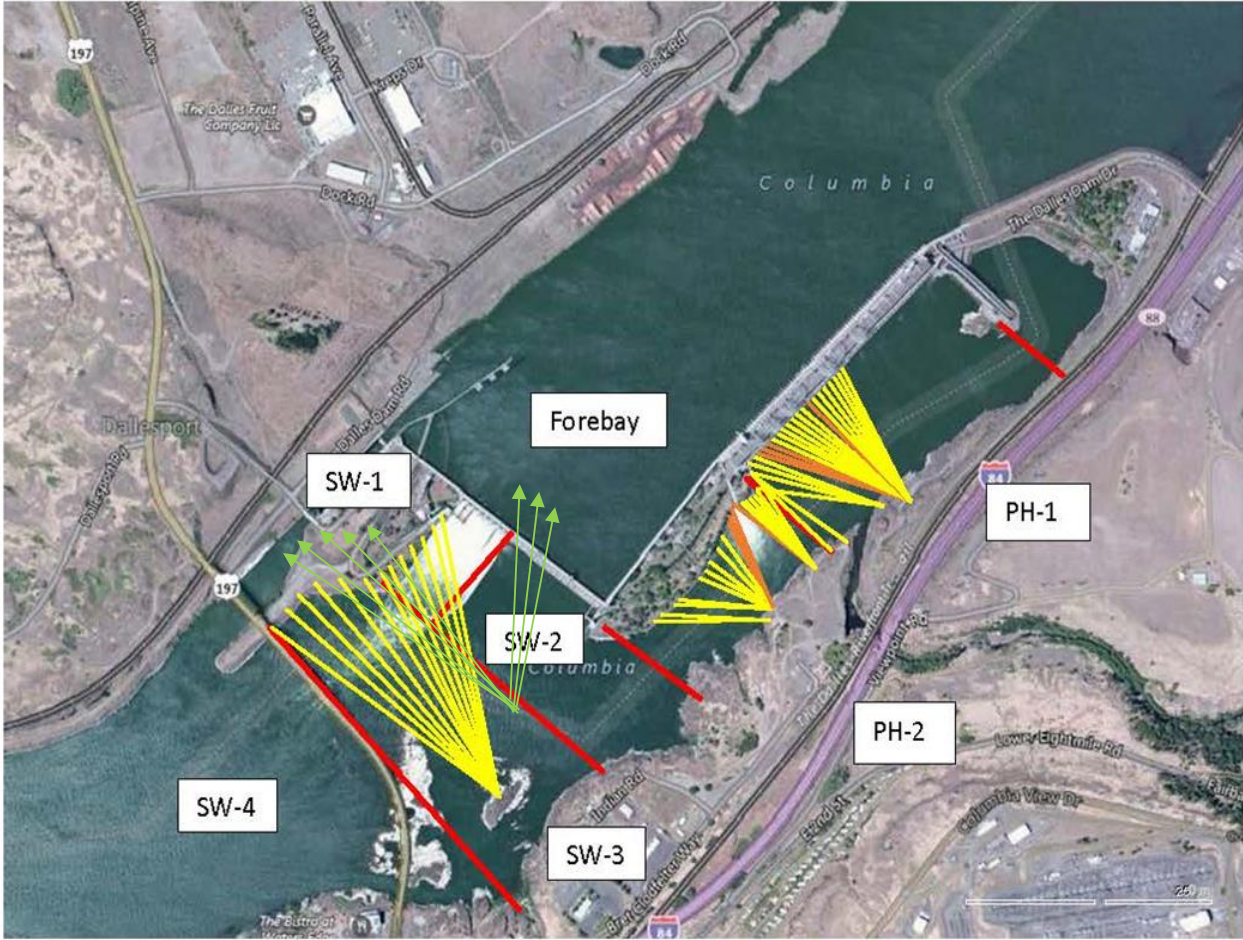
New Avian Lines and laser deterrent zones

Red lines = avian zones      Yellow lines = current wires      Orange lines = down or missing wires

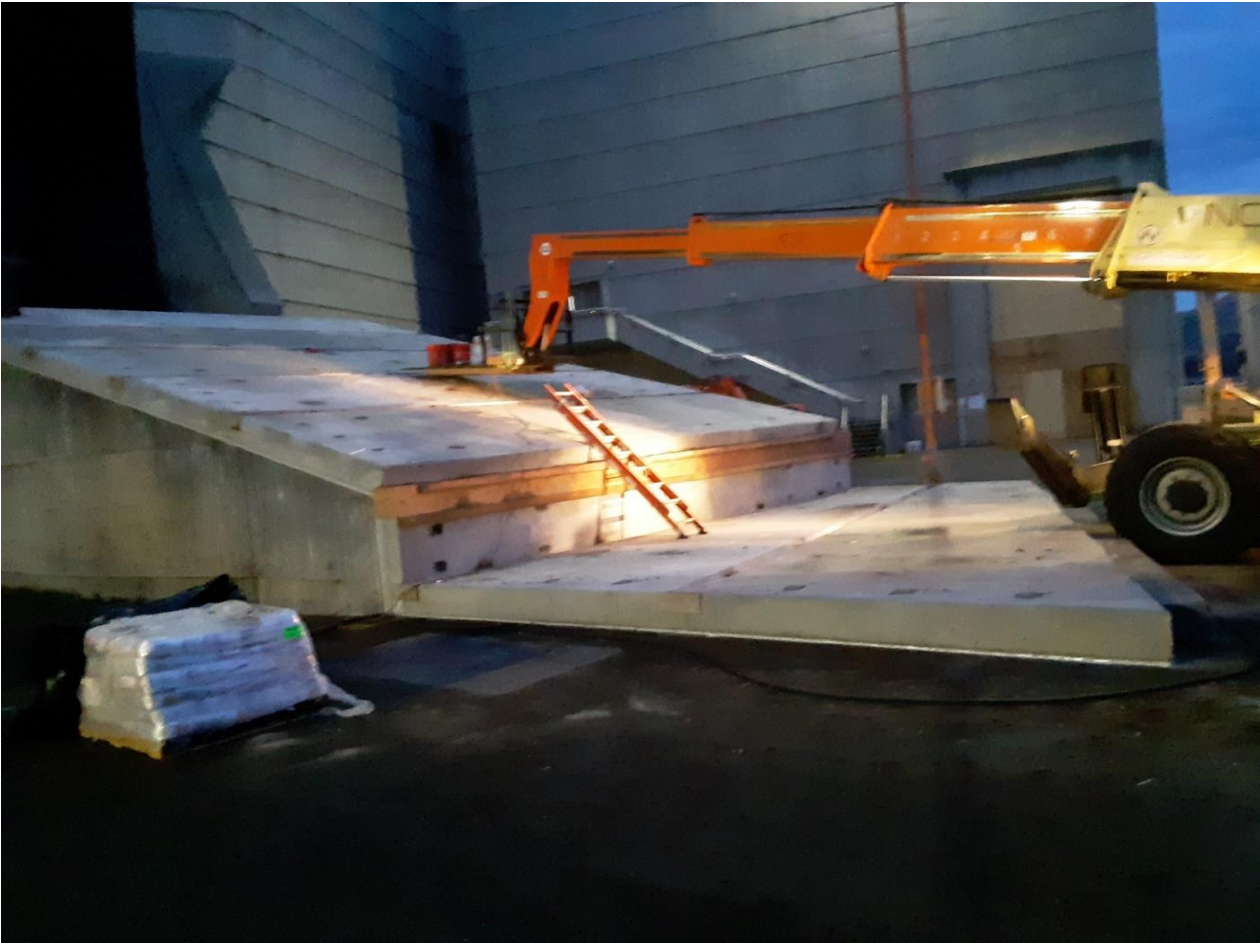
New sluiceway cover to prevent spray and icing
