The Dalles Dam Fishway Status Report

3/7/2021

Inspection Period: 02/28-03/6

THE DALLES DAM

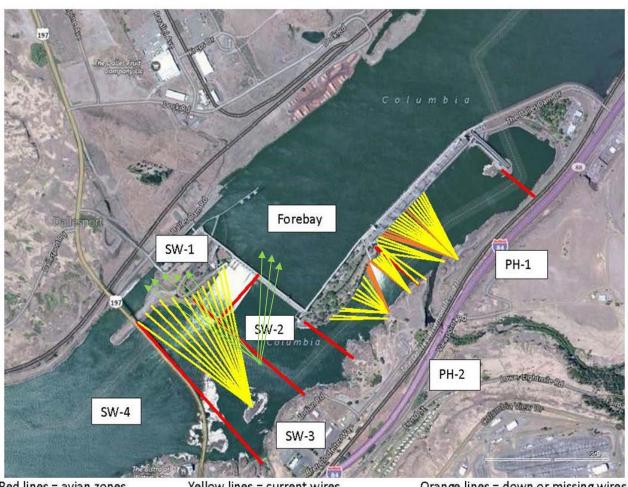
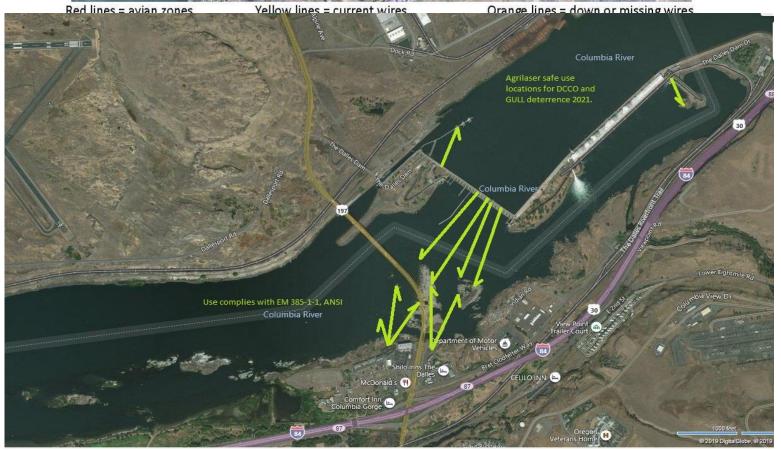
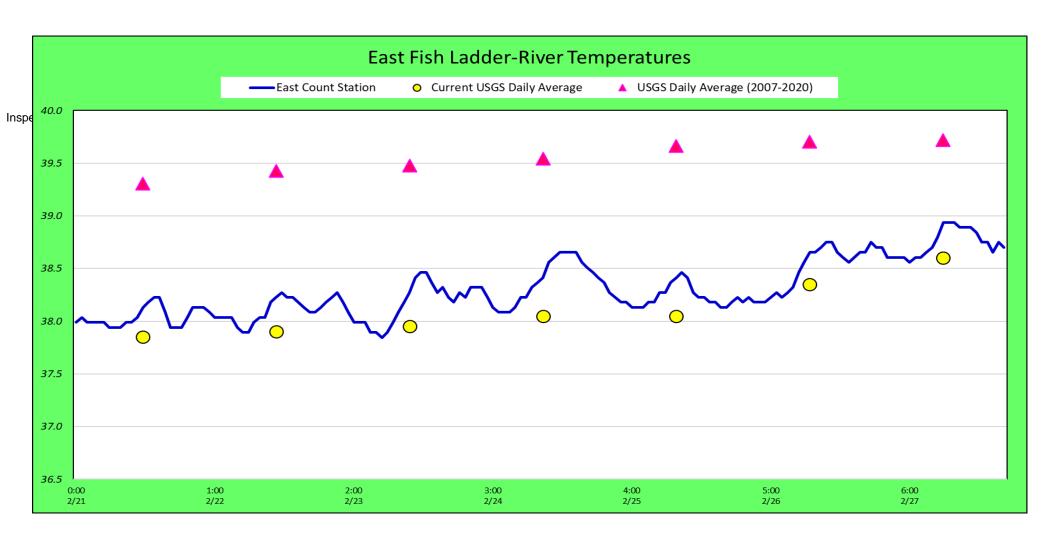
New Avian Lines and laser deterrent zones

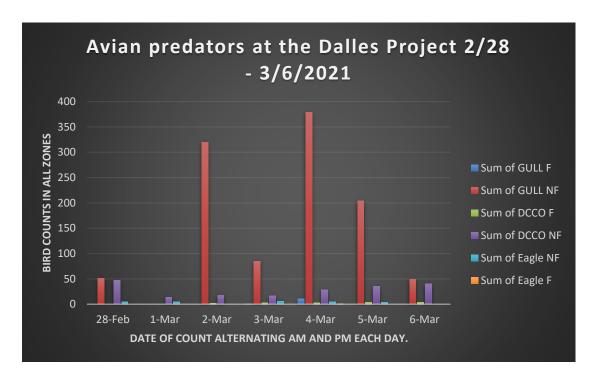
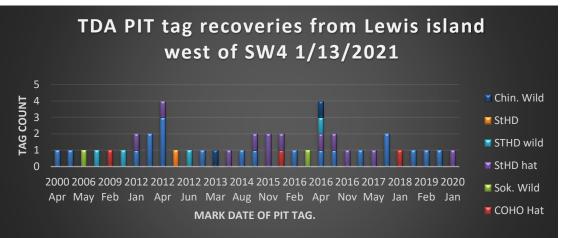
PIT tags recovered from gull and pelican rock resting area west of dam frequently flooded.
