# The Dalles Dam Fishway Status Report

3/21/2021

Inspection Period: 03/14-03/20

## THE DALLES DAM

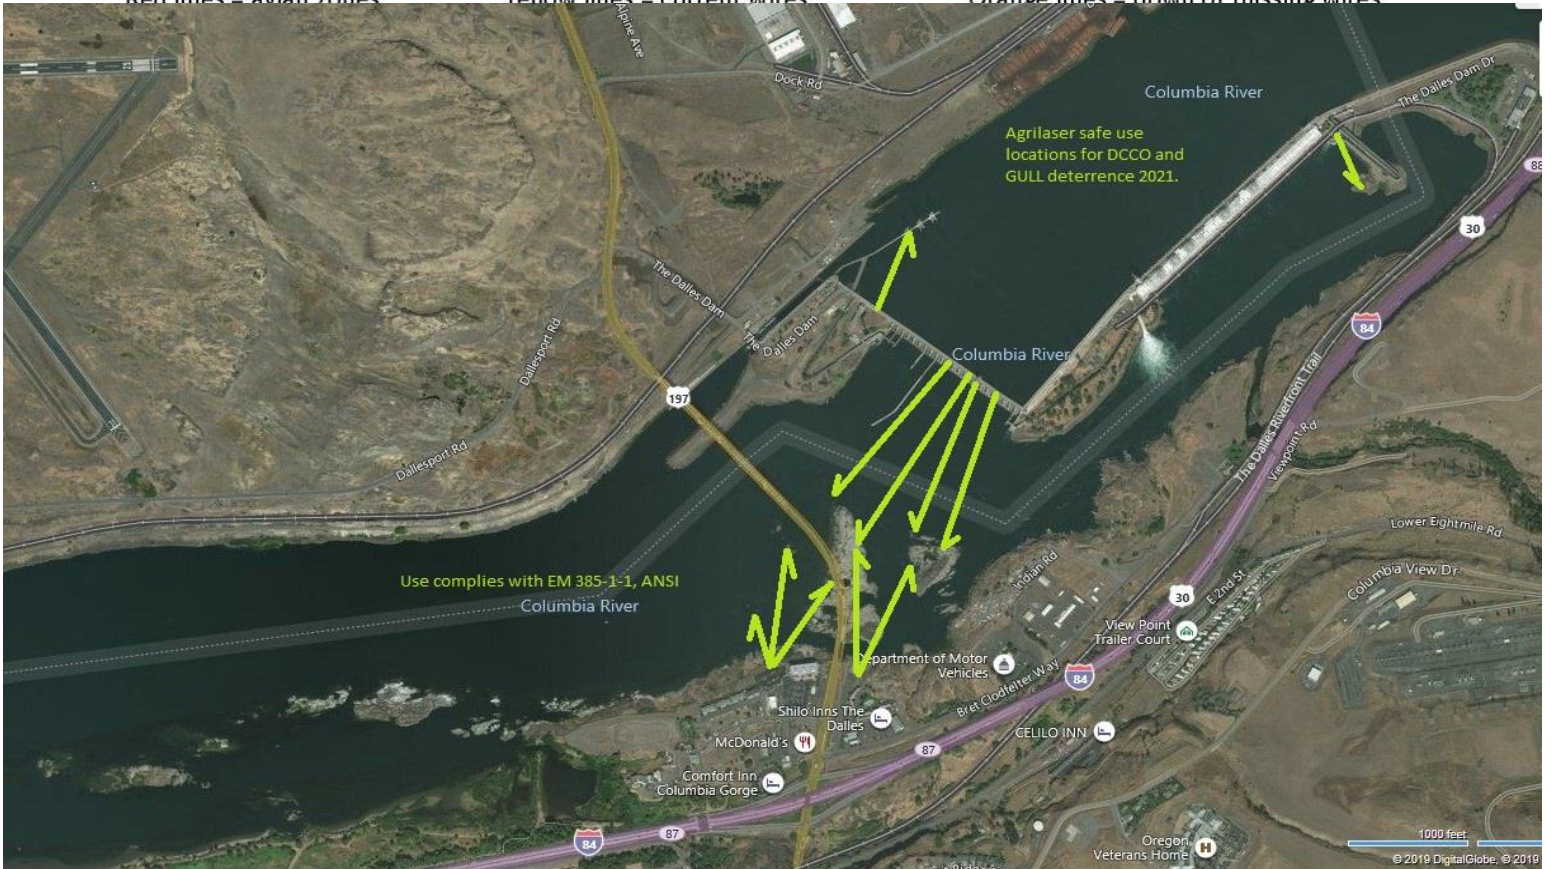
New Avian Lines and laser deterrent zones

Red lines = avian zones      Yellow lines = current wires      Orange lines = down or missing wires

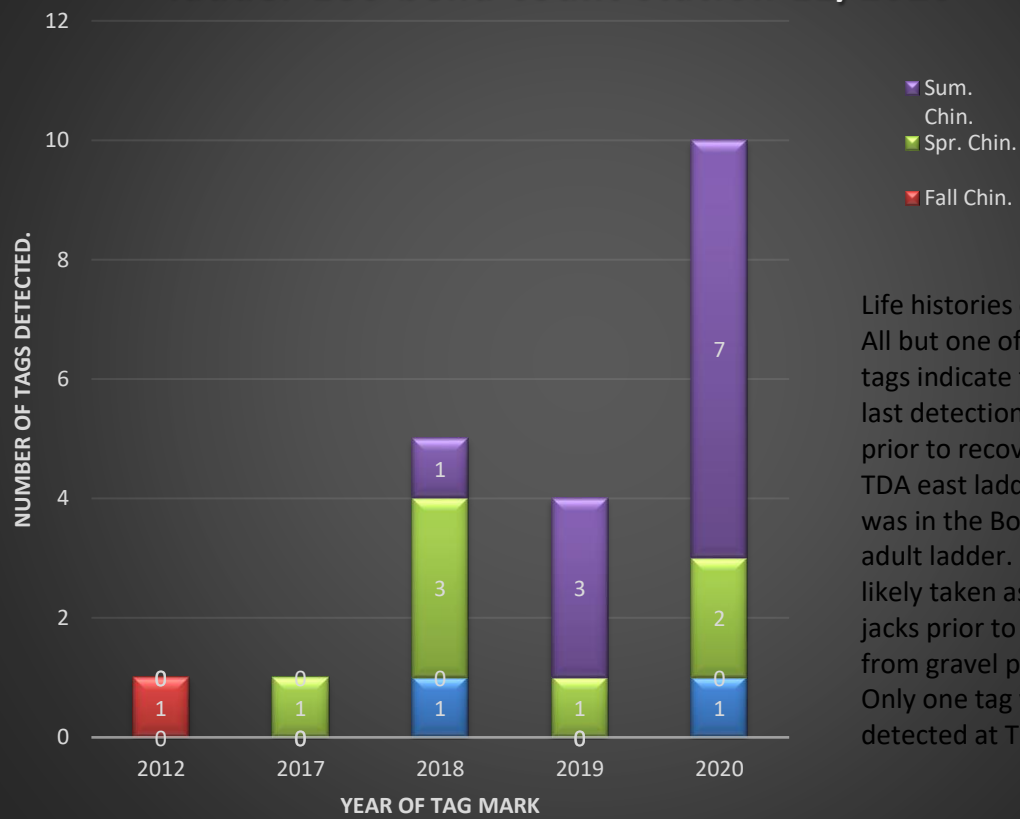
## PIT tag recoveries from inside TDA East fish ladder 180 bend count station 12/2020

Life histories of PIT tags: All but one of these tags indicate that the last detection event prior to recovery in TDA east ladder, was in the Bonneville adult ladder. These likely taken as mini-jacks prior to recovery from gravel pile at TDA. Only one tag was detected at TDA adult

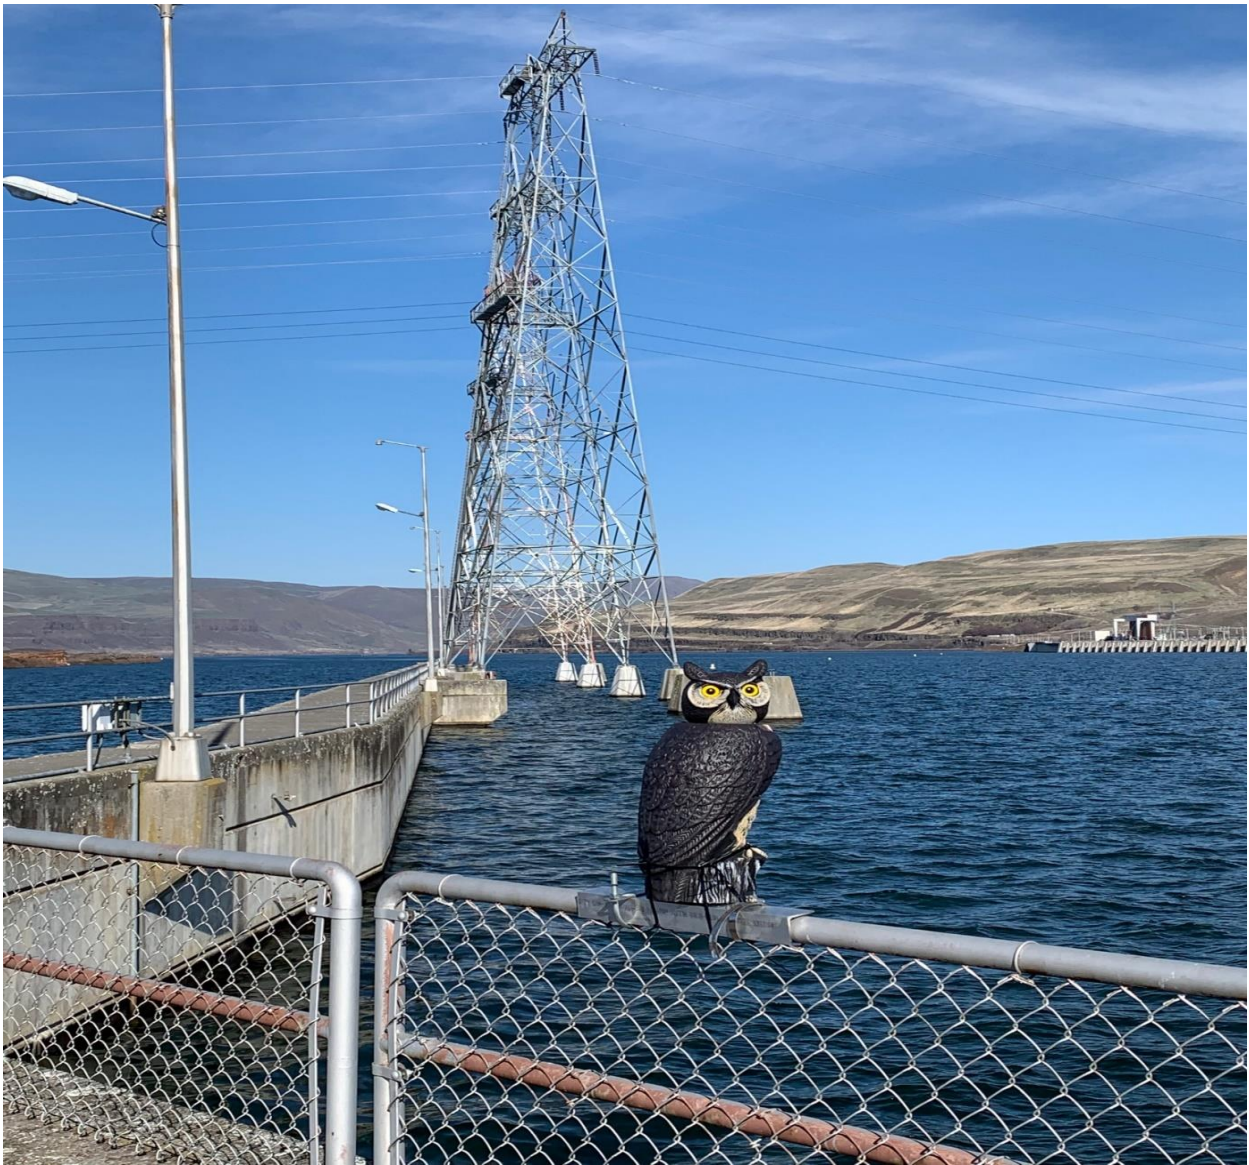
Tying something new for cormorant tower nesting. Head even rotates.
