# The Dalles Dam Fishway Status Report

3/28/2021

Inspection Period: 03/21-03/27

## THE DALLES DAM

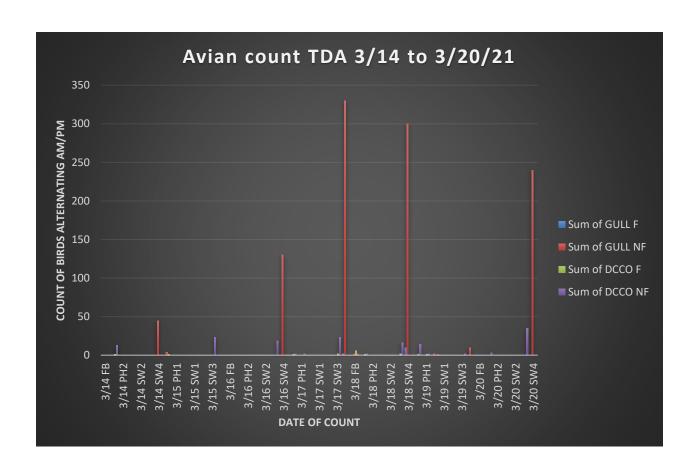
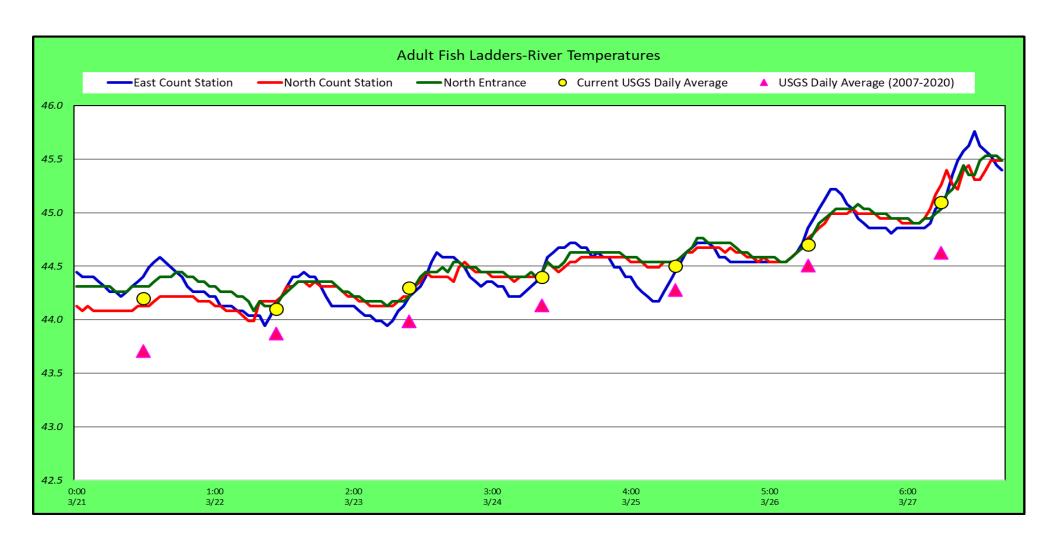
# New Avian Lines and laser deterrent zones

Green laser use for piscivorous bird hazing testing continues. Effective moving cormorants off of BPA towers at dusk.

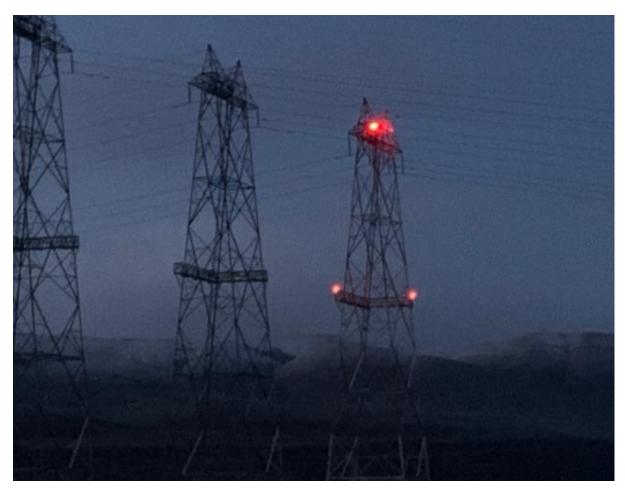
Laser most effective during twilight to deter comorants from overnight roosting. Detering up to 135 cormorants.
