The Dalles Dam Fishway Status Report

5/2/2021

Inspection Period: 04/25-5/1

THE DALLES DAM

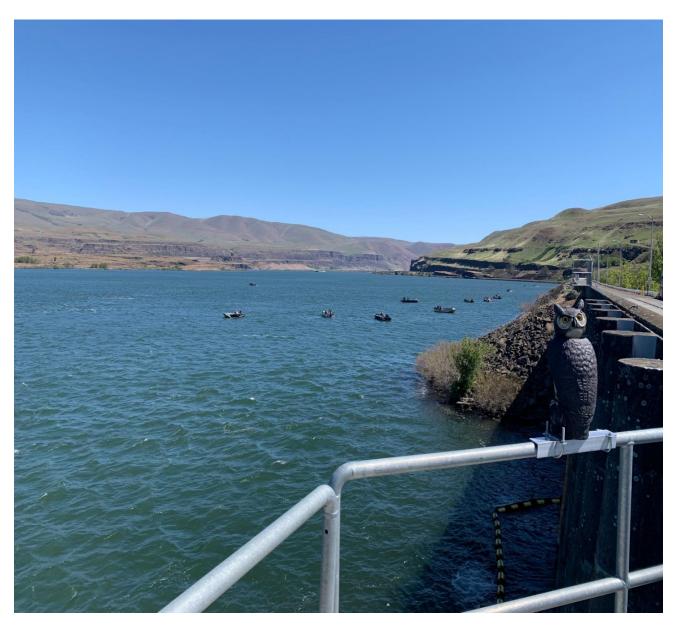
Sunday morning sport fishing upstream of the east ladder exit. Owl decoy doesn't work on them. We often observe them well within 50' of exit.
