The Dalles Dam Fishway Status Report

5/23/2021

Inspection Period: 5/16-5/22

THE DALLES DAM

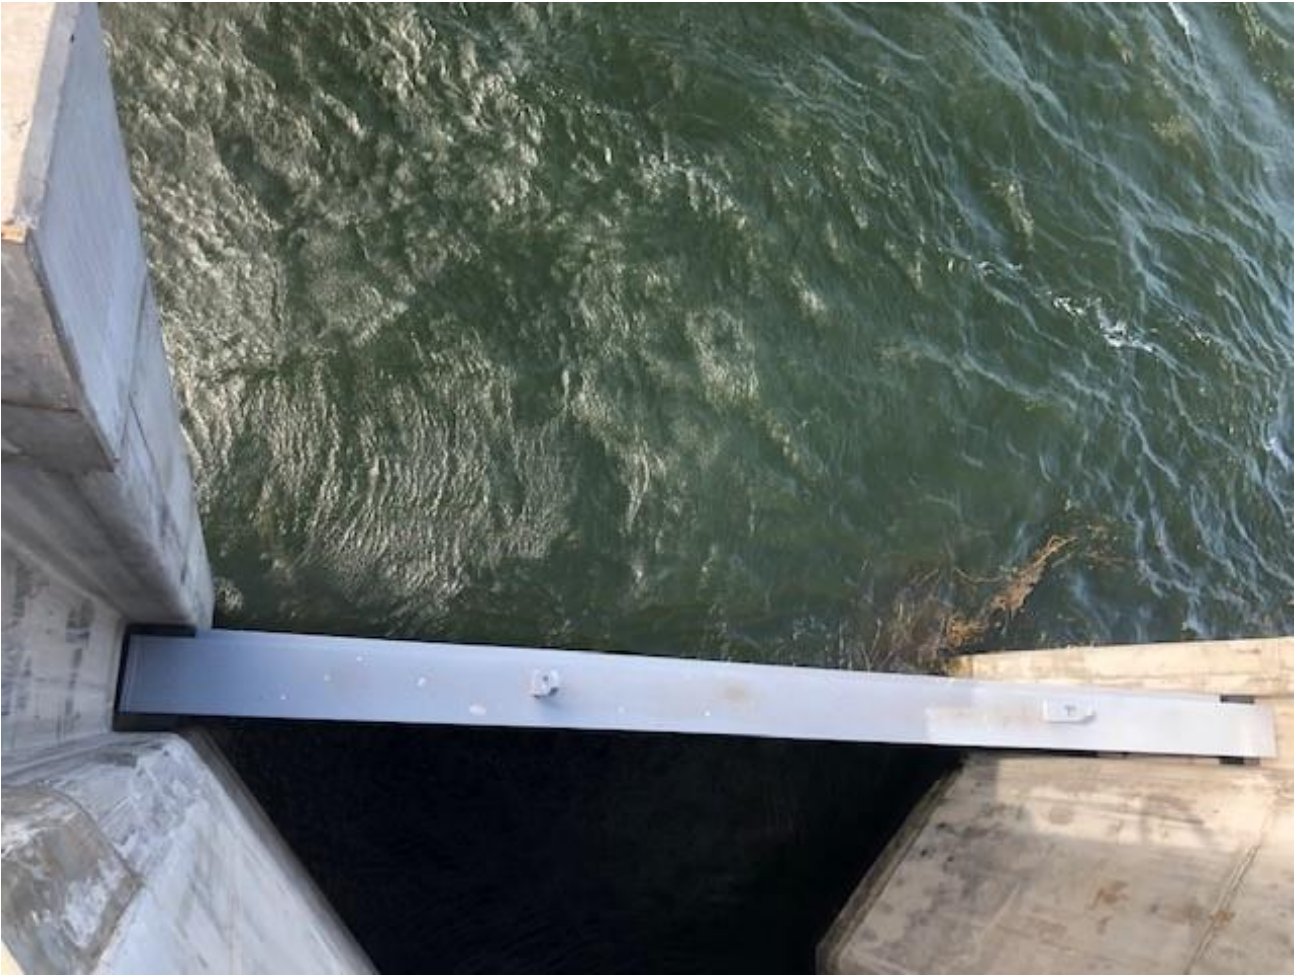
AWS backup system closed just prior to return to fish unit 1. Intake differential increased requiring a second closure cycle to clear. Visible milfoil floated off.

AWS intake, floating off debris during close cycle

AWS intake trashrack - EDR funded for FY21 to investigate solution for debris plugging issue. PDT meetings in progress.
