The Dalles Dam Fishway Status Report

5/30/2021

Inspection Period: 5/26-5/29

THE DALLES DAM

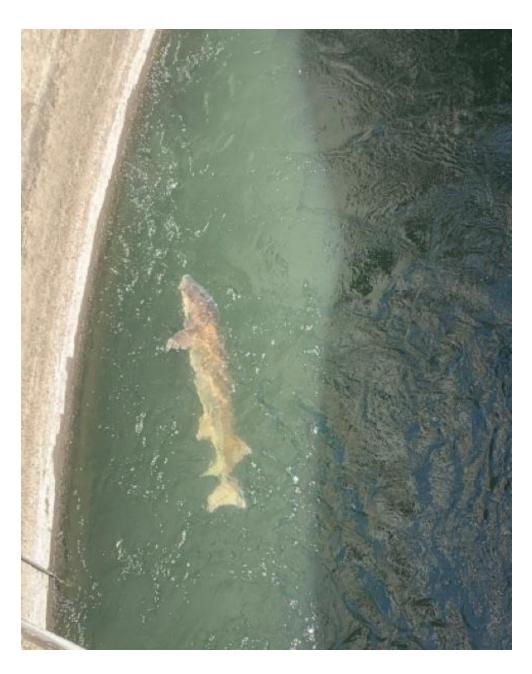
Sturgeons in the east ladder transportation channel chasing adult shad. 5/26/2021

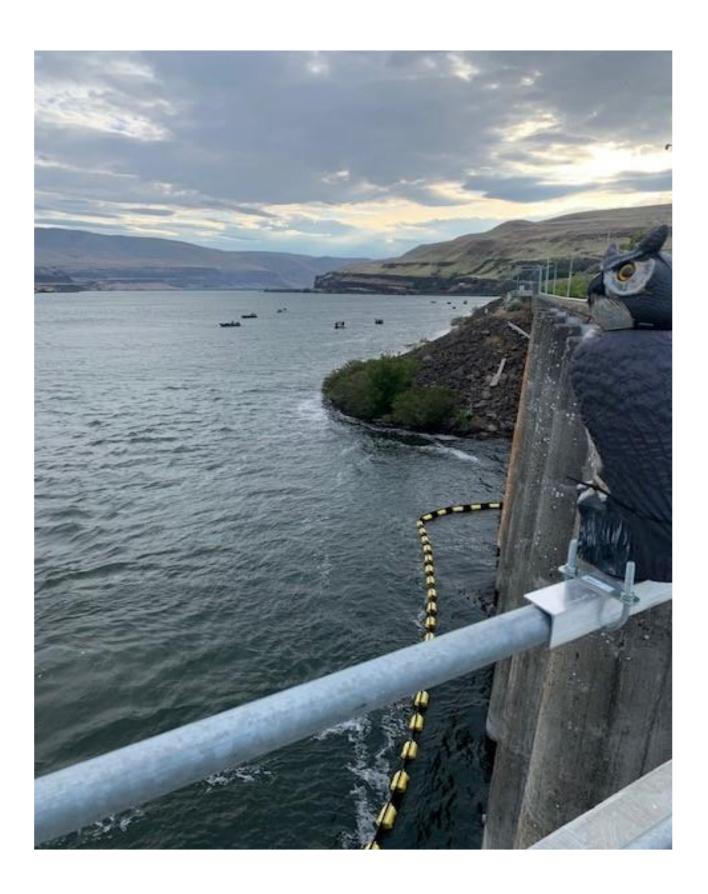
Unhappy sport fishers behaving. Staying greater than 200' from east exit.
