# The Dalles Dam Fishway Status Report

6/6/2021

Inspection Period: 5/30-6/5

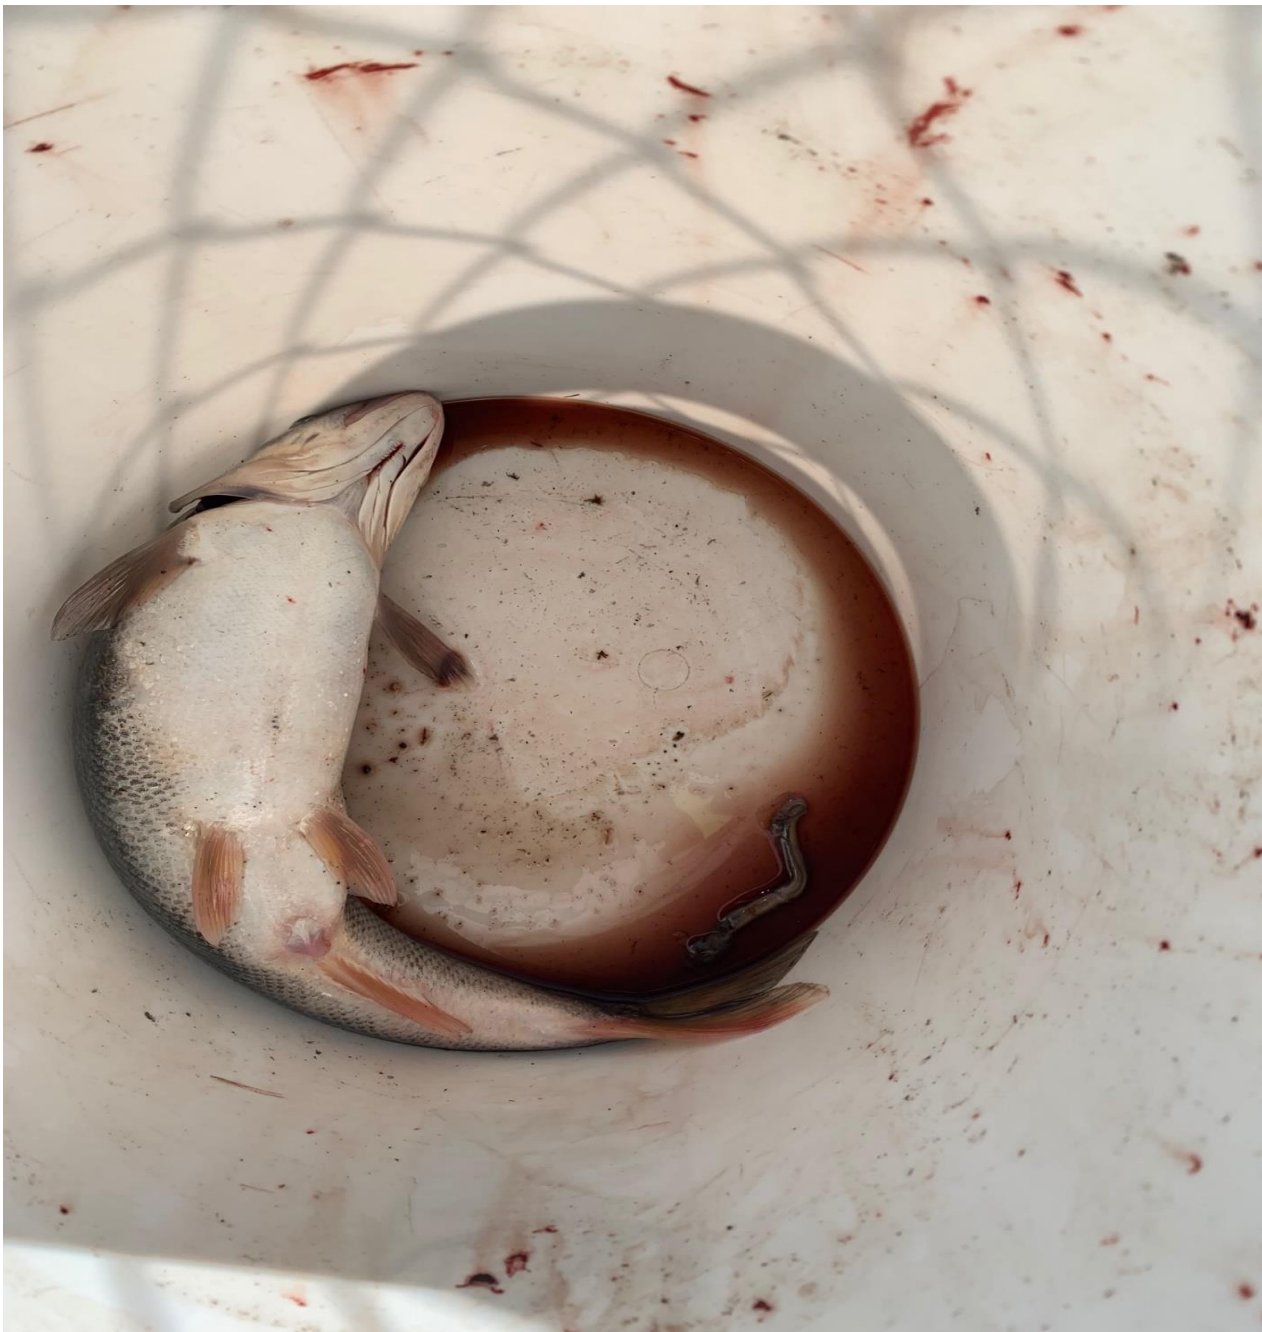
Pikeminnow harvested by dam anglers, puking juv lamprey. **What about the released bass and walleye?**
