The Dalles Dam Fishway Status Report

6/20/2021

Inspection Period: 6/13-6/19

US Army Corps
of Engineers
Portland District

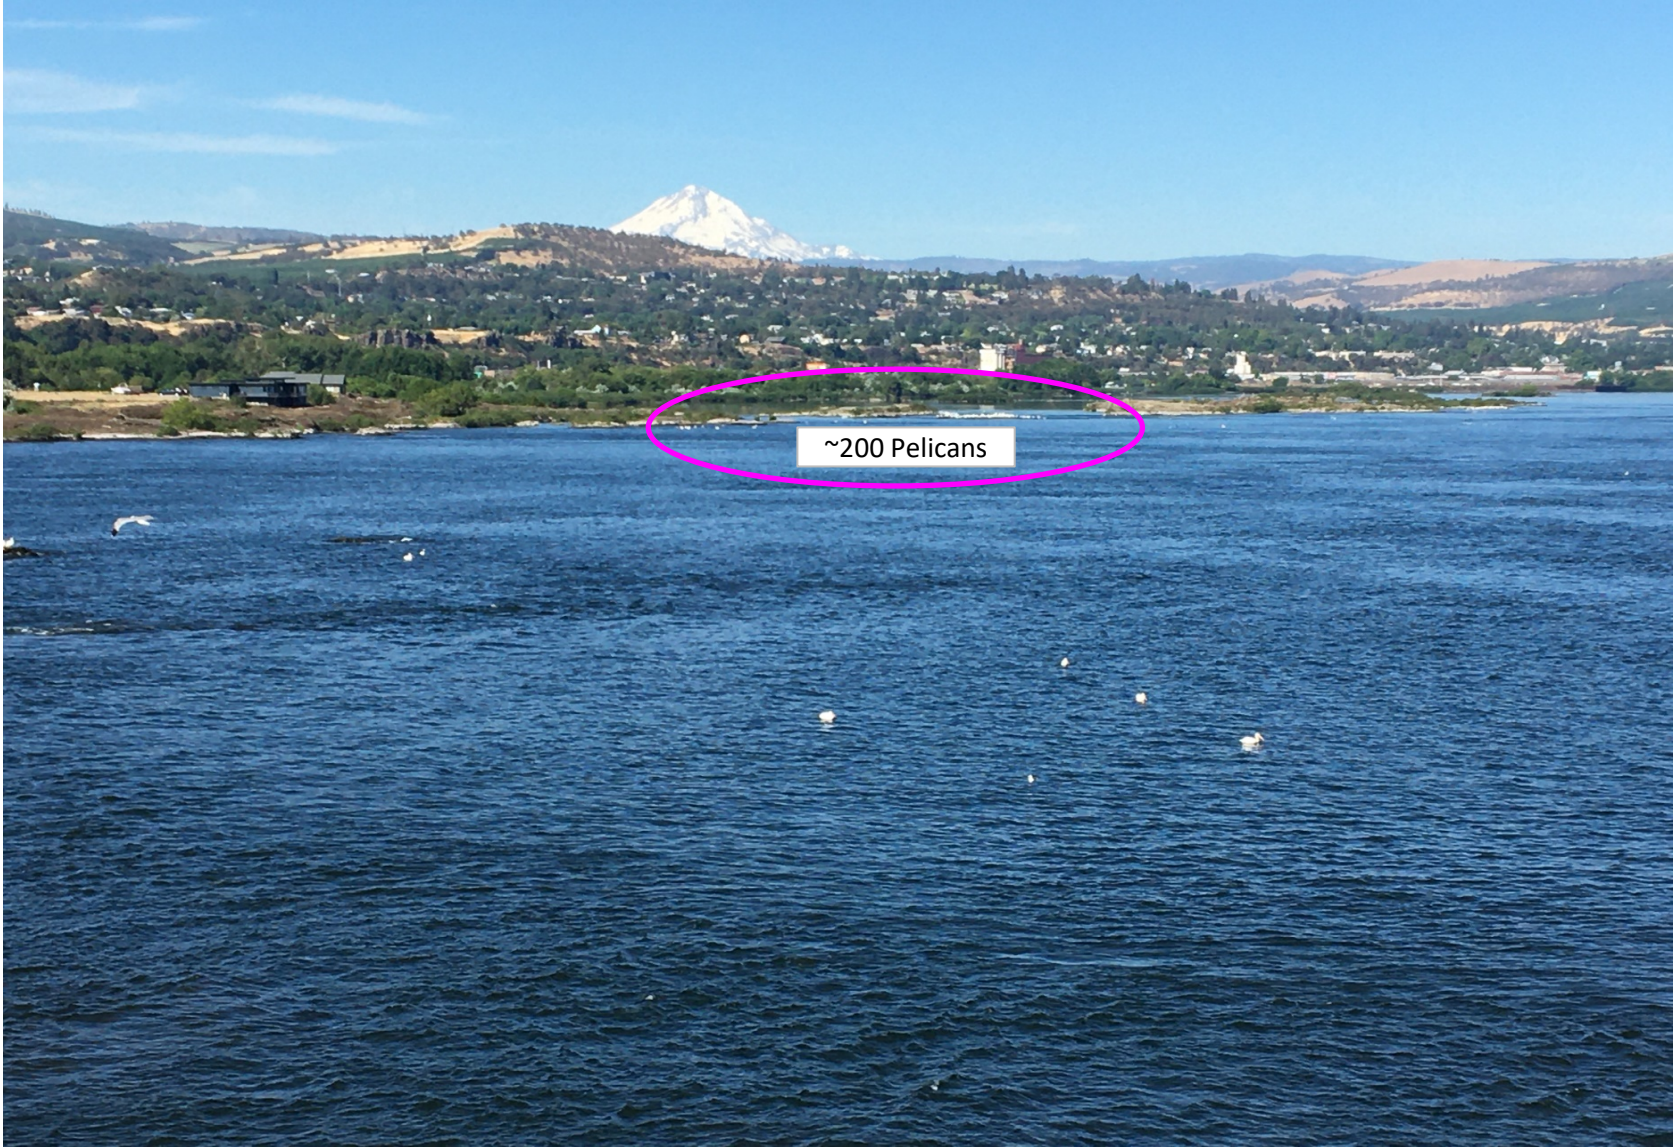
~200 Pelicans

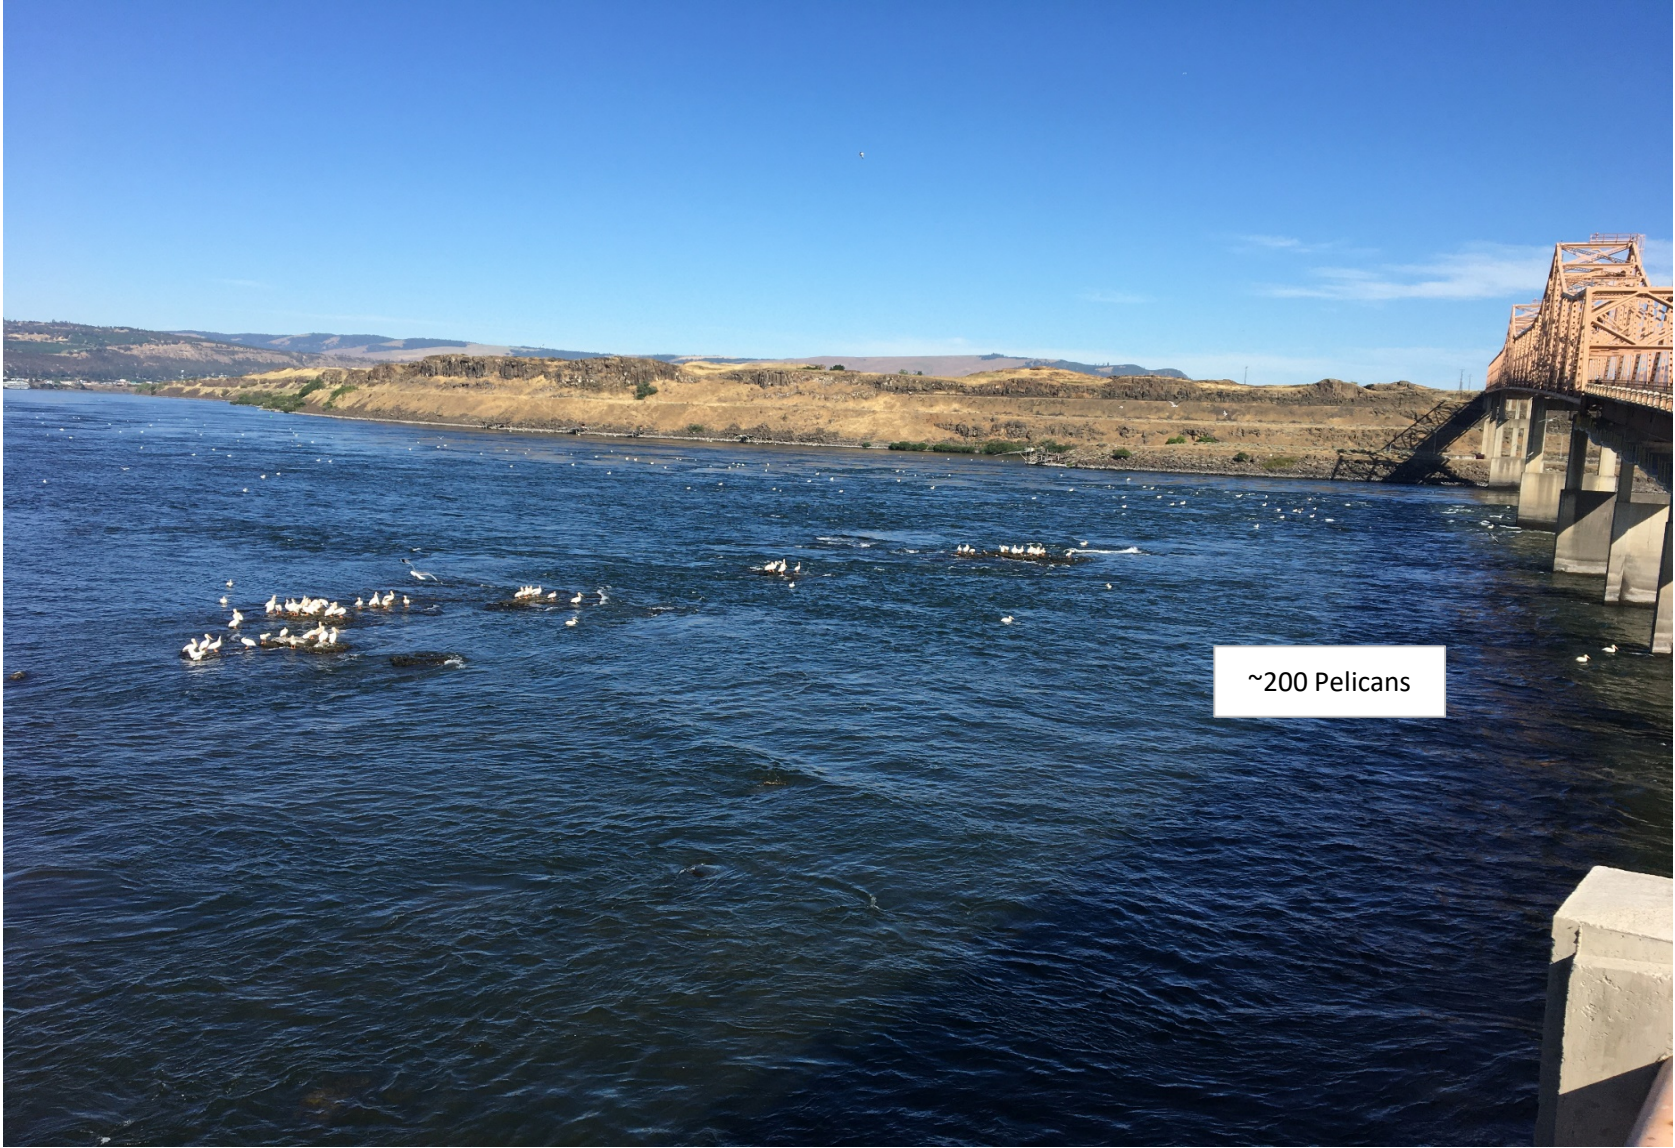
~200 Pelicans

Pelicans appear to be rotating through zones
culminating below spill for optimal feeding
