The Dalles Dam Fishway Status Report

Inspection Period: 6/20-6/26

THE DALLES DAM

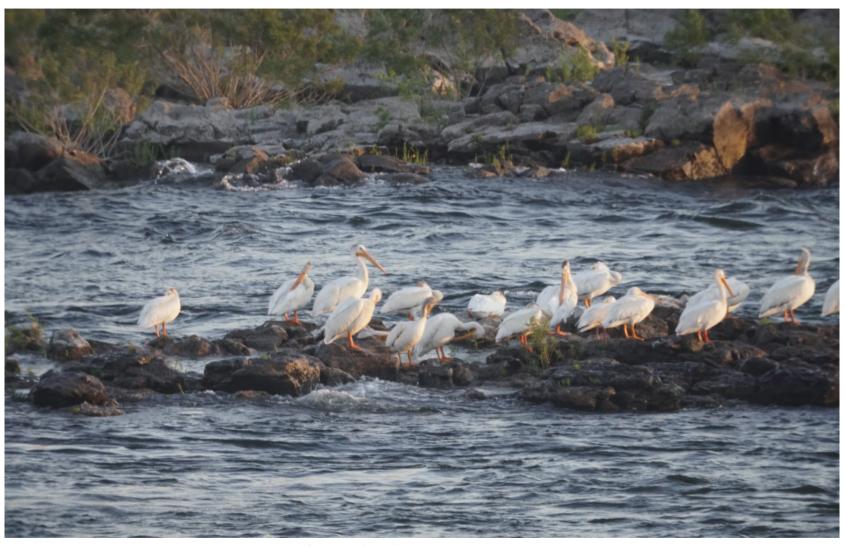
Pelicans resting in SW3 after feeding below spillway-displacing gulls.
