# The Dalles Dam Fishway Status Report

7/25/21

Inspection Period: 7/18-7/24

US Army Corps  
of Engineers  
Portland District

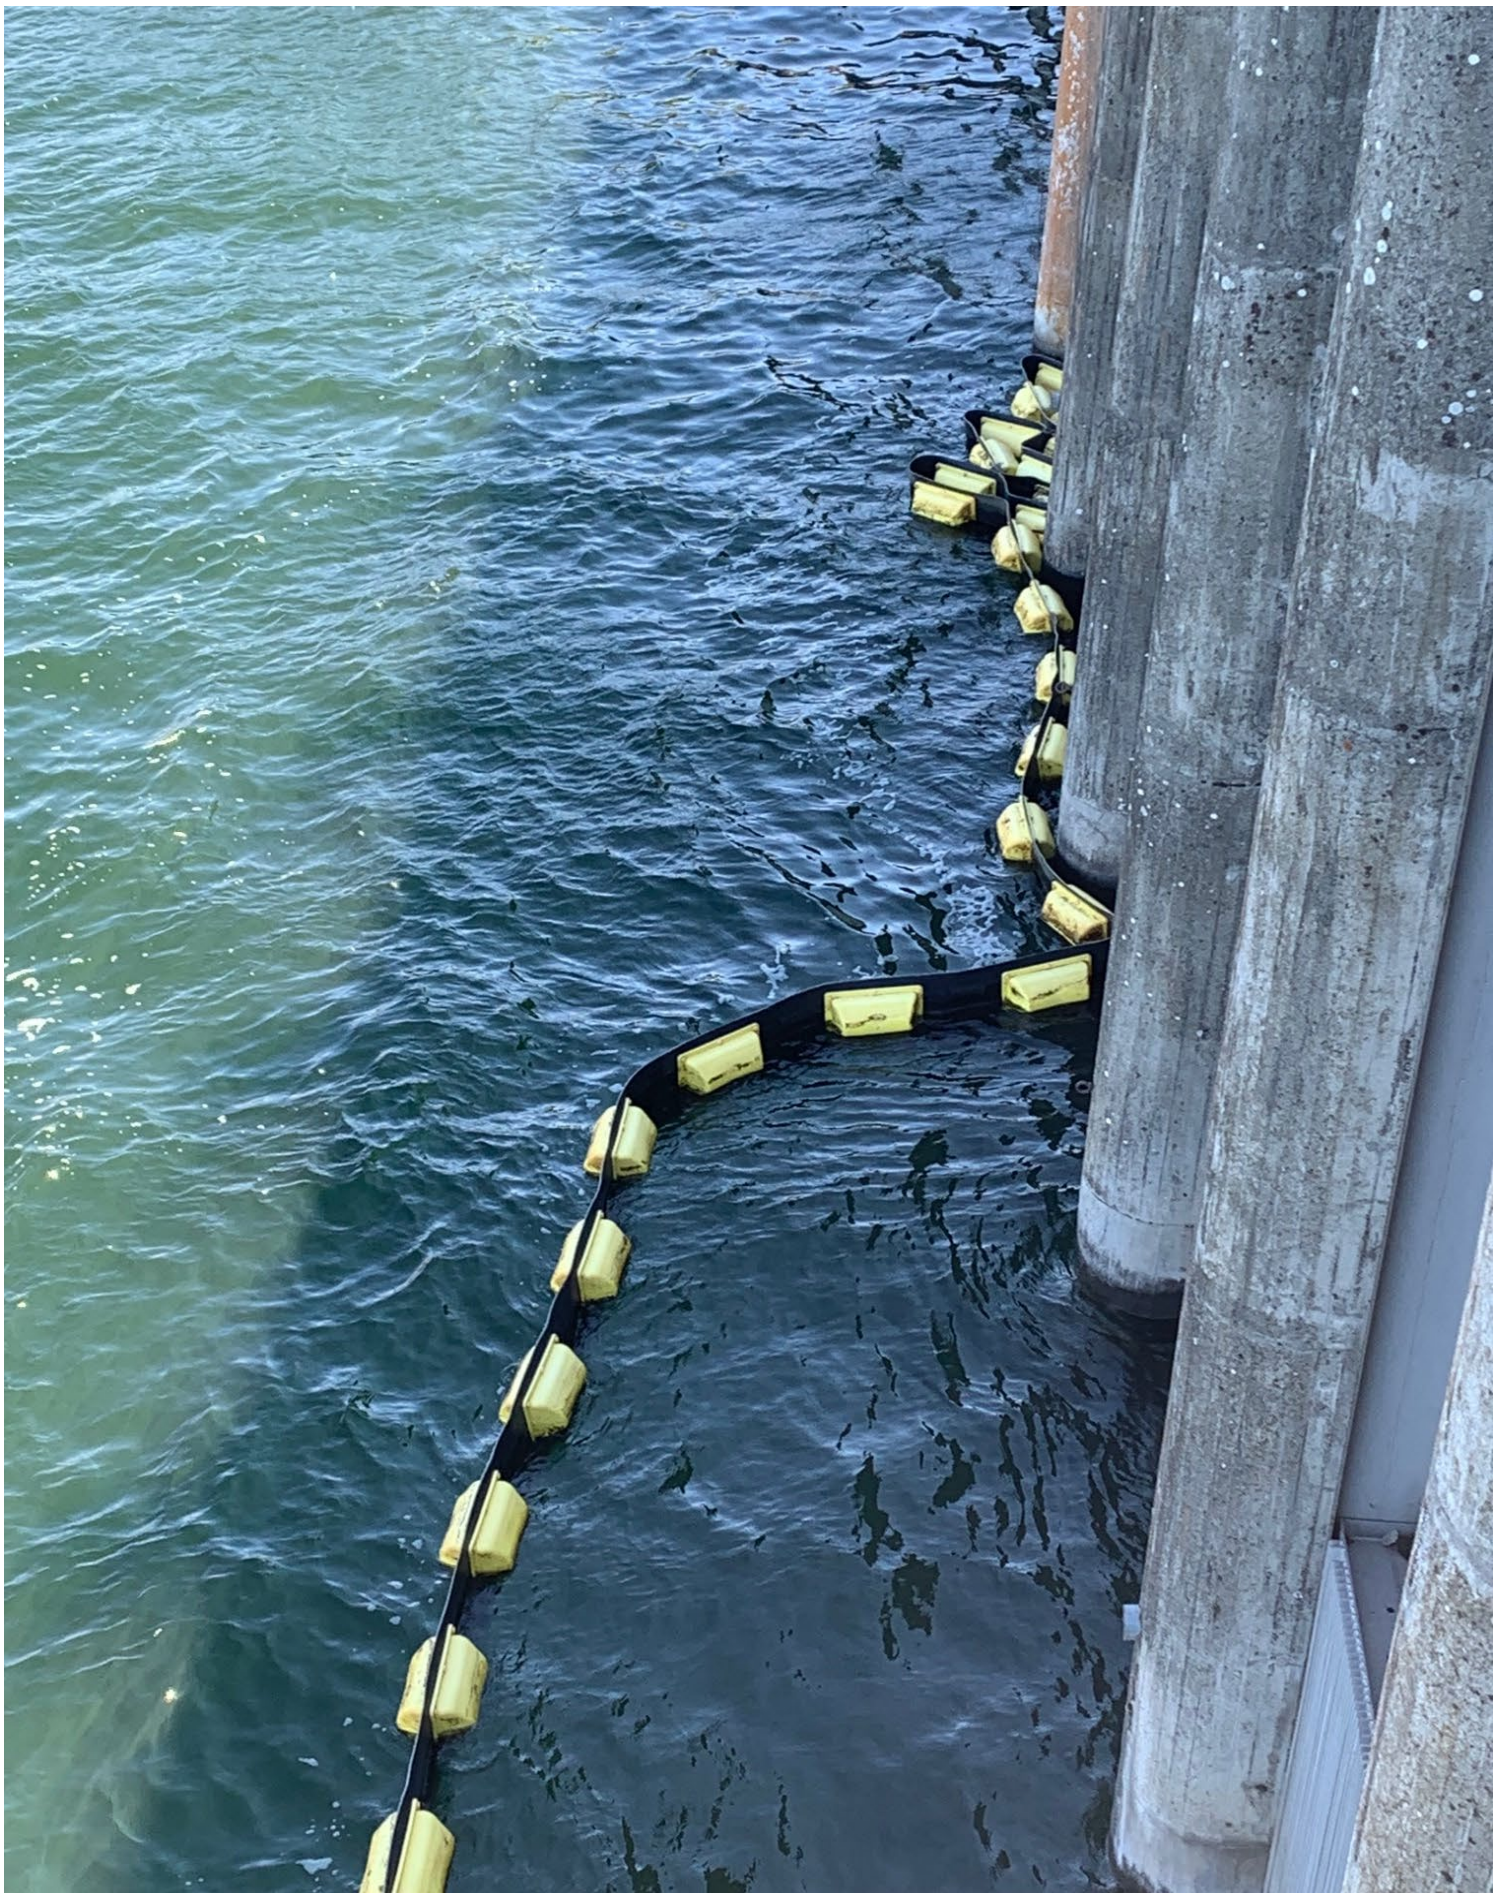
Spillway assessment (MRER); Spillgates 1- 9 rehab date estimate 2034. Includes replacement of spillbay 9 trunnion pin repair  
PUD intake rake returned to service with temporary power. Exploring permanent options.  
Five of 6 east fishway collection channel dewatering pumps removed for repair/rehab. Work to resume in July.  
Fishway automation replacement on hold from lack of staff. East exit, east and south entrances complete. West and north operating with old system.  
Oil boom protecting east exit became unattached, work underway to secure

Boom at East Exit failed at upstream attachment

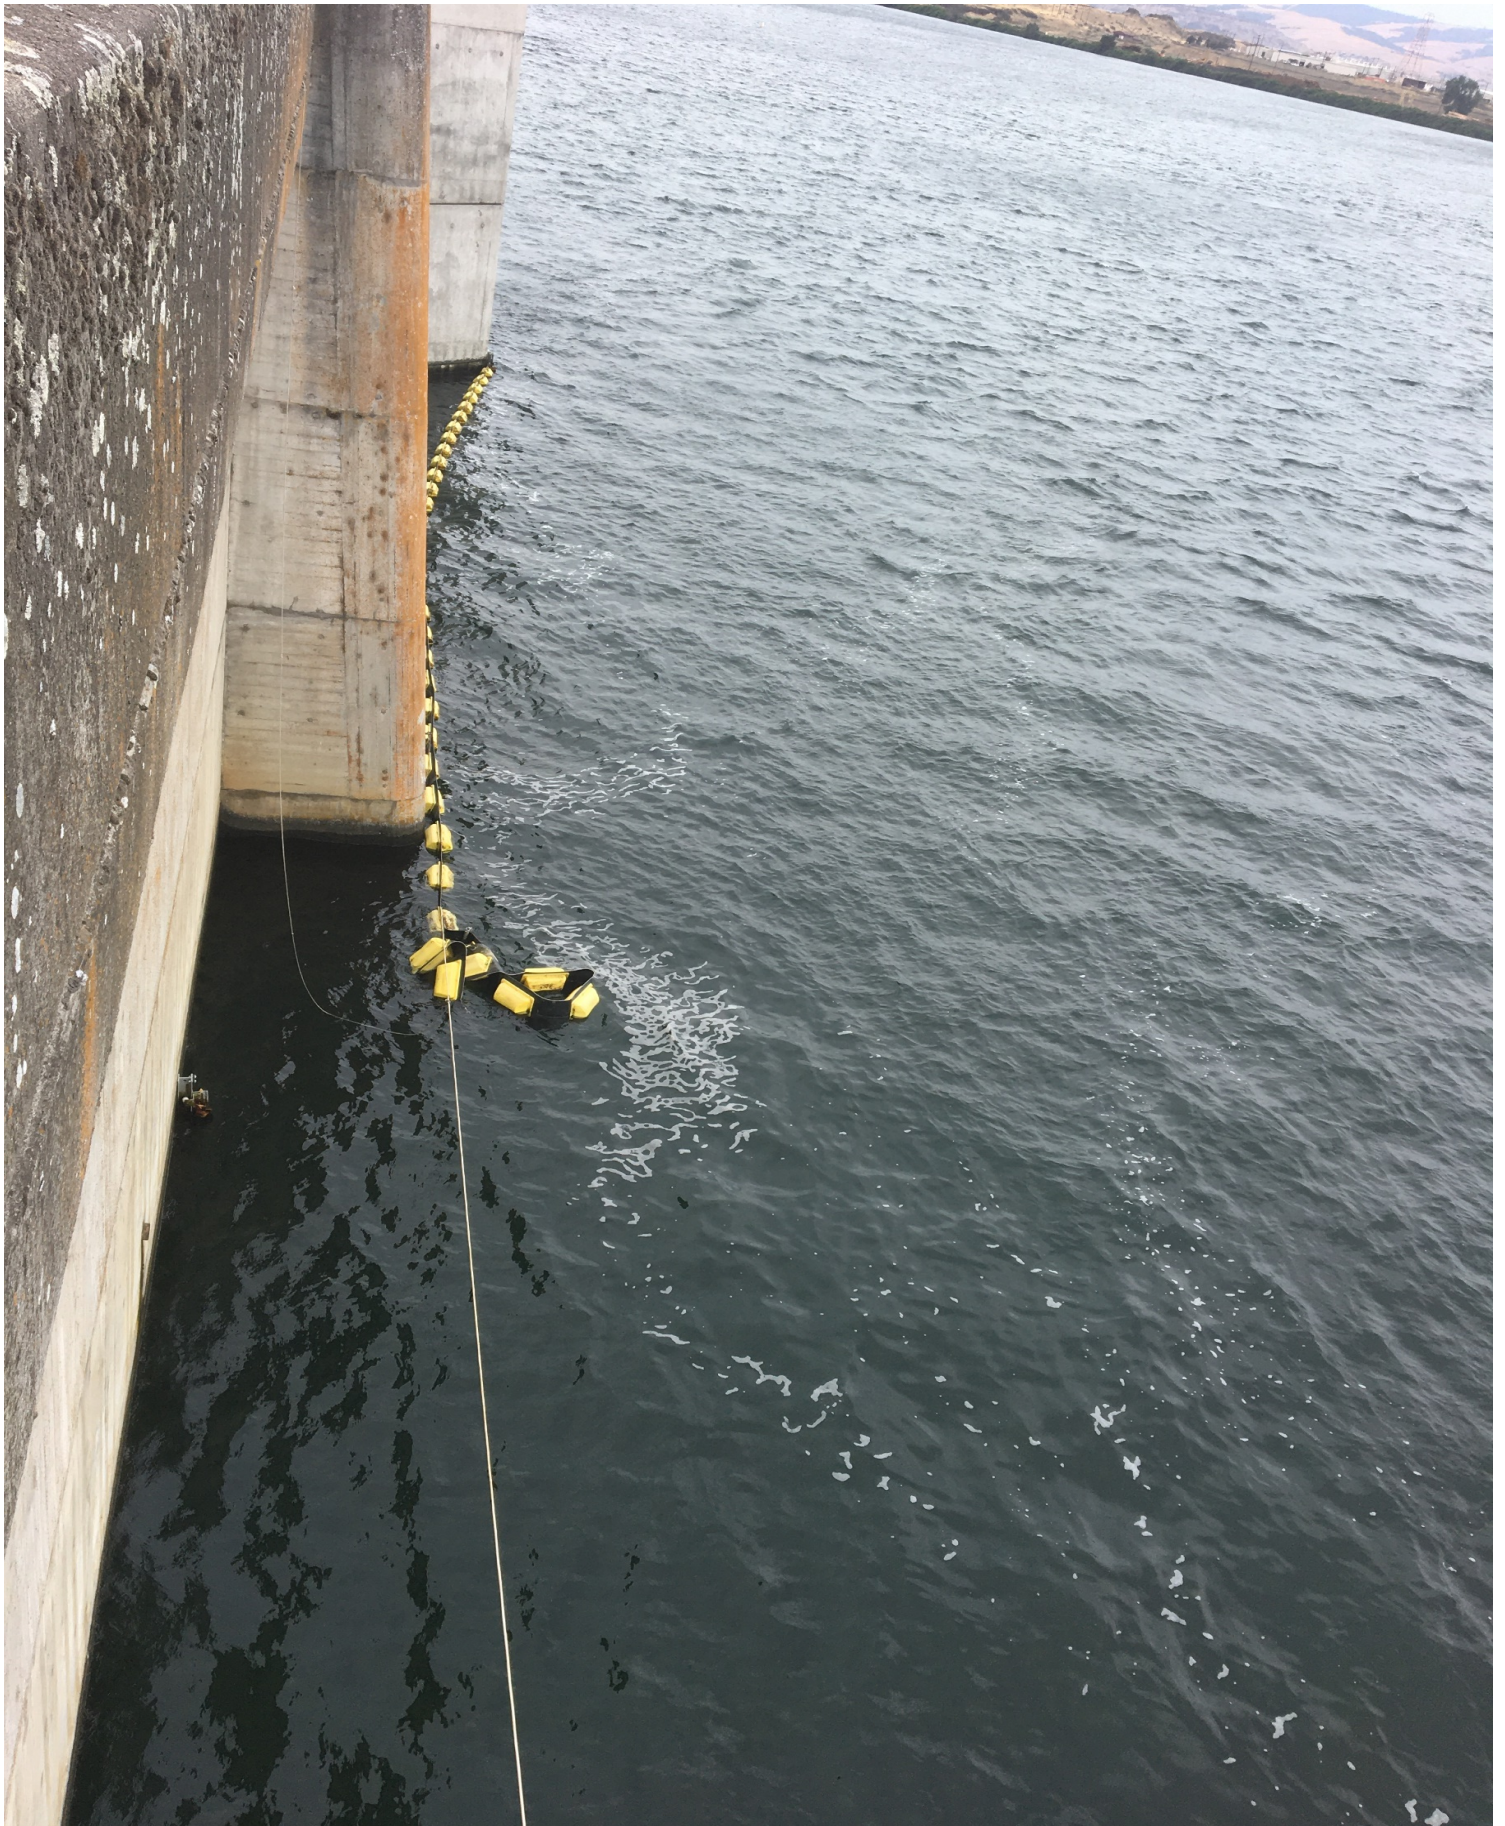
current-temporary status east exit oil boom
