# The Dalles Dam Fishway Status Report

8/8/21

Inspection Period: 8/01-8/07

US Army Corps  
of Engineers  
Portland District

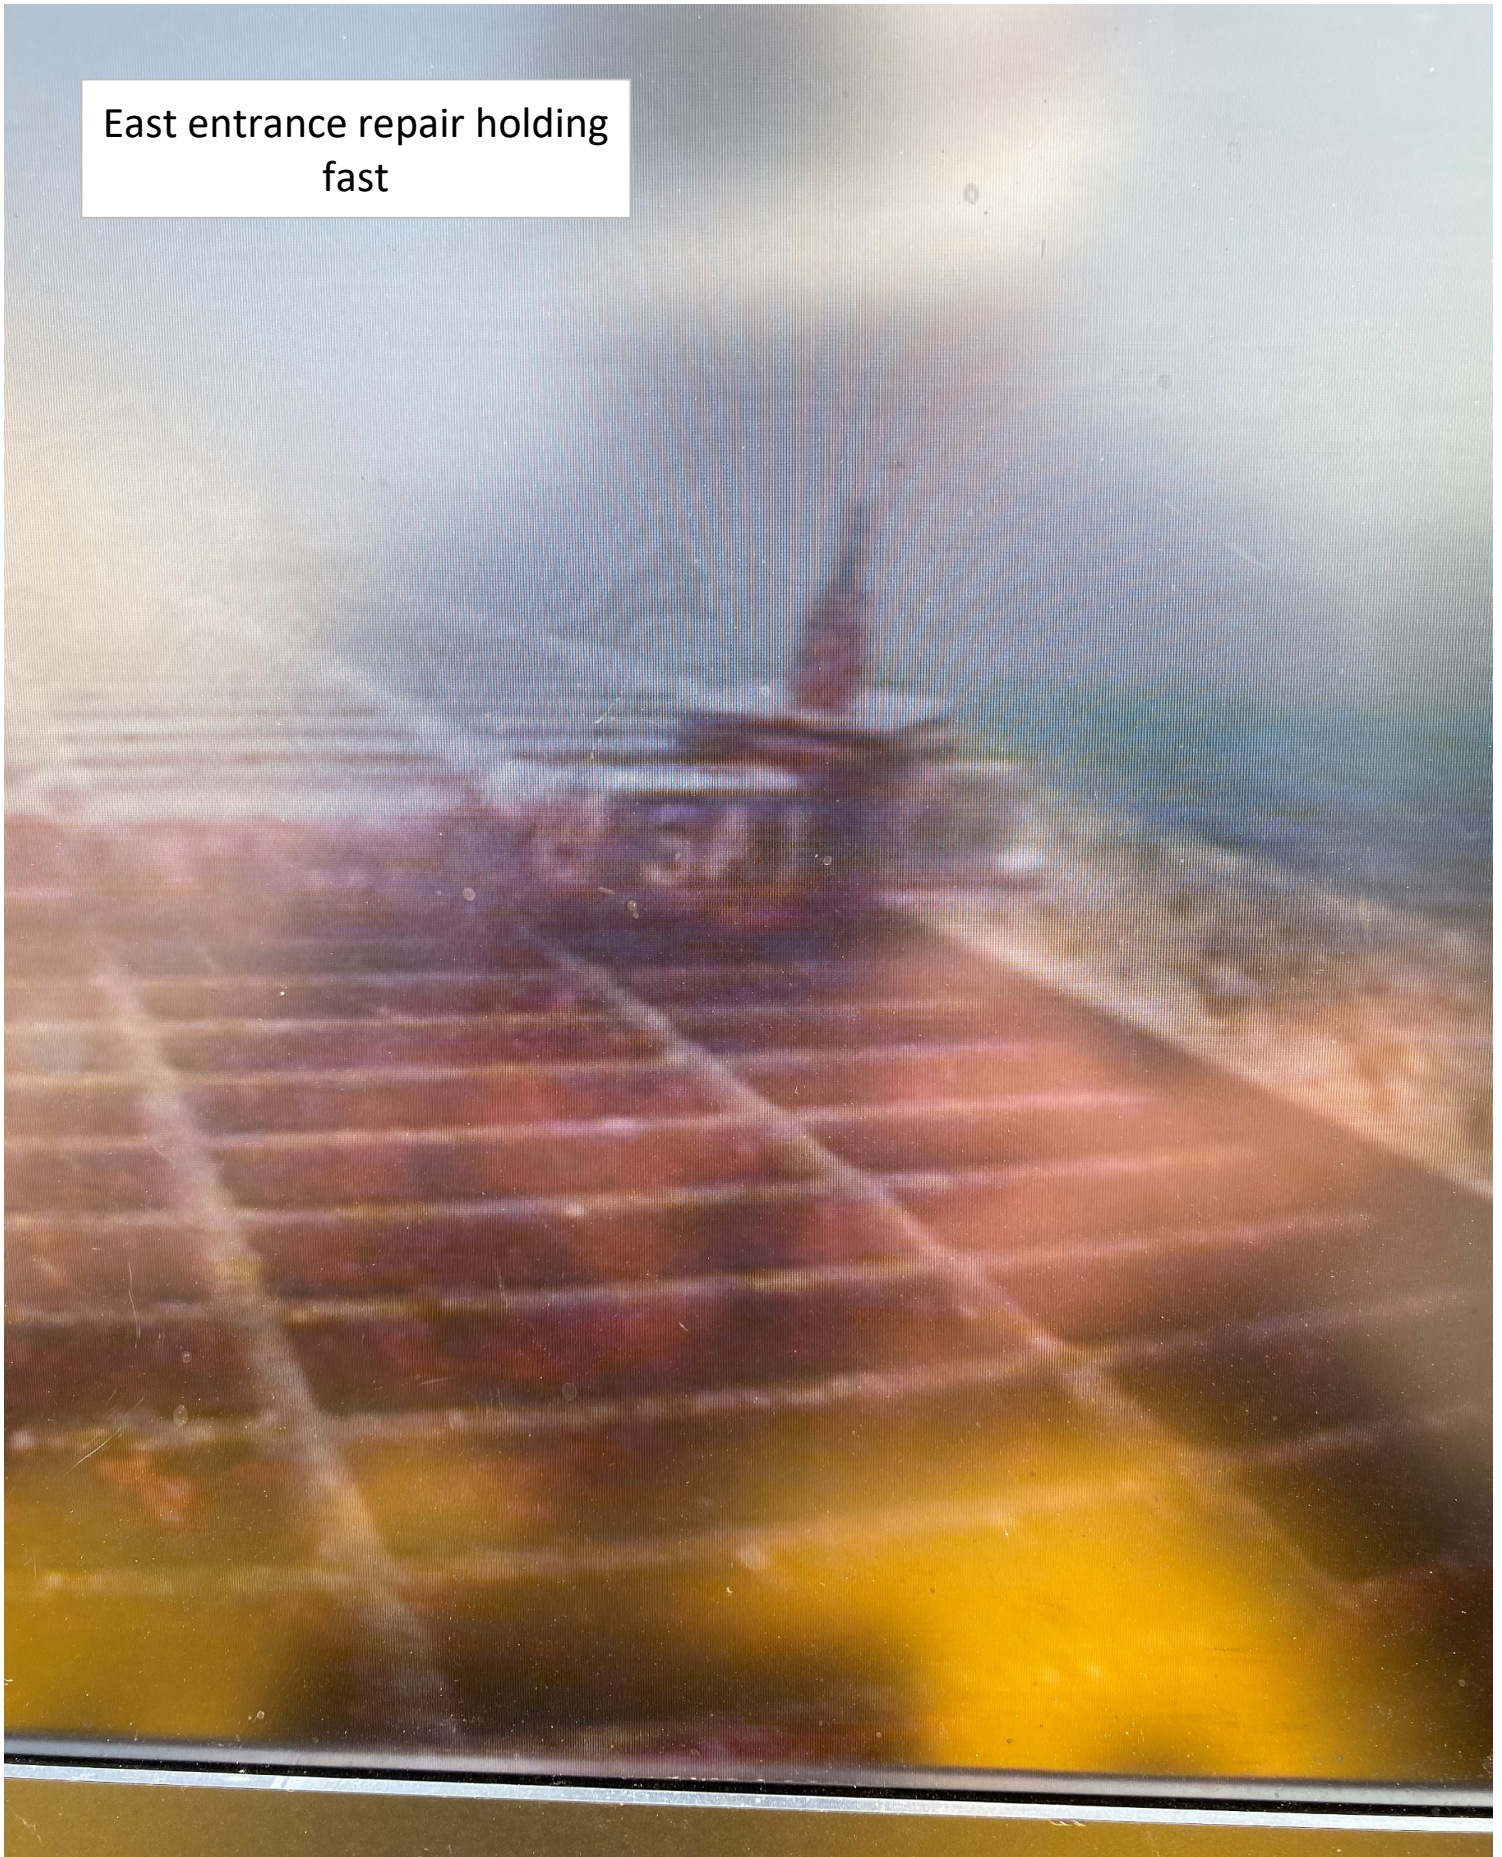
East entrance repair holding  
fast
