# The Dalles Dam Fishway Status Report

Inspection Period: 8/29-9/4/2021

## THE DALLES DAM

US Army Corps  
of Engineers  
Portland District

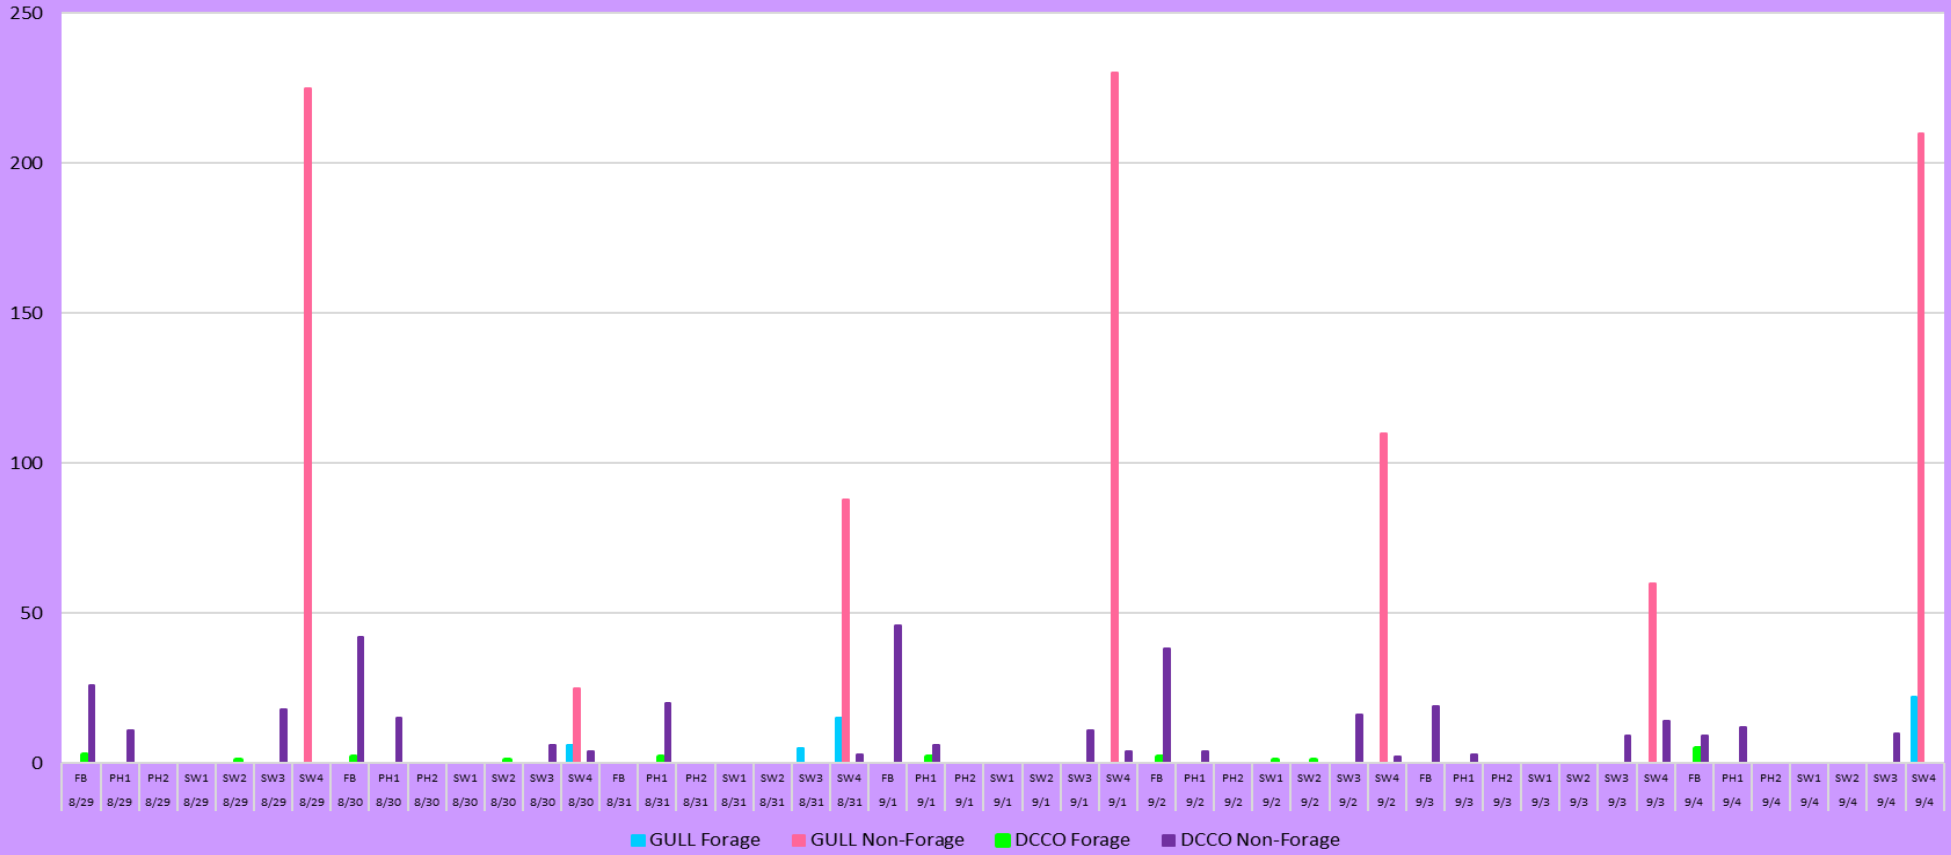
### Piscivorous Avian Activity

Cormorants successfully foraging, gulls present with little foraging, mergansers present-we speculate are here for the emerging juvenile shad

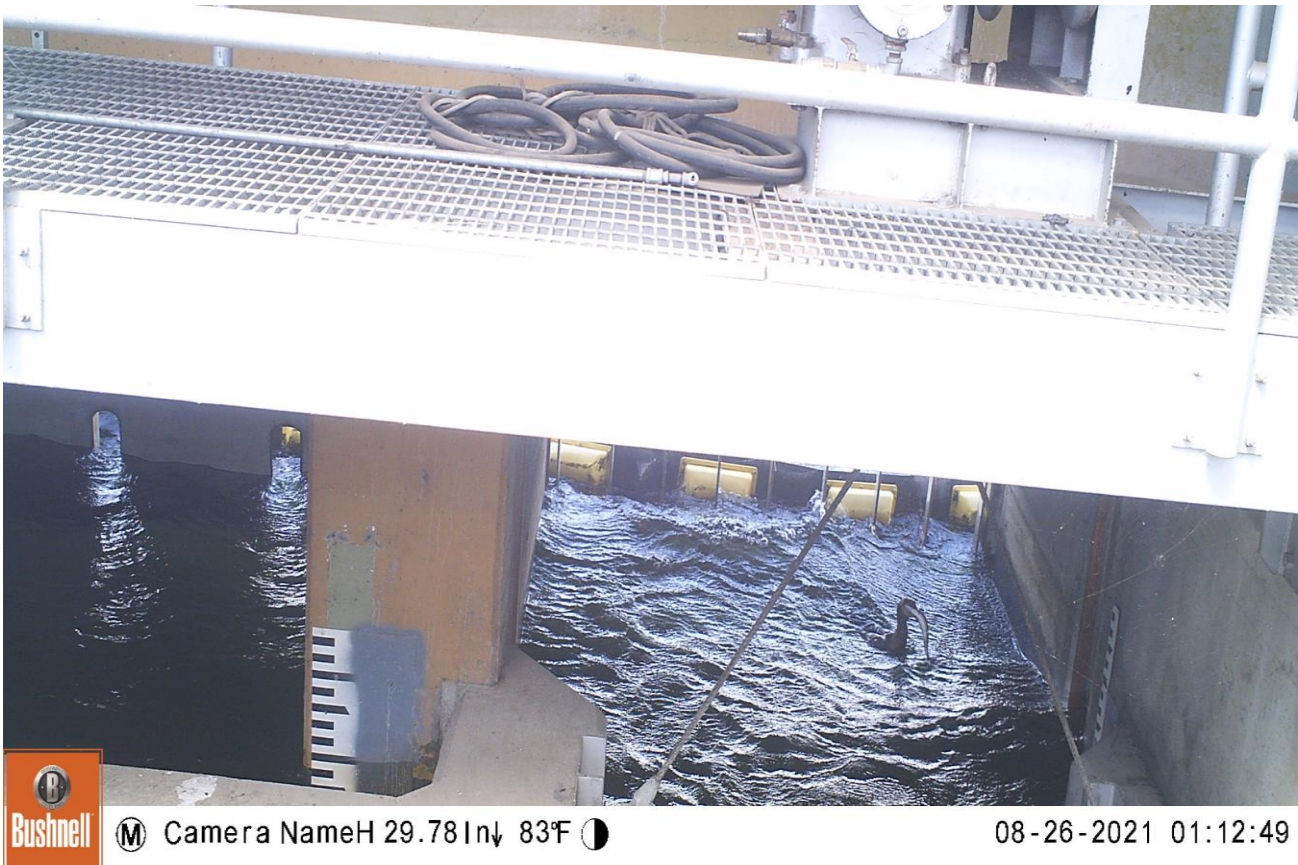
Busted! Game camera evidence of Cormorants feeding on salmonids inside fishladder.
