# The Dalles Dam Fishway Status Report

Inspection Period:9/5-9/11/2021

## THE DALLES DAM

US Army Corps  
of Engineers  
Portland District

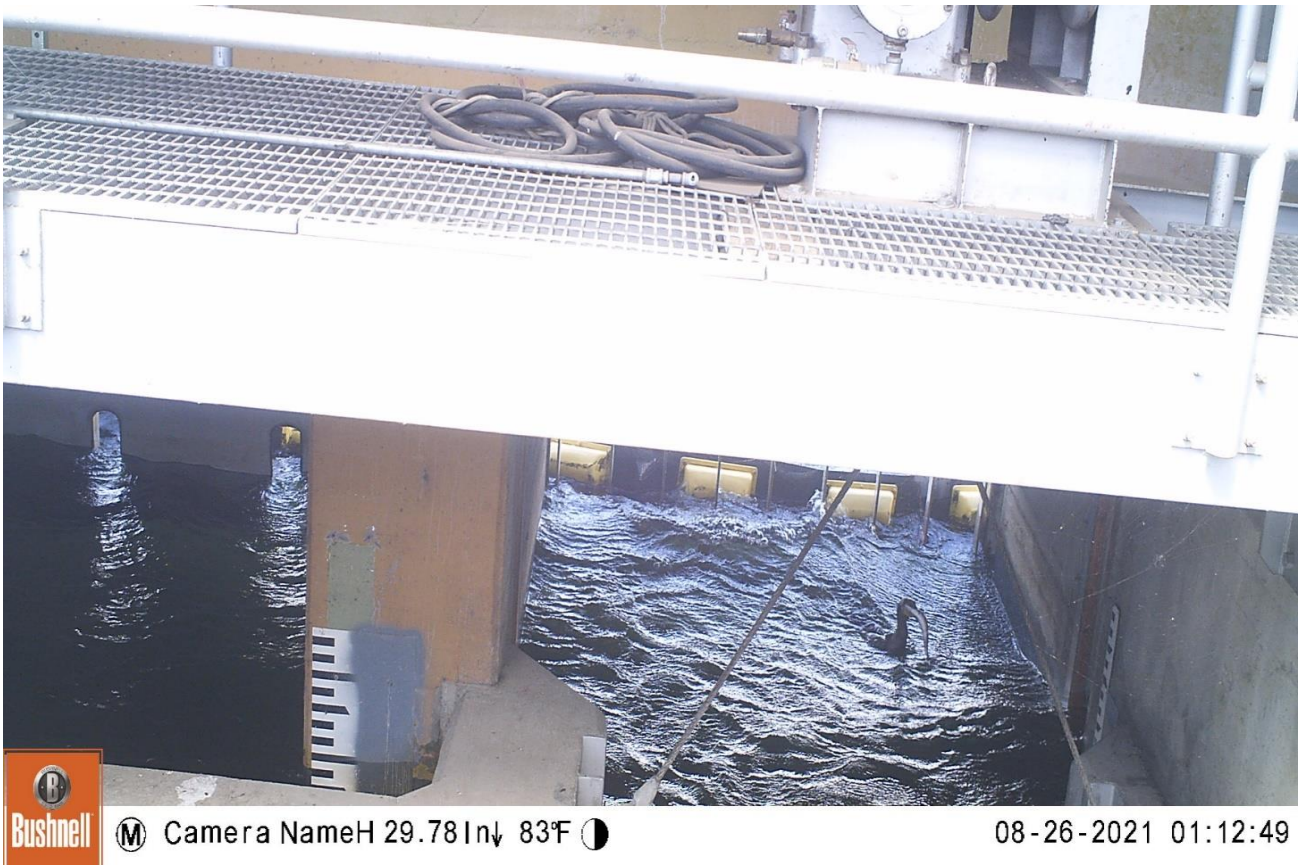
Busted! Game camera evidence of Cormorants feeding on salmonids inside fishladder.
