The Dalles Dam Fishway Status Report

Inspection Period:9/20-9/25/2021

THE DALLES DAM

US Army Corps
of Engineers
Portland District

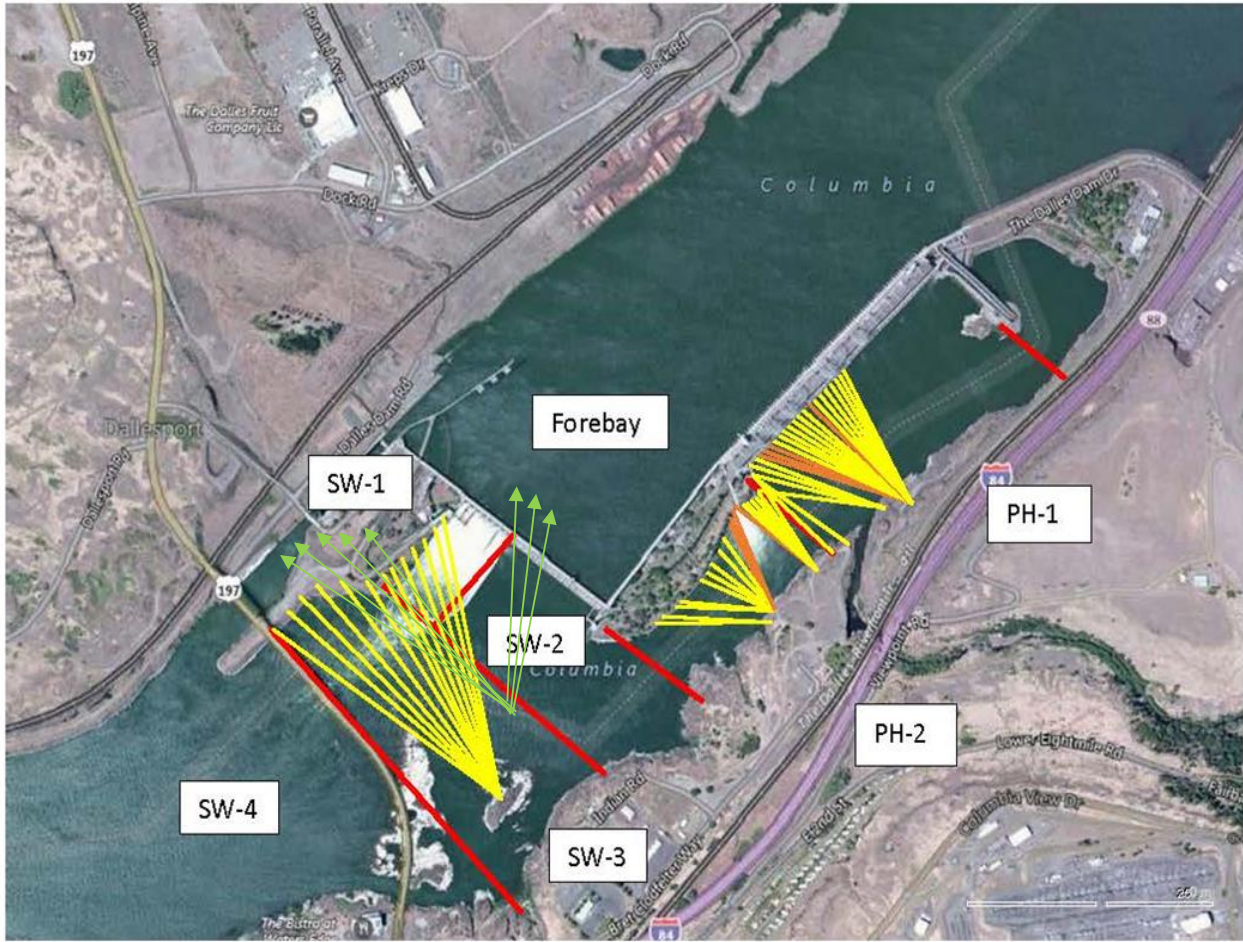
New Avian Lines and laser deterrent zones

Orange lines = down or missing wires

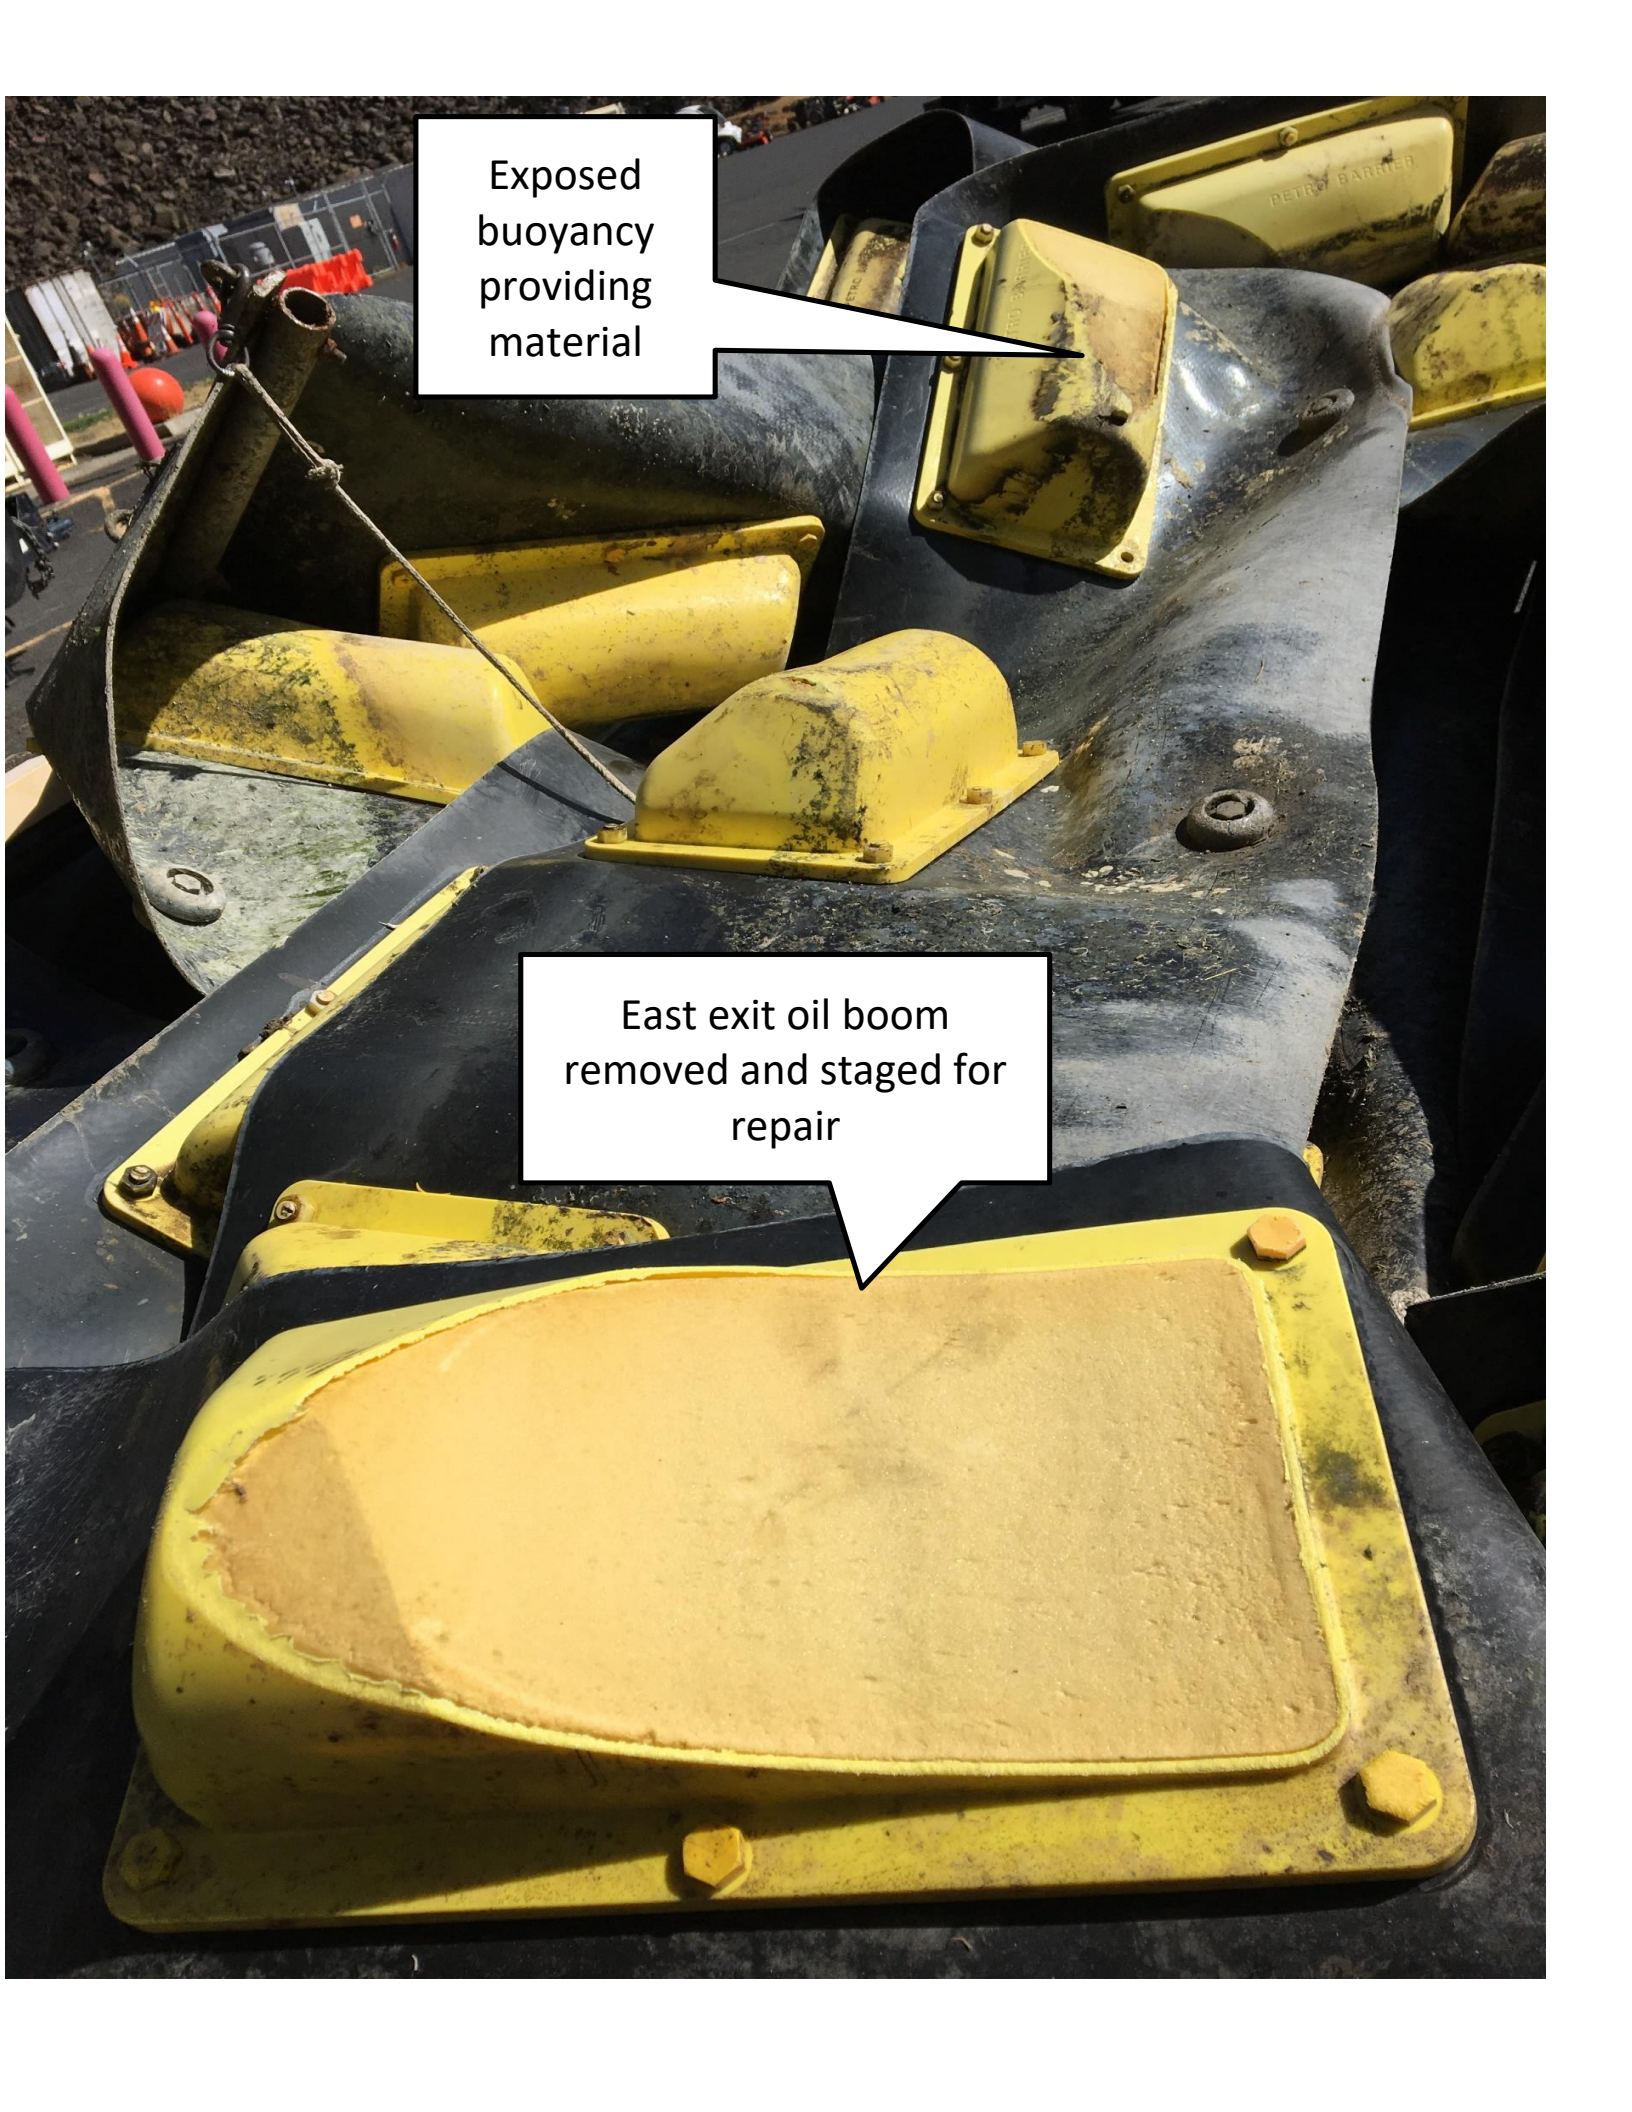
Permanent oil boom removed from east exit for repairs. Possible redesign before install.

Exposed buoyancy providing material

East exit oil boom removed and staged for repair
