# The Dalles Dam Fishway Status Report

10/10/21

Inspection Period:10/3-10/9/2021

## THE DALLES DAM

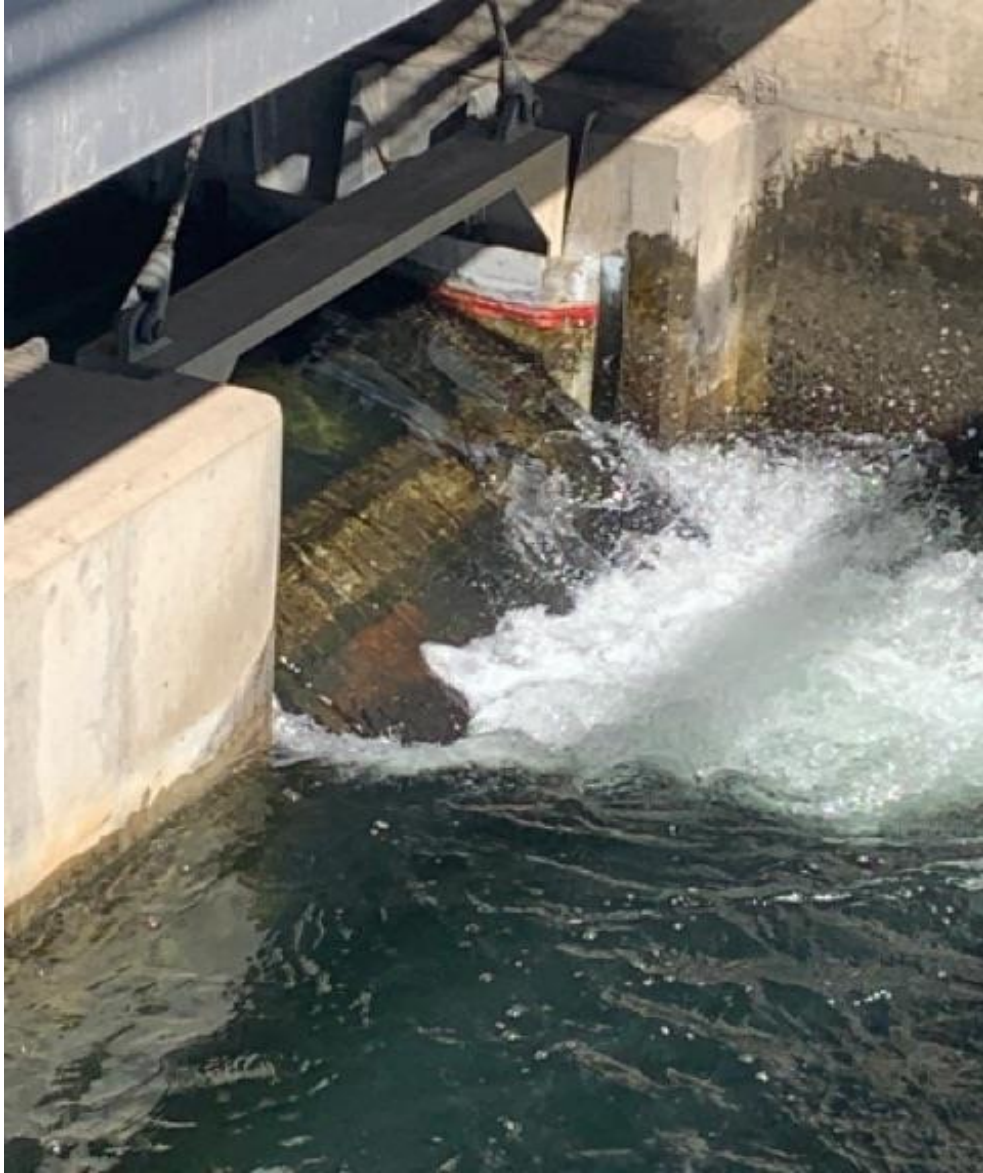
Fall chinook going over the top of weir 159 at the Dalles east ladder exit.
