The Dalles Dam Fishway Status Report

Inspection Period:10/10-10/16/2021

THE DALLES DAM

US Army Corps
of Engineers
Portland District

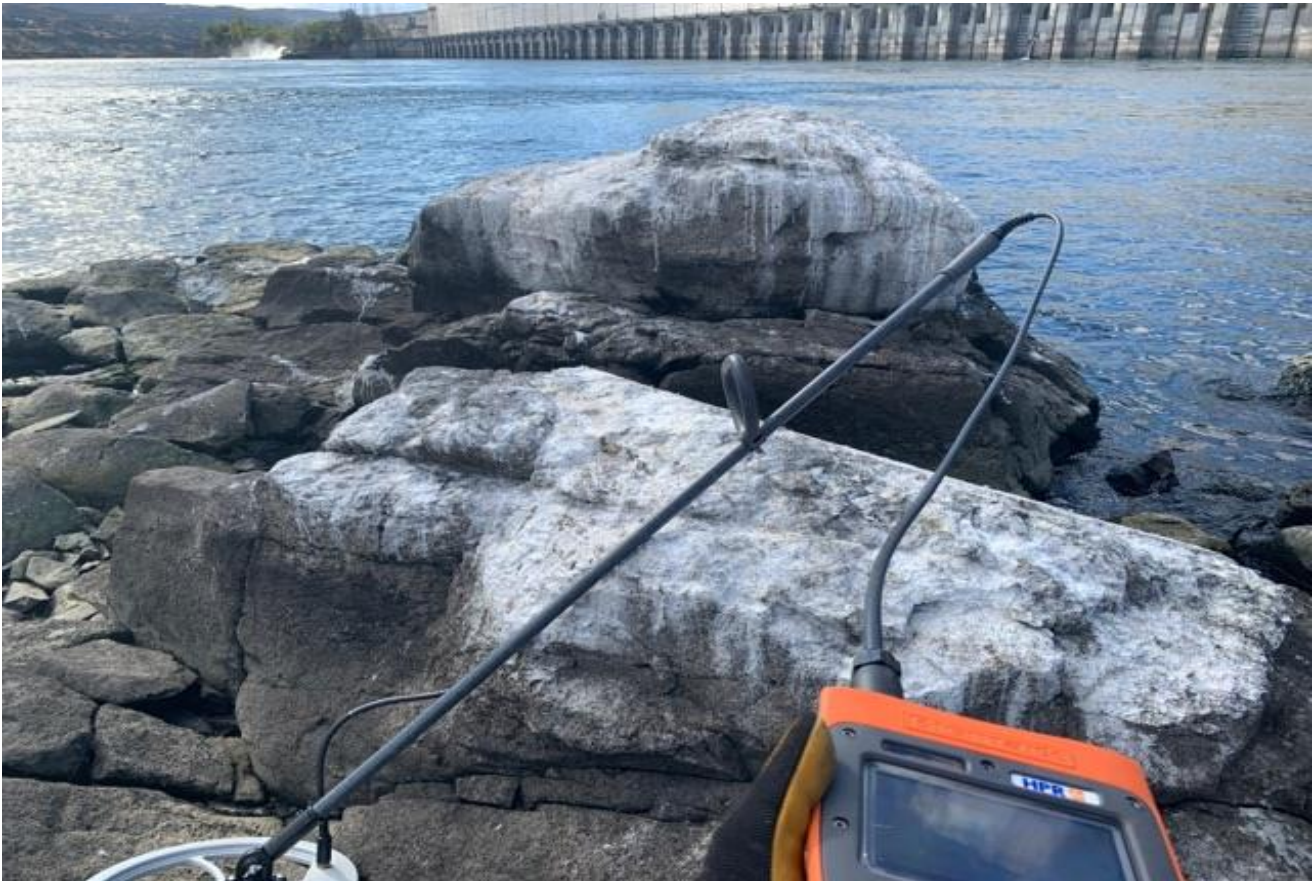
Scanning predatory bird resting sites for PIT tags
