The Dalles Dam Fishway Status Report

Inspection Period:10/31-11/6/2021

THE DALLES DAM

US Army Corps
of Engineers
Portland District

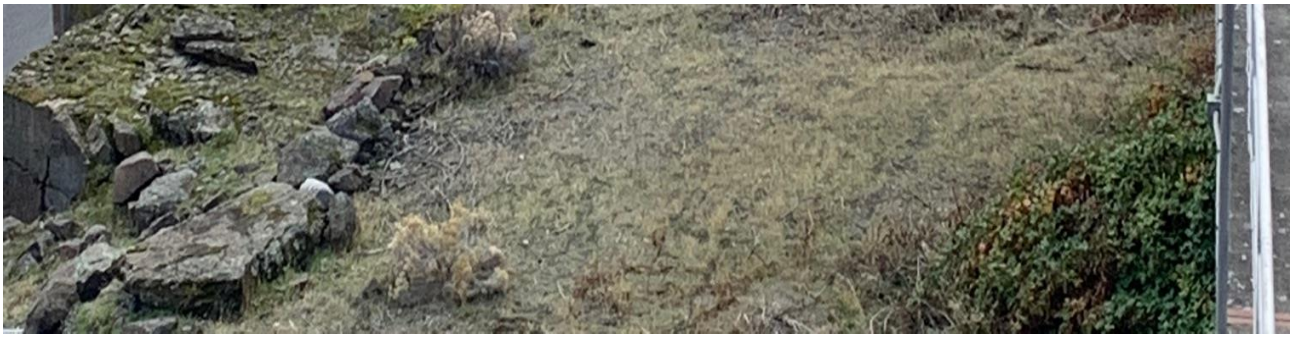
PUD clearing area for new sample tank
