The Dalles Dam Fishway Status Report

Inspection Period: 11/7 - 11/13/2021

THE DALLES DAM

US Army Corps
of Engineers
Portland District

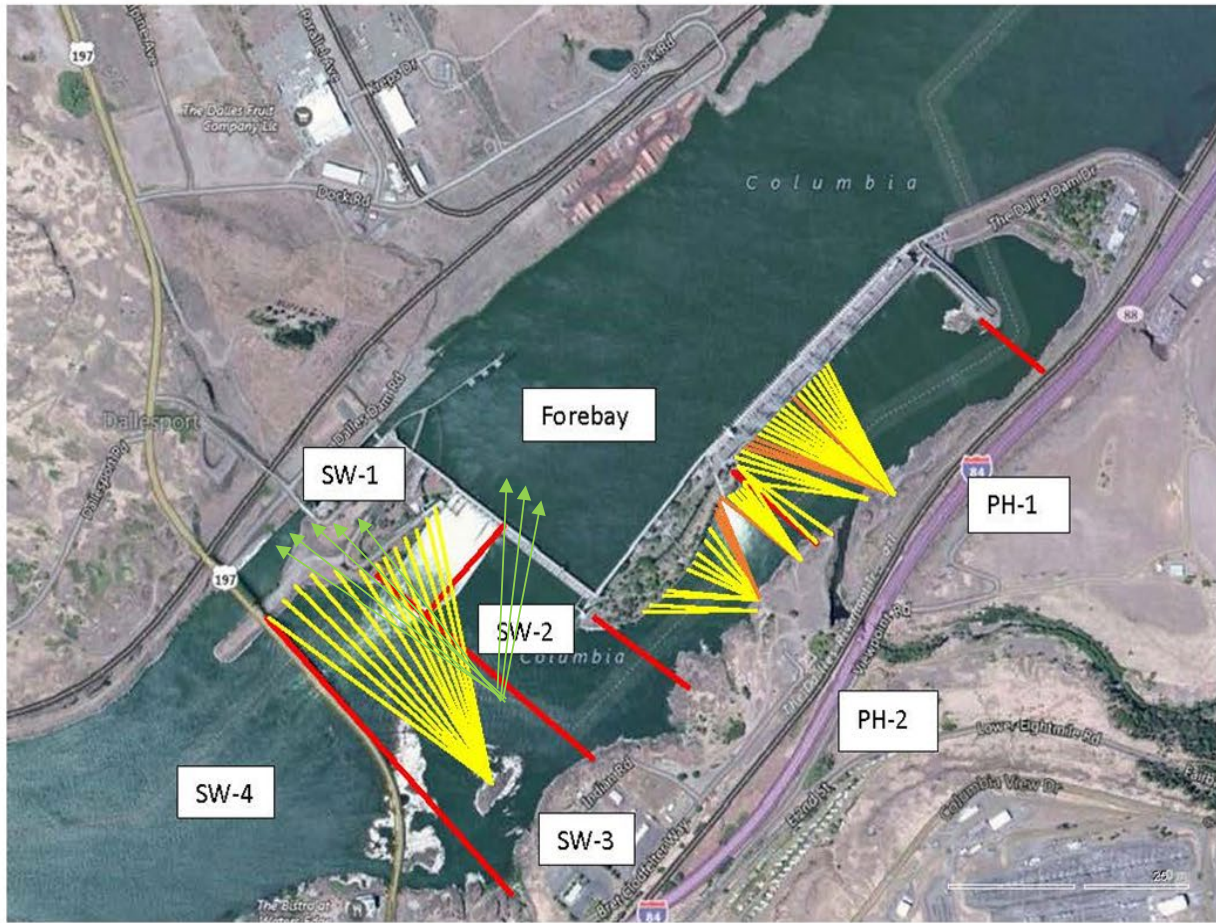
New Avian Lines and laser deterrent zones

Red lines = avian zones

Yellow lines = current wires

Orange lines = down or missing wires

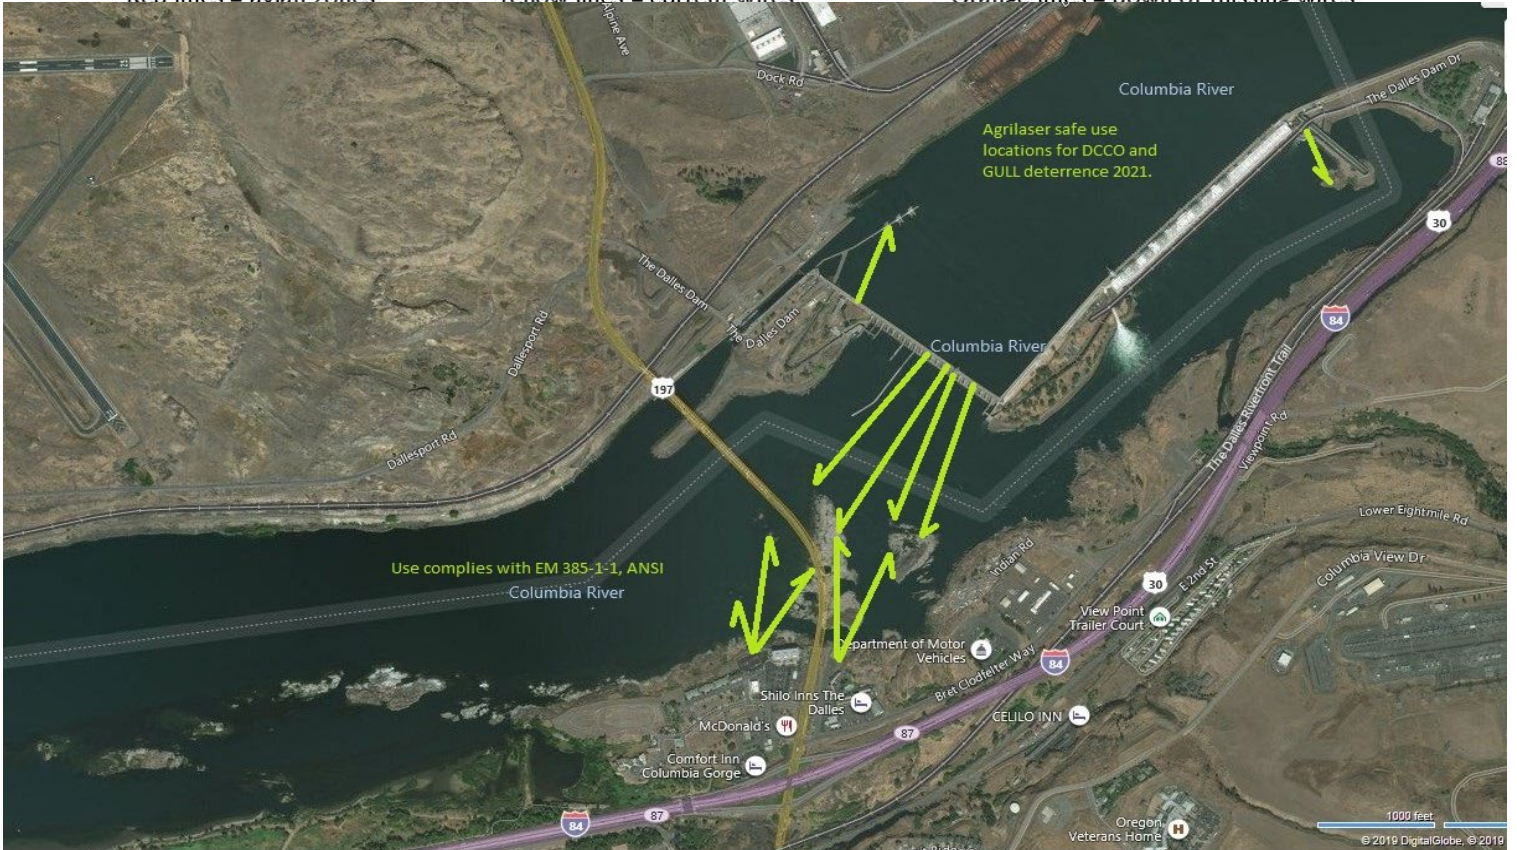
Agrilaser safe use locations for DCCO and GULL deterrence 2021.

PH1- cormorants <20
PH2- gull and cormorant activity, infrequent, single digits
SW1-gulls resting on spill wall
SW2-DCC foraging, single digits
SW3-Cormorants>20
SW4-gull hangout
FB- intermittent DCC, gulls resting on US navlock wing wall

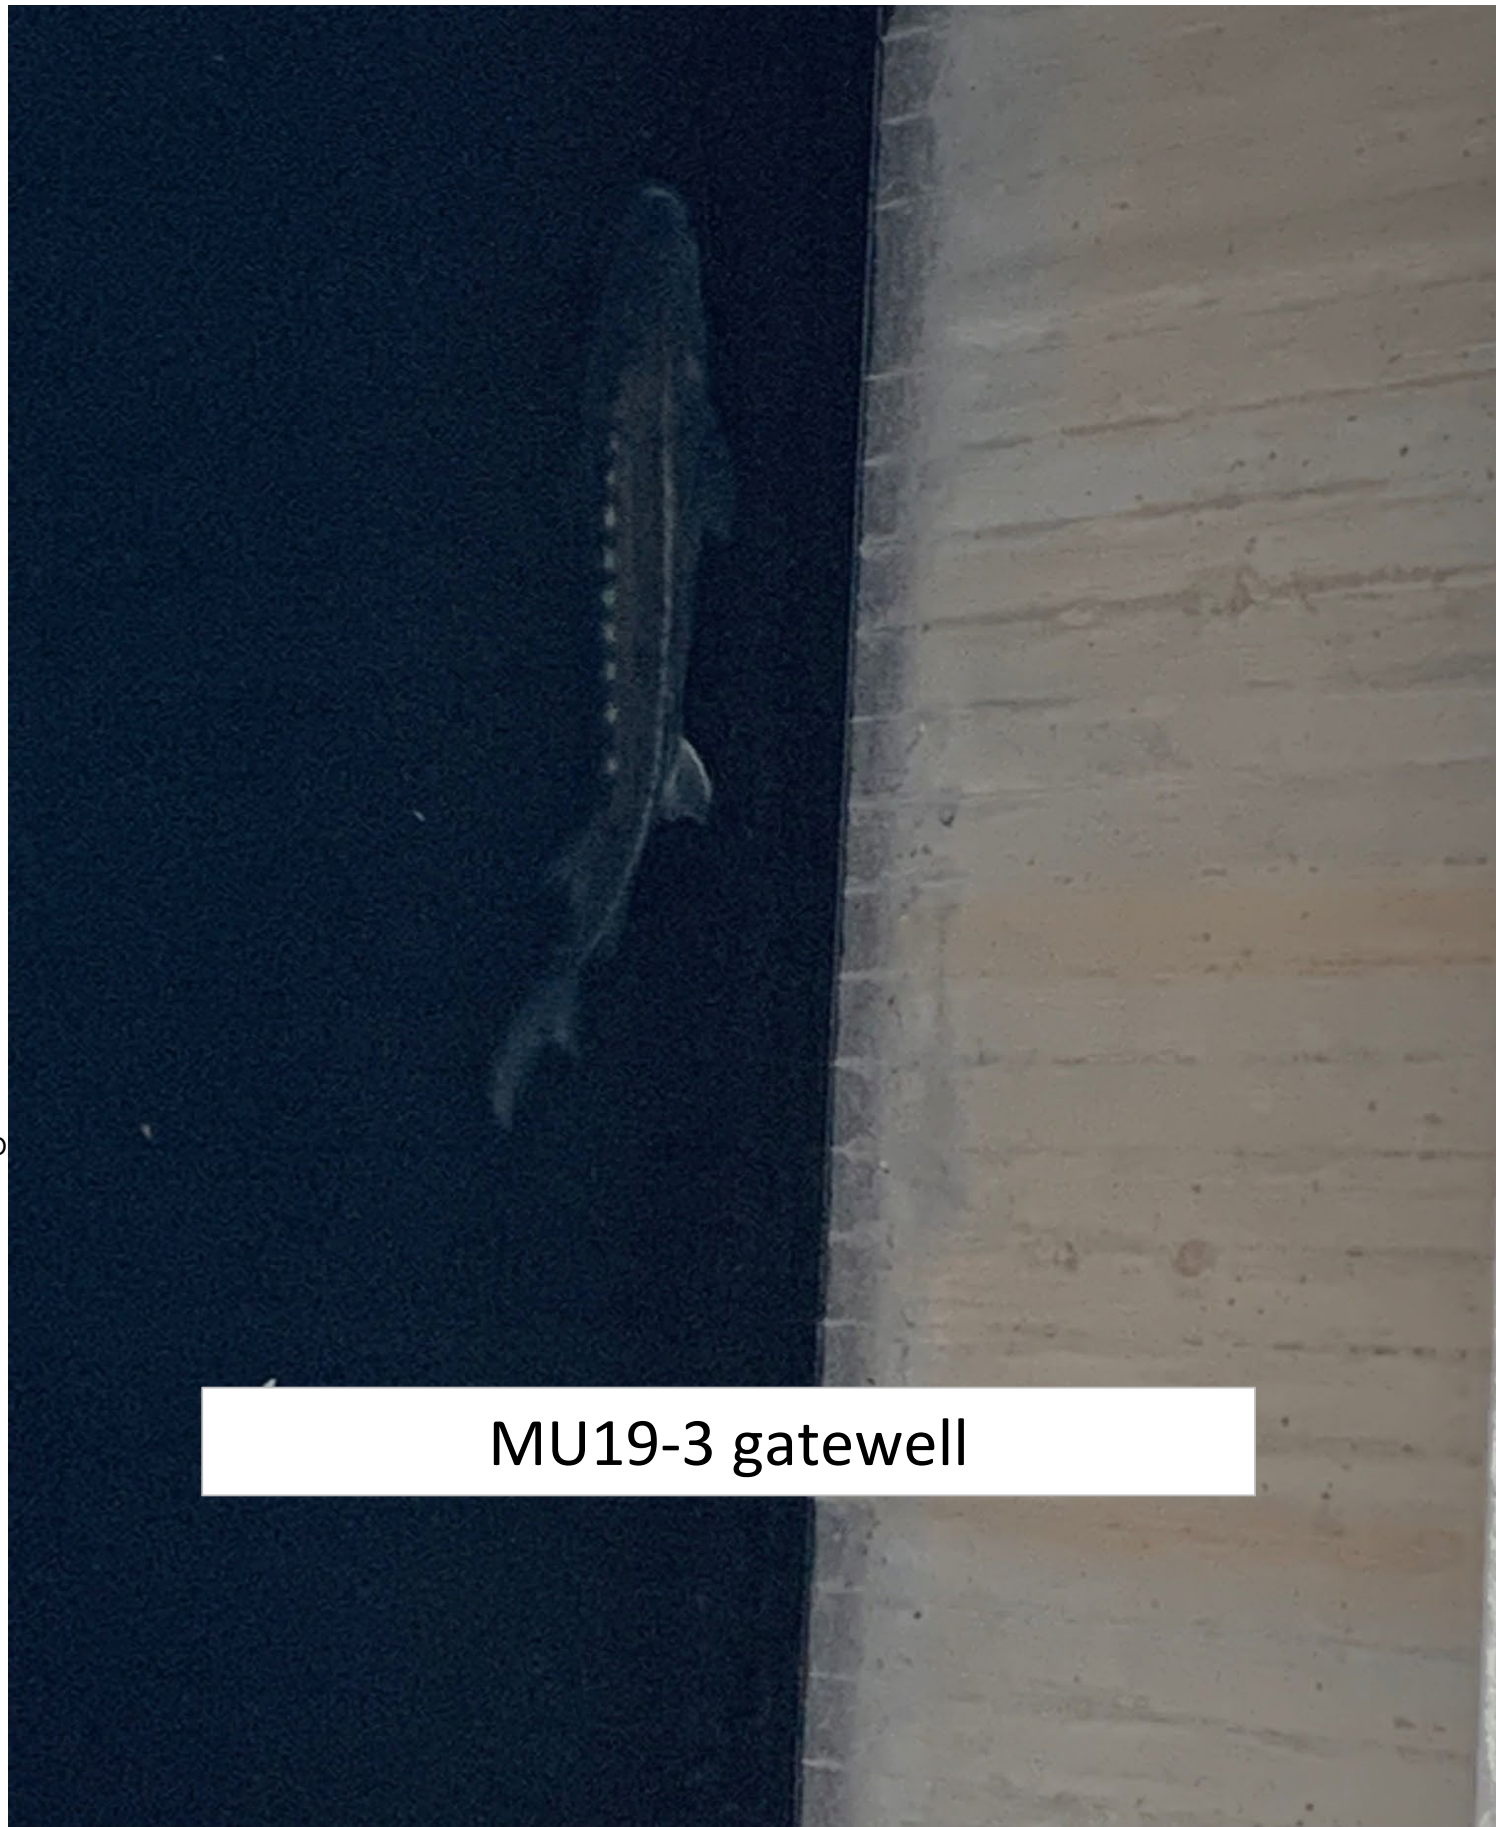
MU19-3 gatewell

| Gatewells | 0 | Weekly | Large sturgeon present in MU19-3 gatewell. No mortality 11/7/2021. |
