The Dalles Dam Fishway Status Report

Inspection Period: 11/28 - 12/4/2021

THE DALLES DAM

US Army Corps
of Engineers
Portland District

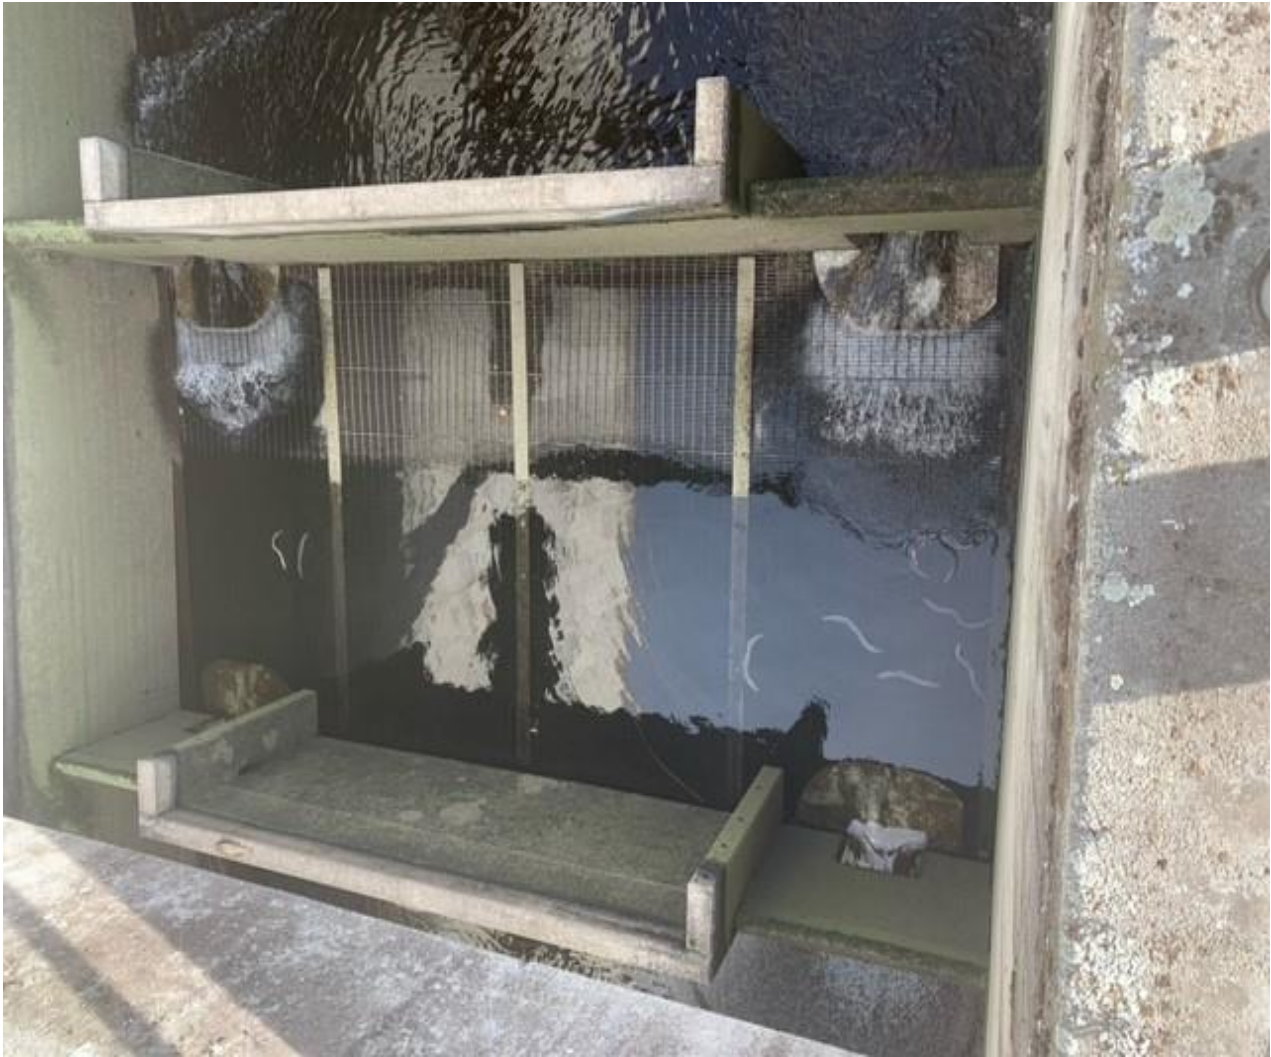
33 lamprey morts found days following dewatering. MFR provided to FPOM.

Lamprey mortality in east fishladder dewater. MFR provided to FPOM.

Fish Accords Lamprey Passage plan for The Dalles ongoing at 30% DDR junction pool. Will discuss east ladder dewatering lamprey morts.
