The Dalles Dam Fishway Status Report

Inspection Period: 1/30 - 2/5/2022

THE DALLES DAM

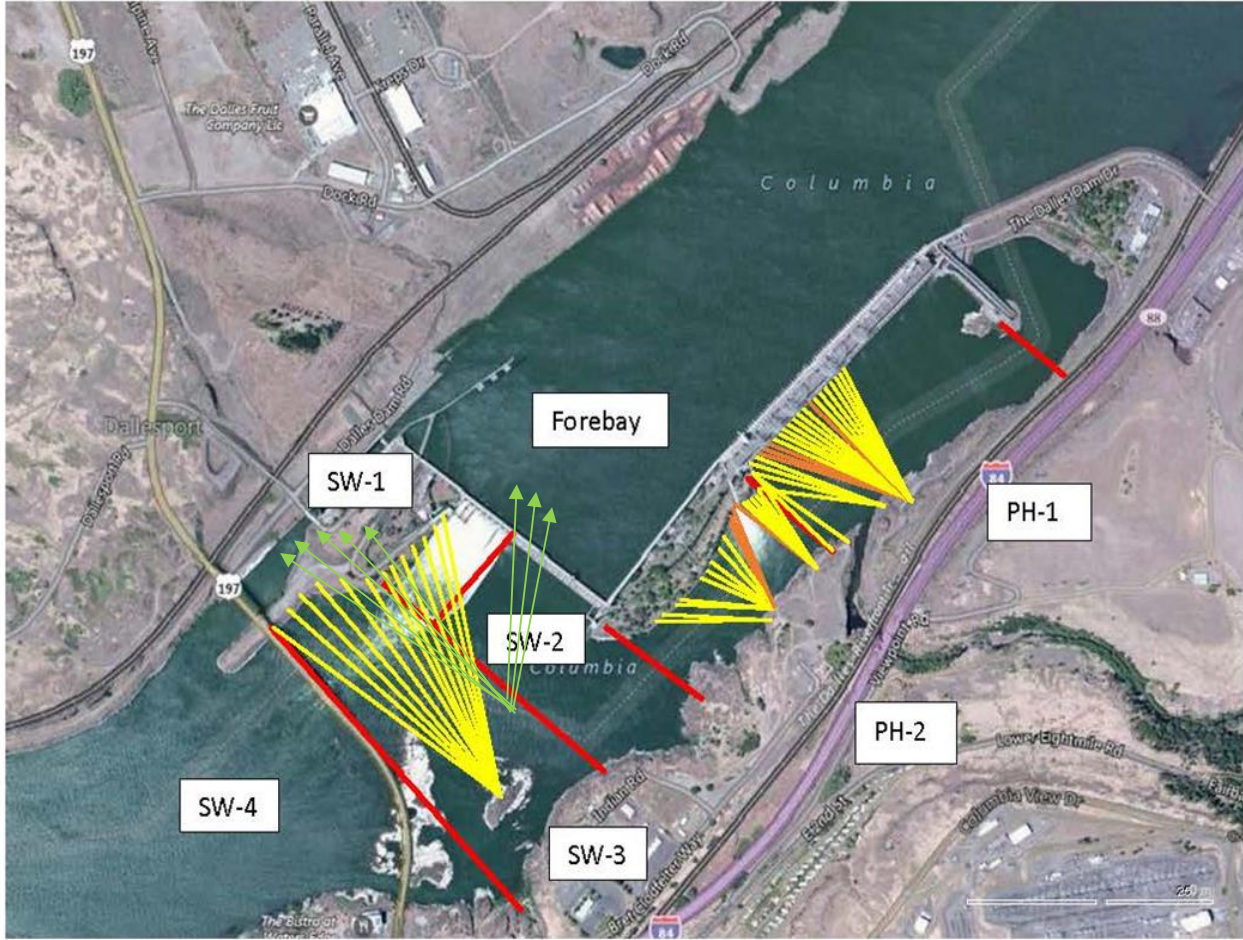
New Avian Lines and laser deterrent zones

Orange lines = down or missing wires

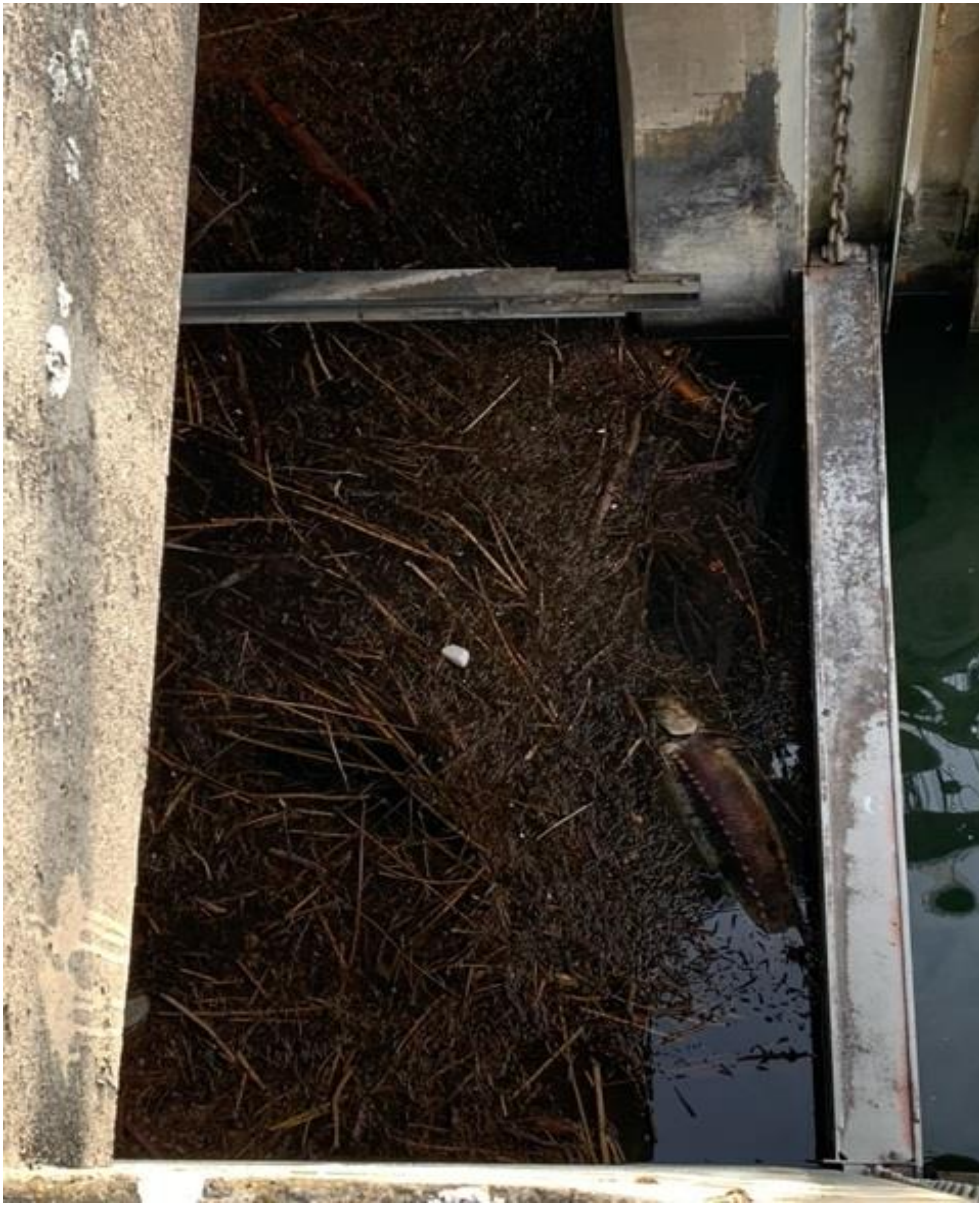
Large sturgeon mortality found in sluiceway channel. Floated in with debris through open forebay sluiceways. Lowered PIT scanner - no PIT identified.
