The Dalles Dam Fishway Status Report

Inspection Period 7/17-7/23 2022

THE DALLES DAM

US Army Corps
of Engineers
Portland District

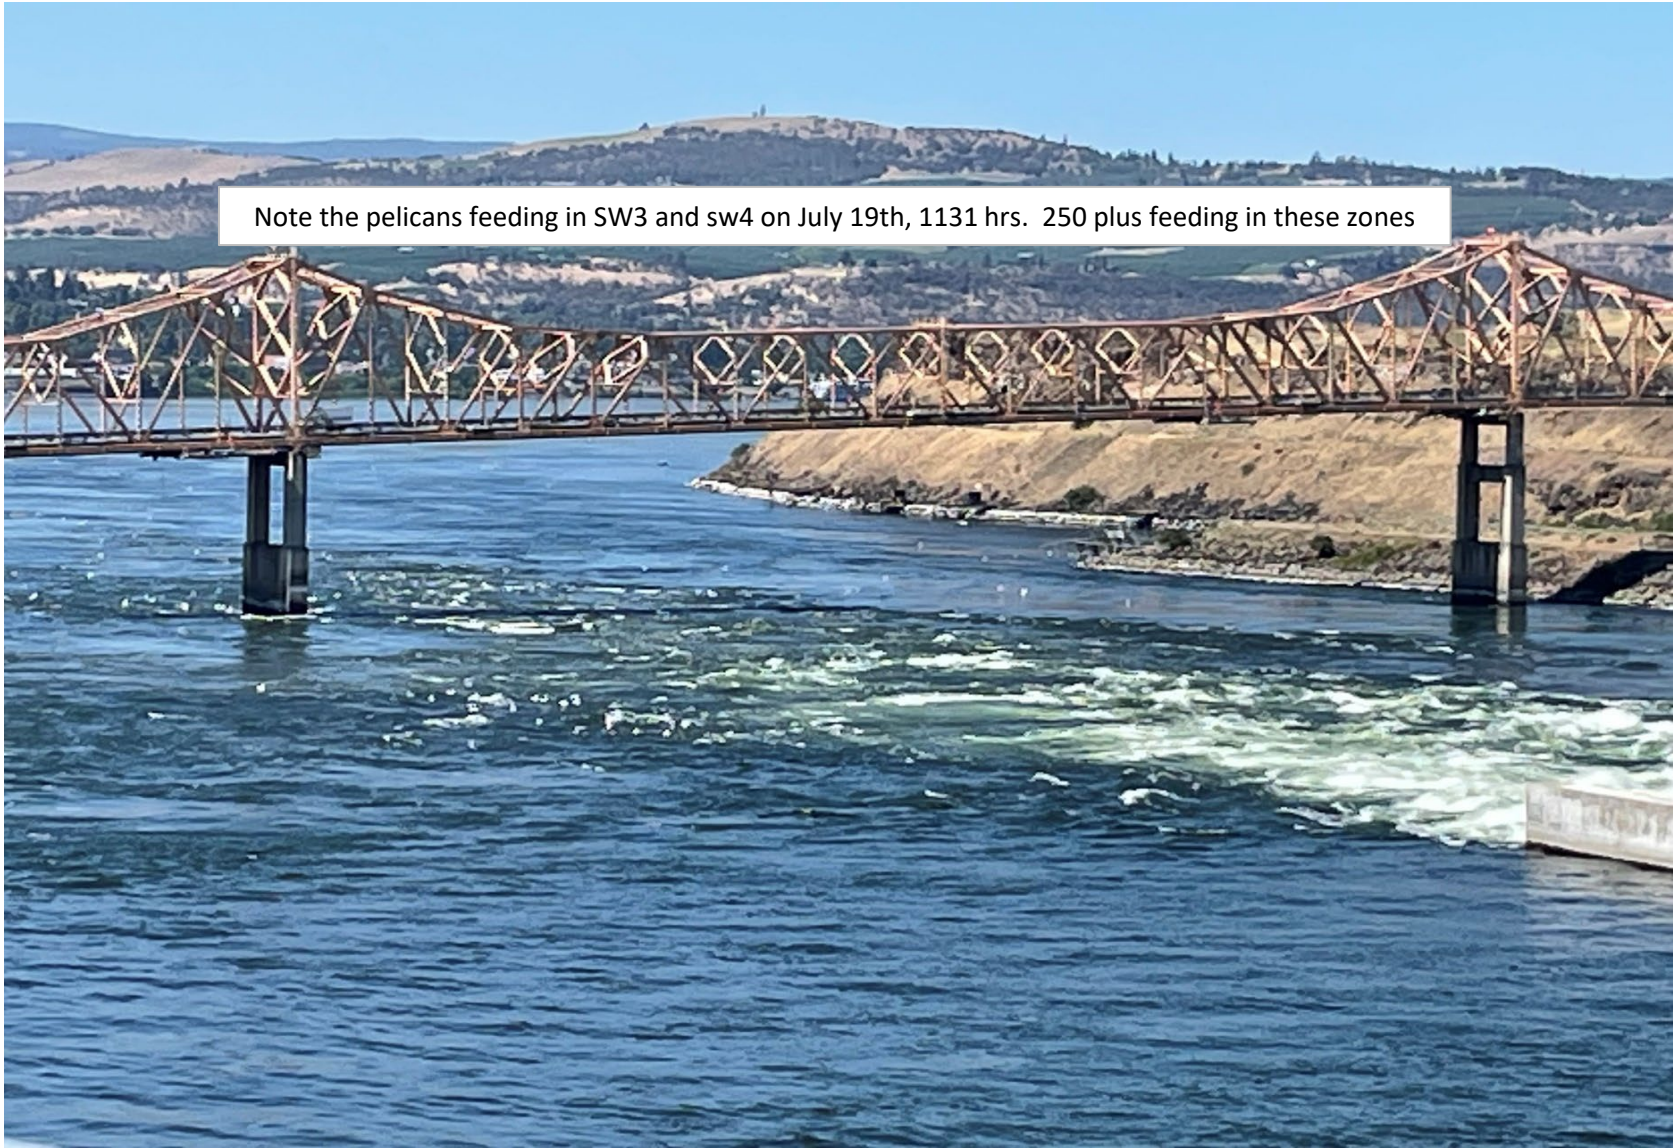
Note the pelicans feeding in SW3 and sw4 on July 19th, 1131 hrs. 250 plus feeding in these zones

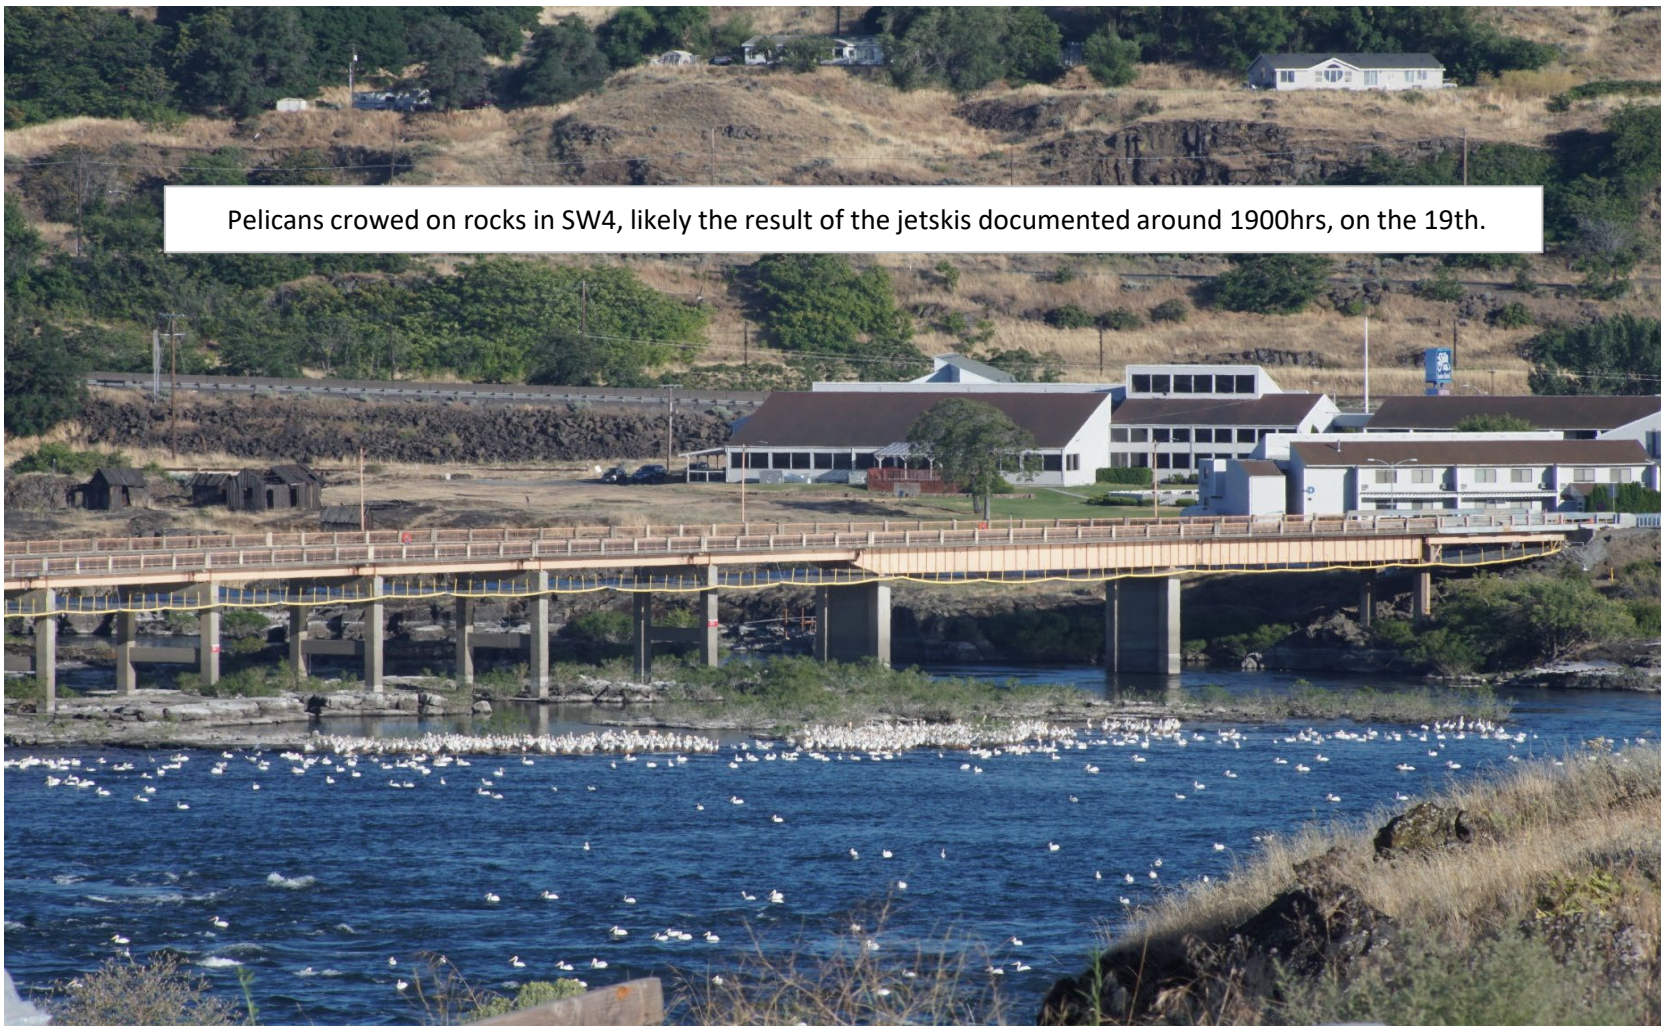
Pelicans crowded on rocks in SW4, likely the result of the jetskis documented around 1900hrs, on the 19th.

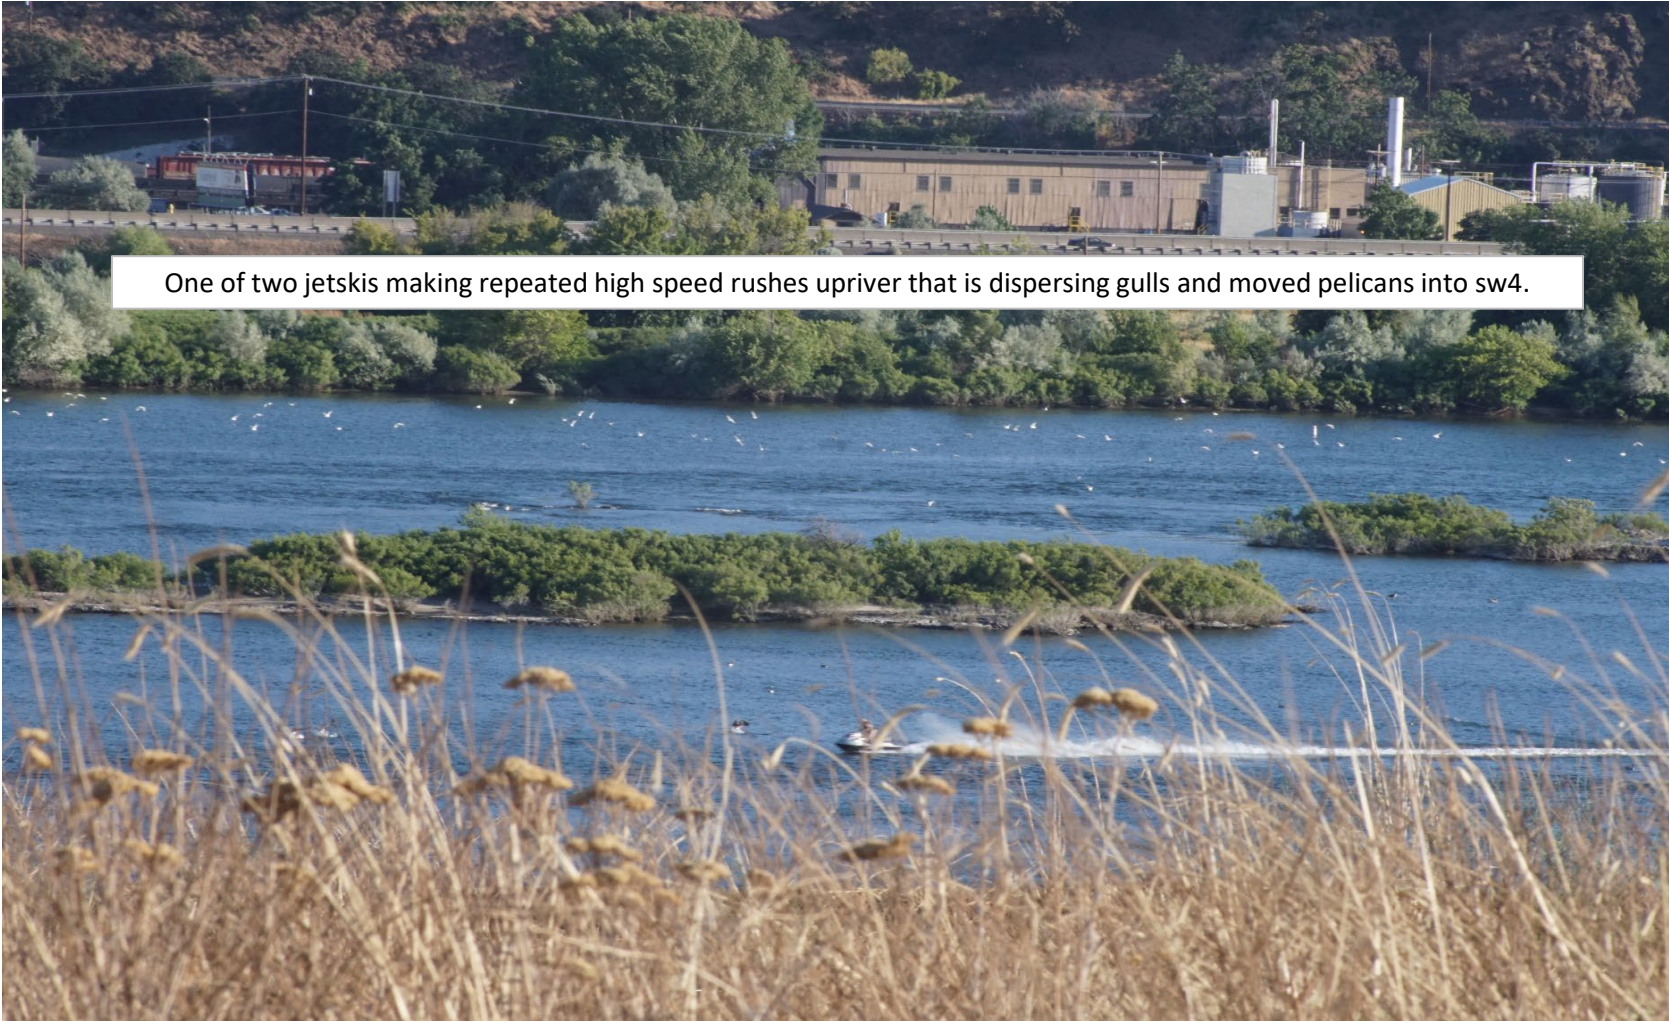
One of two jetskis making repeated high speed rushes upriver that is dispersing gulls and moved pelicans into sw4.
