The Dalles Dam Fishway Status Report

Inspection Period 10/9-10/15, 2022

THE DALLES DAM

US Army Corps
of Engineers
Portland District

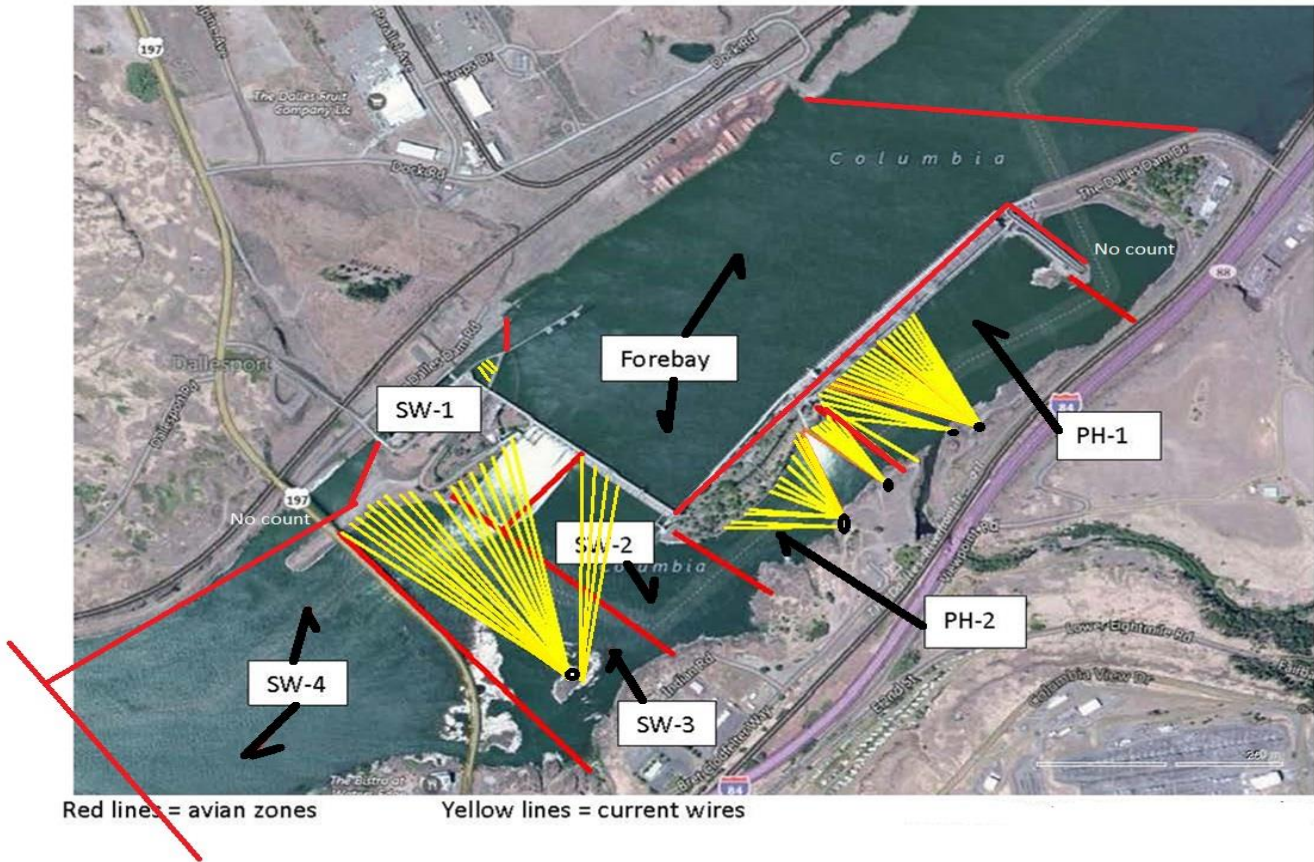
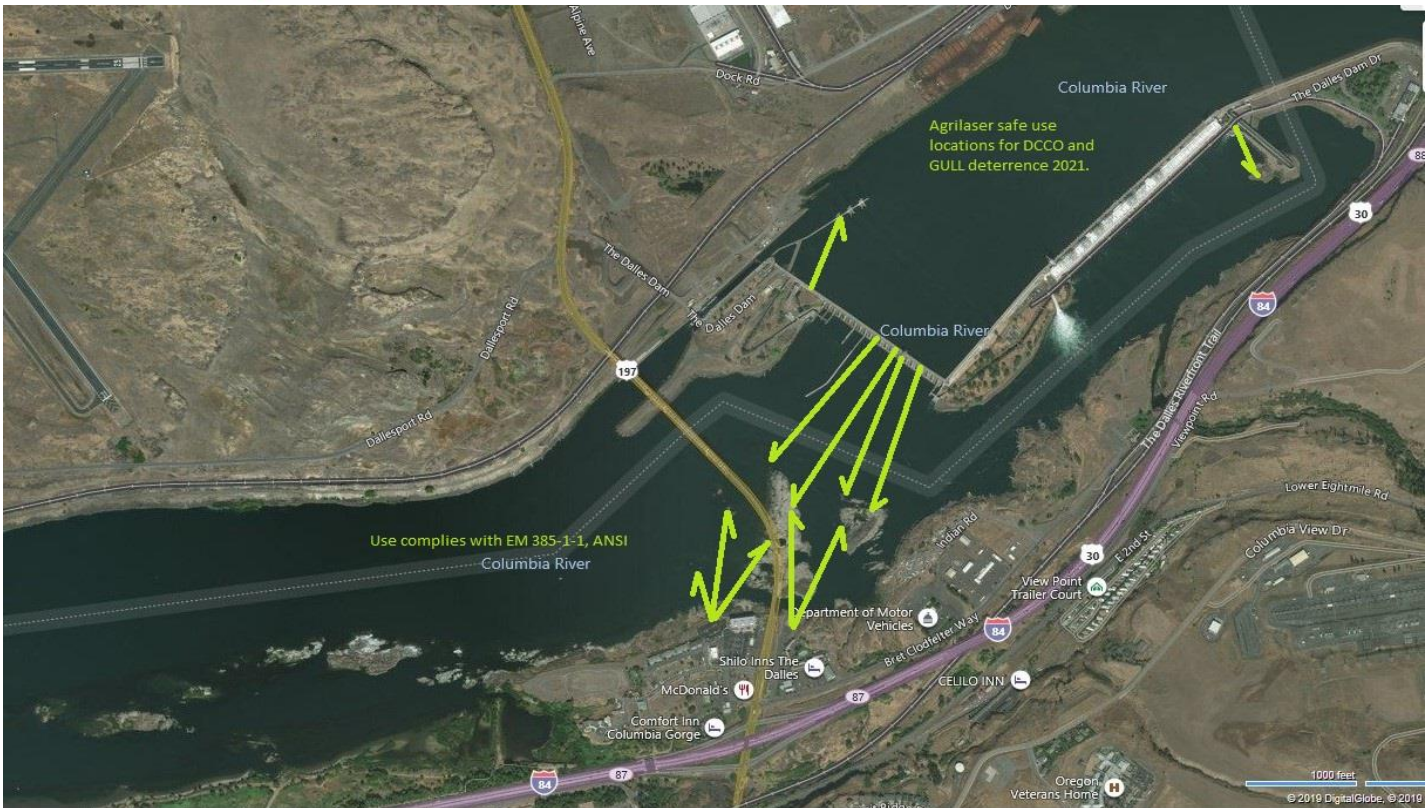
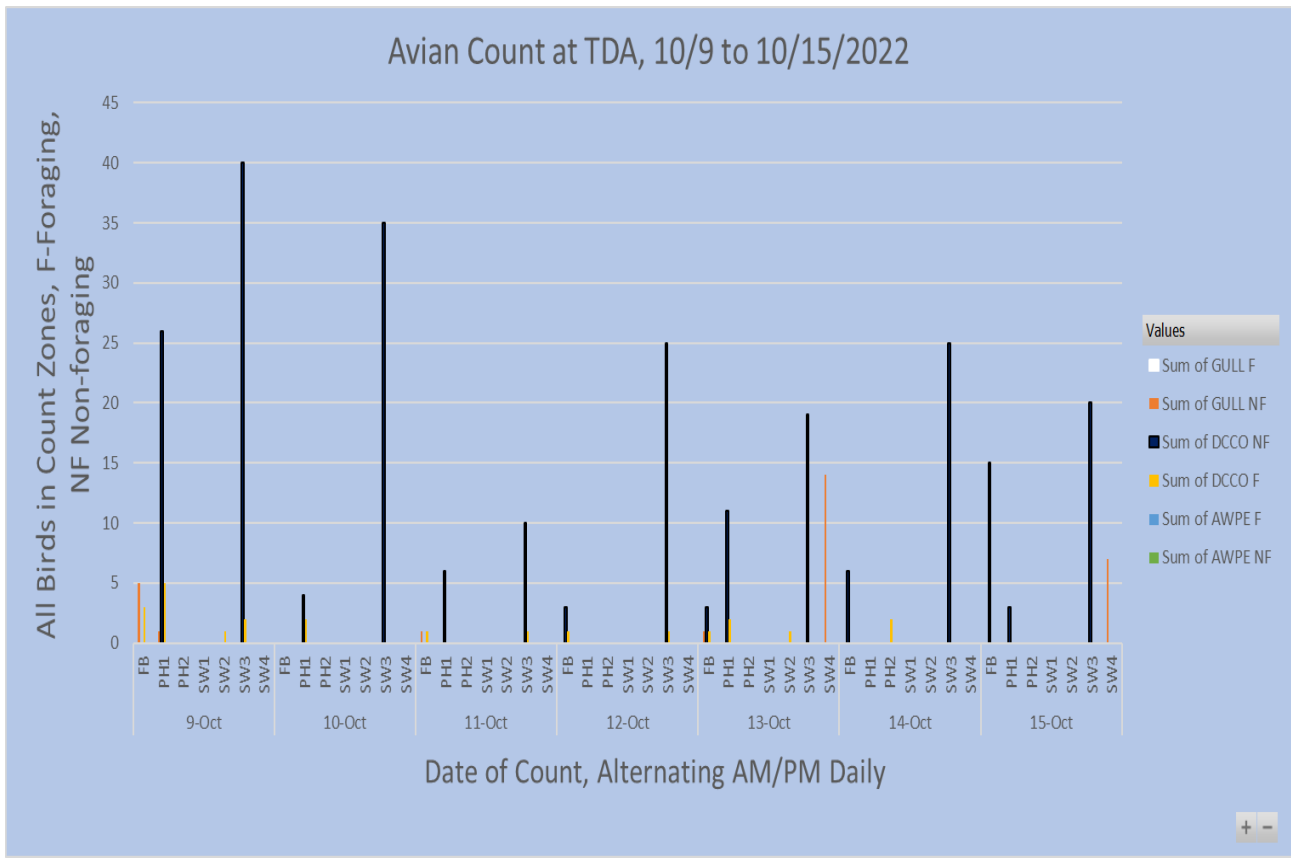
Bird Count Zones, Avian Lines and Laser Deterrent Sites

Declining cormorants in PH1 possibly due to Gadfly, motion sensor noise deterrent at East PH shoreline.

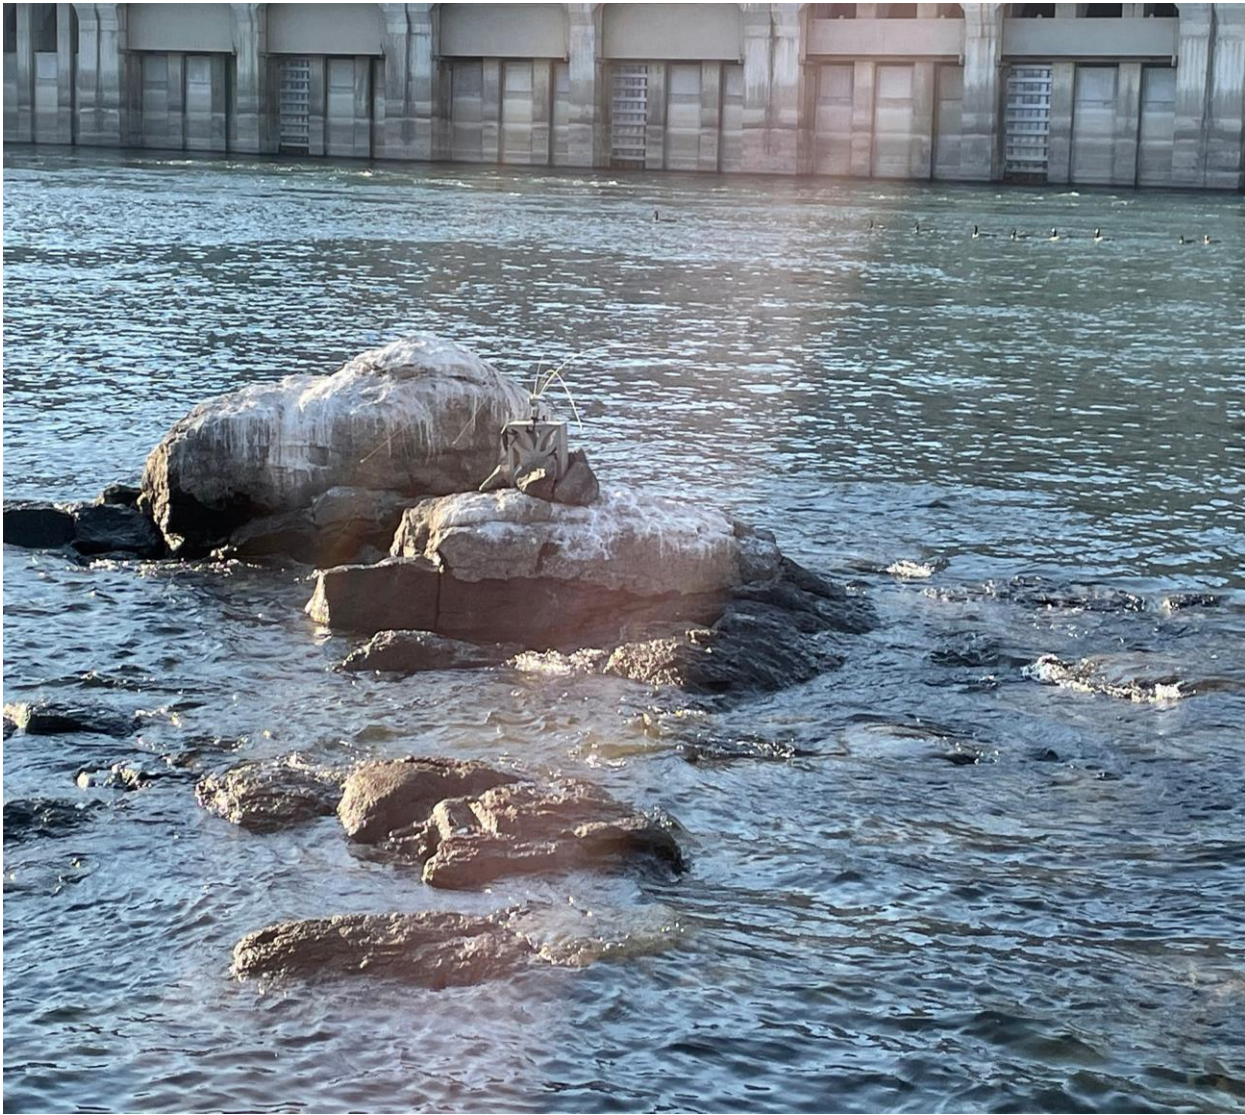
Gadfly noisemaker and "long legs" bird deterrents able to reduce cormorants on shoreline. Had to be relocated

with water levels.
