| The | Dalles Dan | Status Report THE DALLES DAM | | | | | | | | | | | |
| The Dalles Dam | Inspections OOC | Criteria Limit | Total Number of Inspections:7Temperature:37.6°FComments:Eagle numbers increasing.Weekly Ave. Secchi:5.4 | | | | | | | | | | |

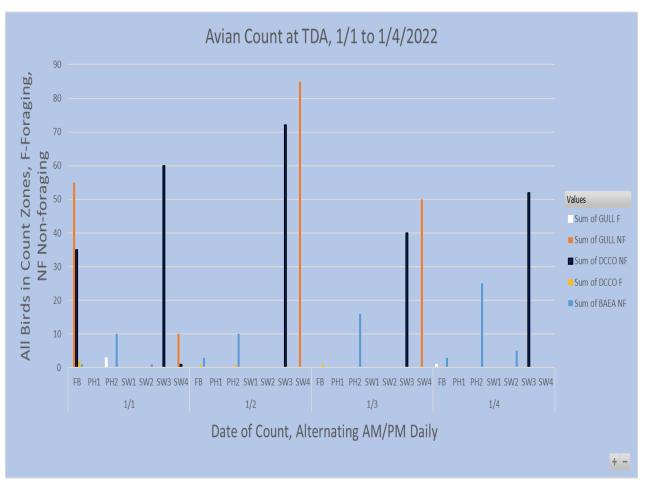
Note the blue bar indicates the number of eagles on project. The more eagles, the less gulls.

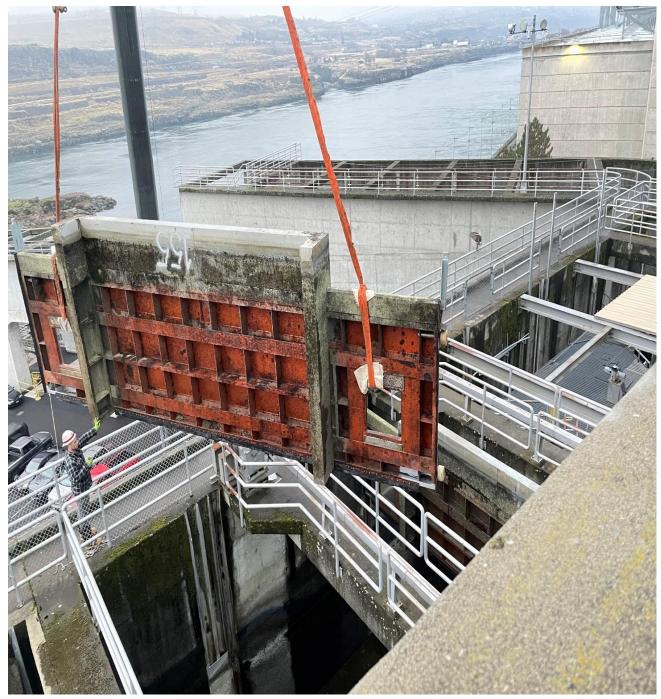
Repaired 155 weir installation. Lamprey orifices cut in bottom corners.

ROV inspection of fish unit intake trashrack Jan18 to assess aquatic vegetation buildup. Planning to use fish unit intake trashrack rake in anticipation for future debris buildup concerns. To be in service be March 1. EFL exit weir 155 repair in progress. Weirs 154 and 155 cut lamprey orifices per PDT recommendation. Plan to pull north entrance trashrack end of Jan for inspection. Calibrations: North entrance maintaining criteria. 1/5/2023 Spillway assessment; Spillgates 1- 9 rehab 2034. Includes spillbay 9 trunnion pin repair. Spillway crane first priority Planning spill gates 9 and 10 cable and gearbox swap. Replacing bulkhead seals needed. Completion estimate end march. Fish unit rehab Phase 1A awaiting funding. AWS intake trashrack debris management - PDT reviewing alternatives.

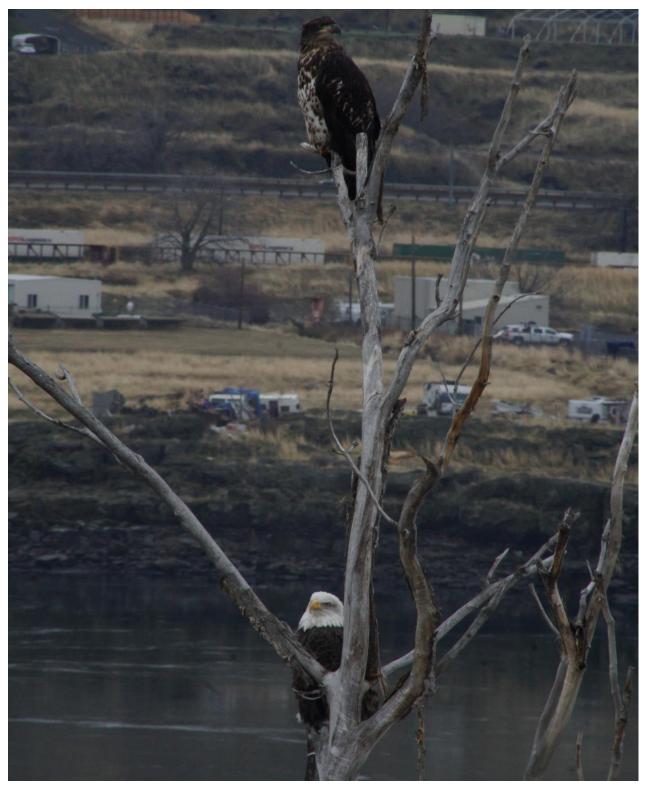
Eagles roosting north of SW1 near ladder entrance. Lone Pine village in the background.
