# The Dalles Dam Fishway Status Report

Inspection Period 1/22-1/29, 2022

## THE DALLES DAM

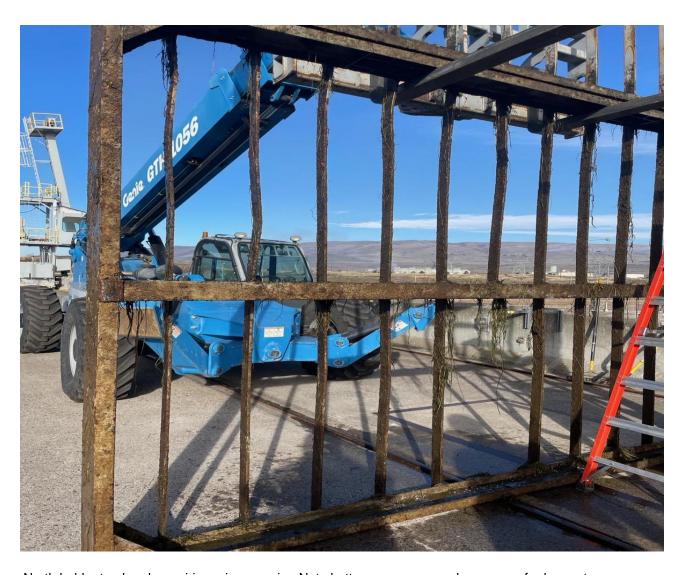
North fishladder intake trashrack removed for minor repairs. PUD intake top rack pulled and inspected.

North ladder trashrack requiring minor repairs. Note bottom vane removed years ago for large strugeon egress
