The Dalles Dam Fishway Status Report

Inspection Period 3/19-3/25, 2023

THE DALLES DAM

US Army Corps
of Engineers
Portland District

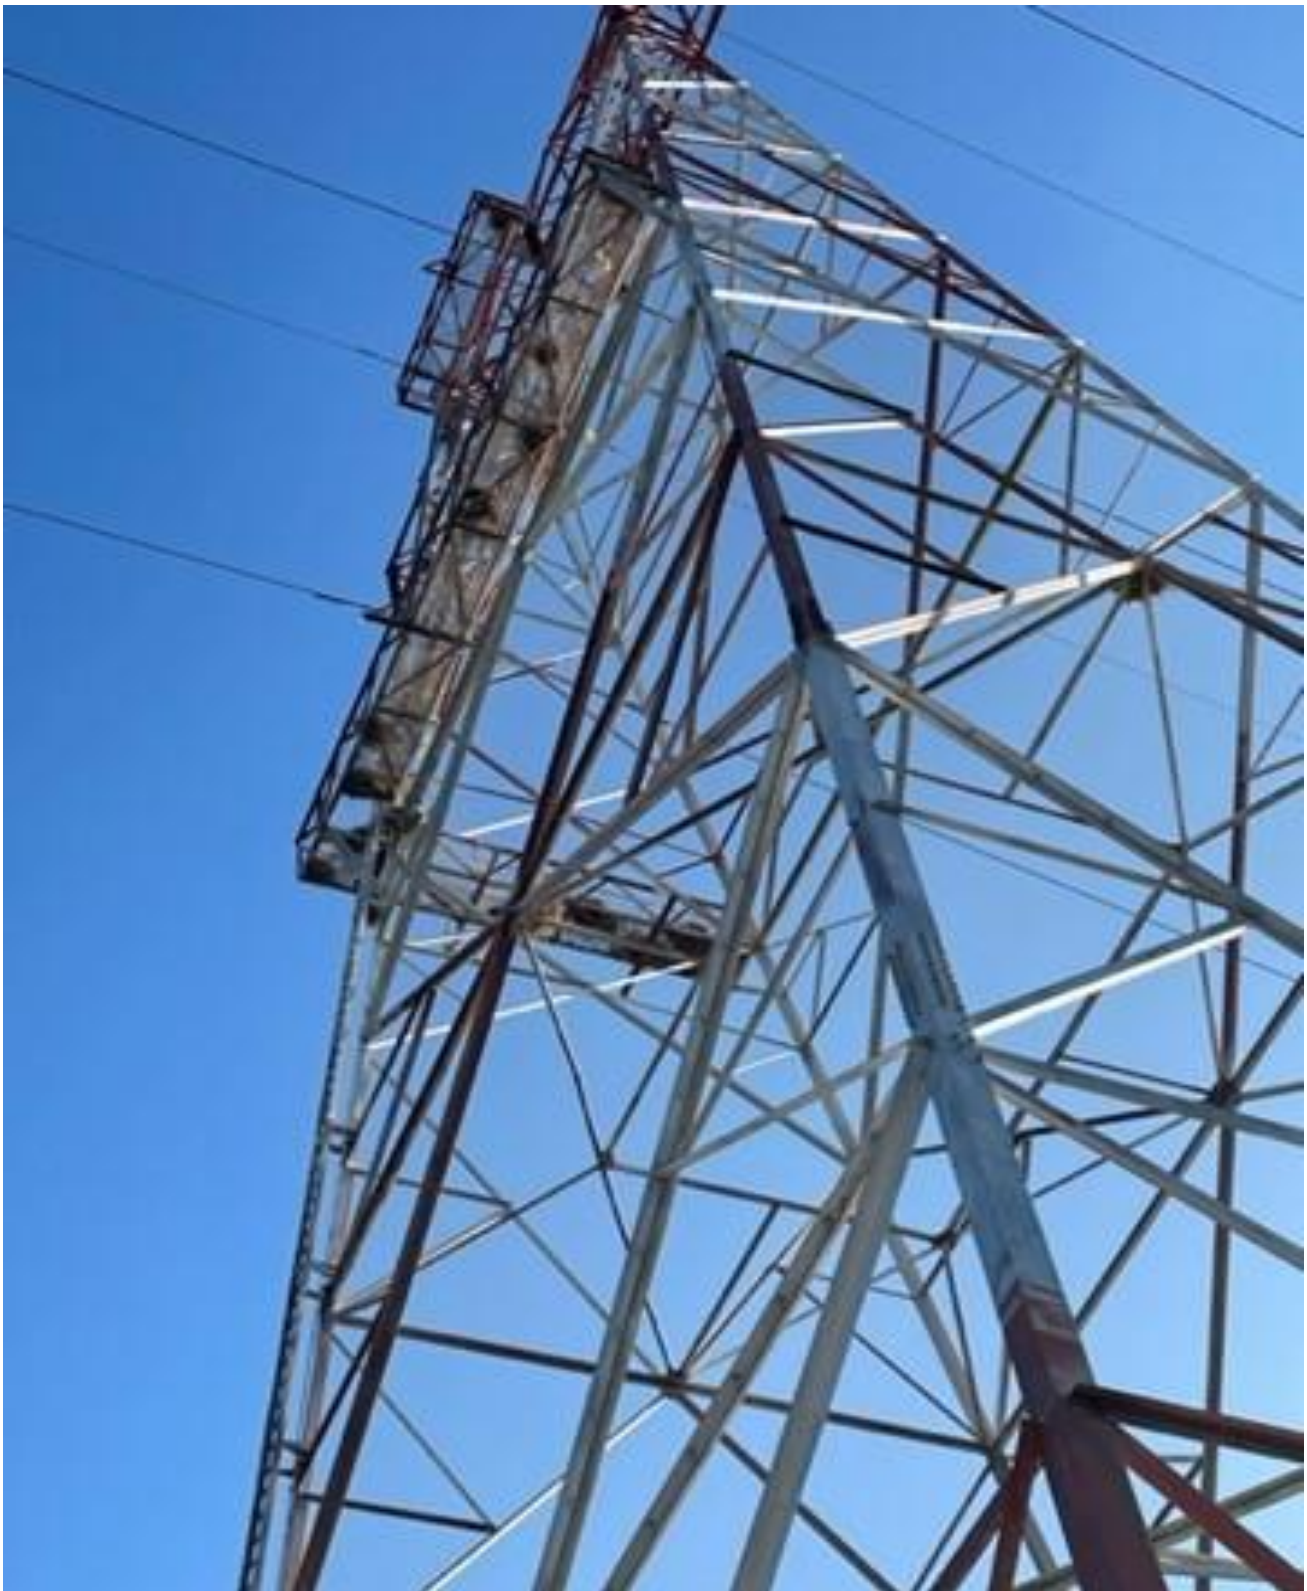
Deterring cormorants before nesting starts with air horns and frequent yelling curse words.
