The Dalles Dam Fishway Status Report

Inspection Period 09/24-09/30, 2023

THE DALLES DAM

US Army Corps
of Engineers
Portland District

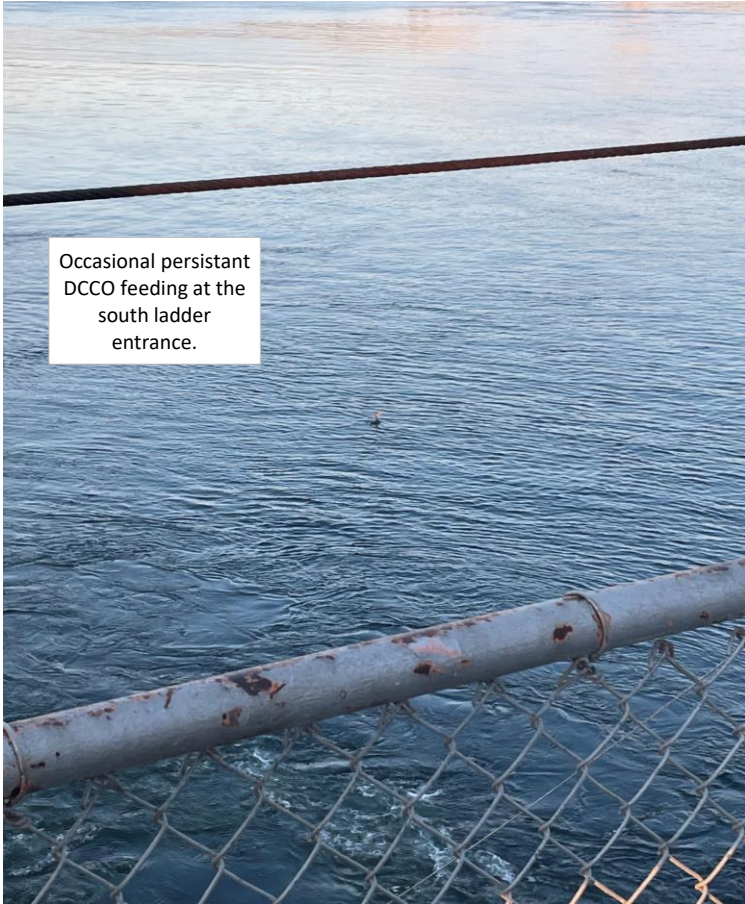
Occasional persistent
DCCO feeding at the
south ladder
entrance.

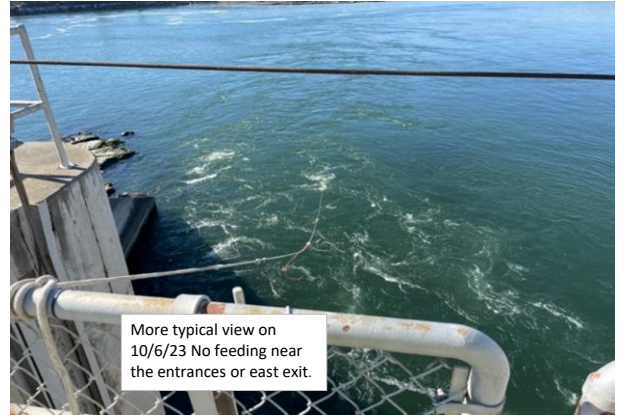
More typical view on
10/6/23 No feeding near
the entrances or east exit.
