The Dalles Dam Fishway Status Report

10/15/23

Inspection Period 10/8-10/14, 2023

THE DALLES DAM

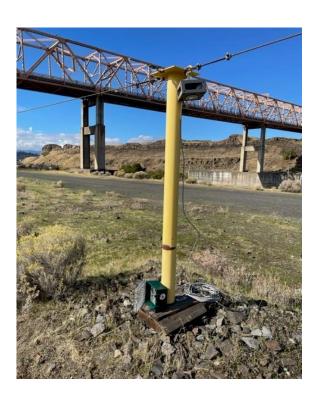
Possible location for Bird Gard sound deterrent on north peninsula.

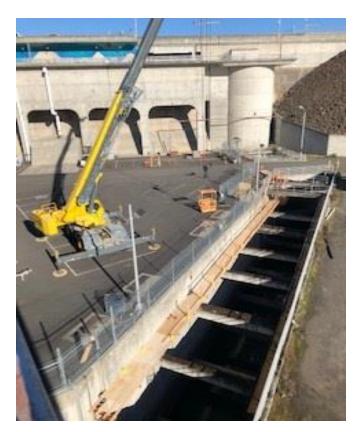
Lamprey trap tank water supply being installed in old fishlock channel
