The Dalles Dam Fishway Status Report

Inspection Period 10/22-10/28, 2023

THE DALLES DAM

US Army Corps
of Engineers
Portland District

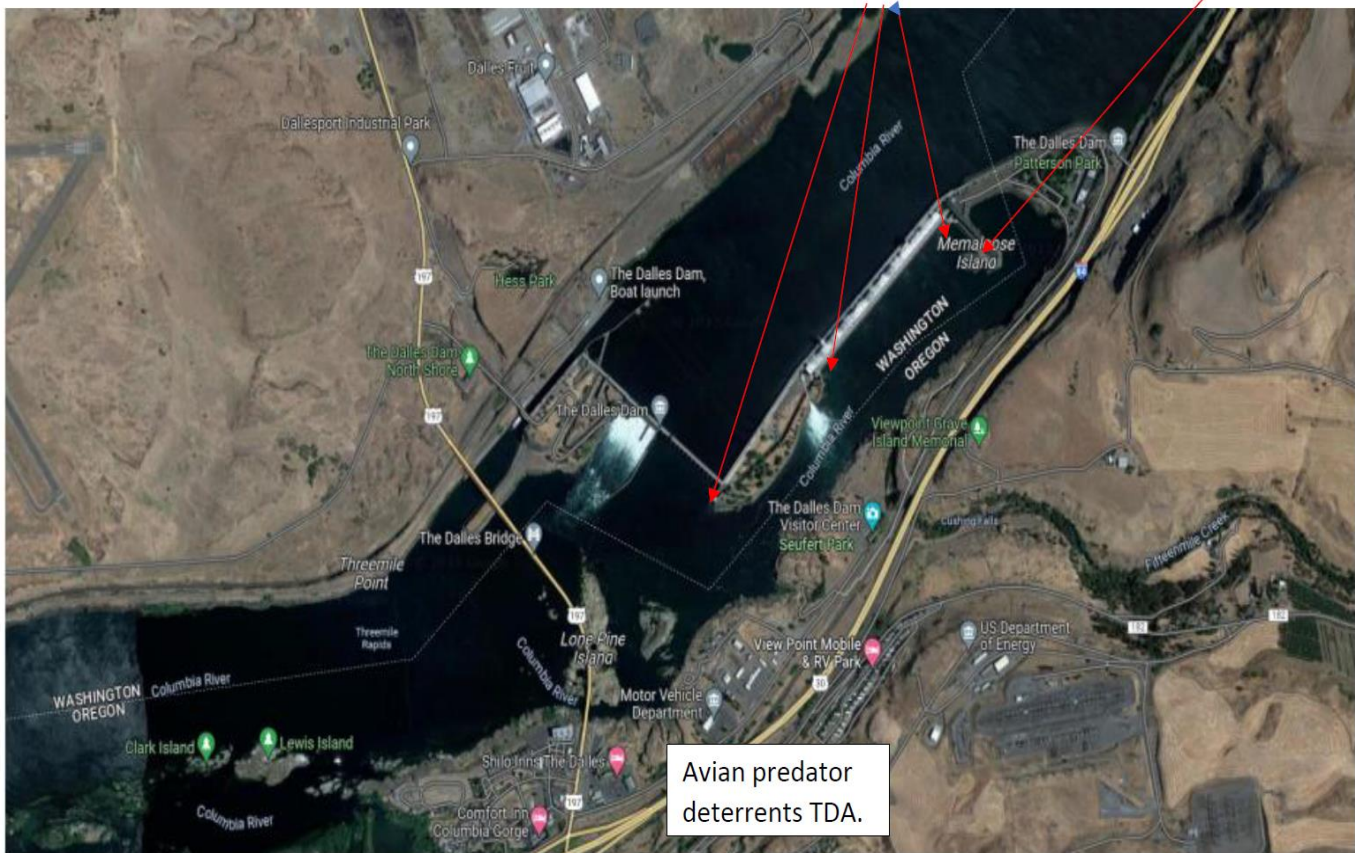
Avian predator tori lines and audio distress Bird Gard. 10/2023

Tori lines at East Ladder entrances.

Bird Gard audio deterrent.

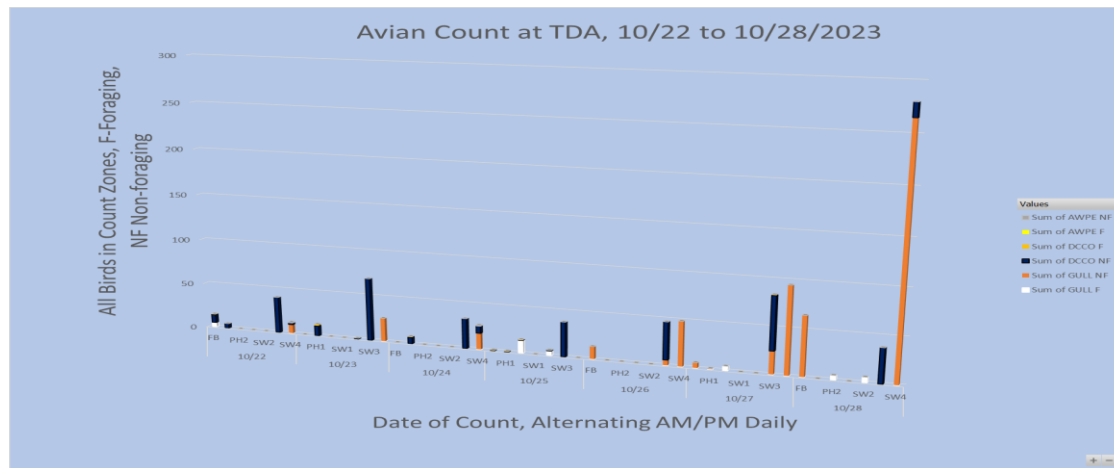
Decline DCCO in PH1 may be due to Bird Gard audio deterrent. Increase in CAGU/RBGU PH2.

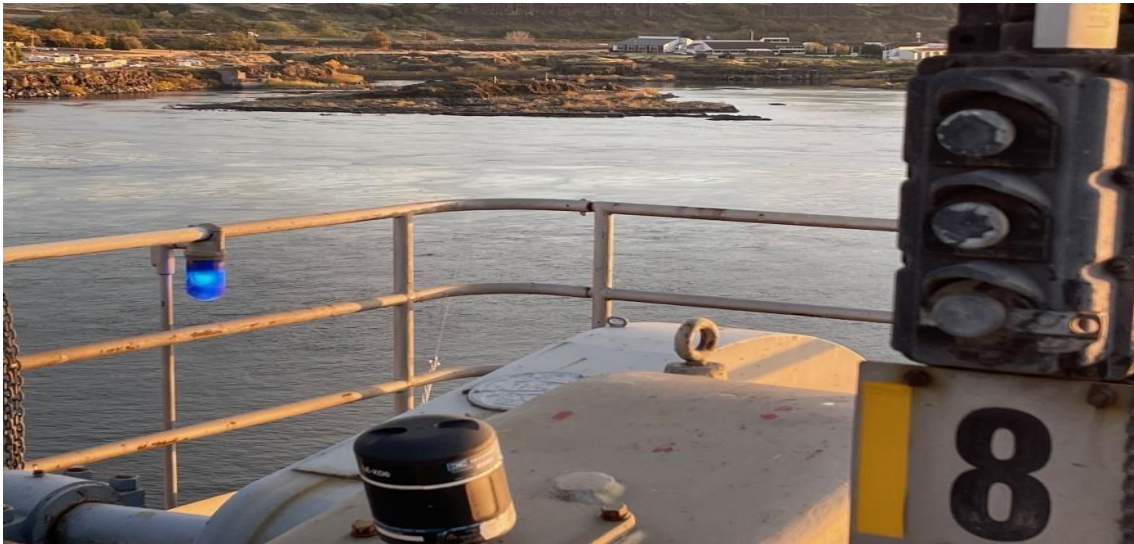
Gull line intact at spill gate 8. Line at spill gate 9 is down (SW3). Gulls and cormorants in PH2 and SW2/3 and the Navlock downstream. Navlock gulls not in count zones.
