The Dalles Dam Fishway Status Report

Inspection Period 10/29-11/04, 2023

THE DALLES DAM

US Army Corps
of Engineers
Portland District

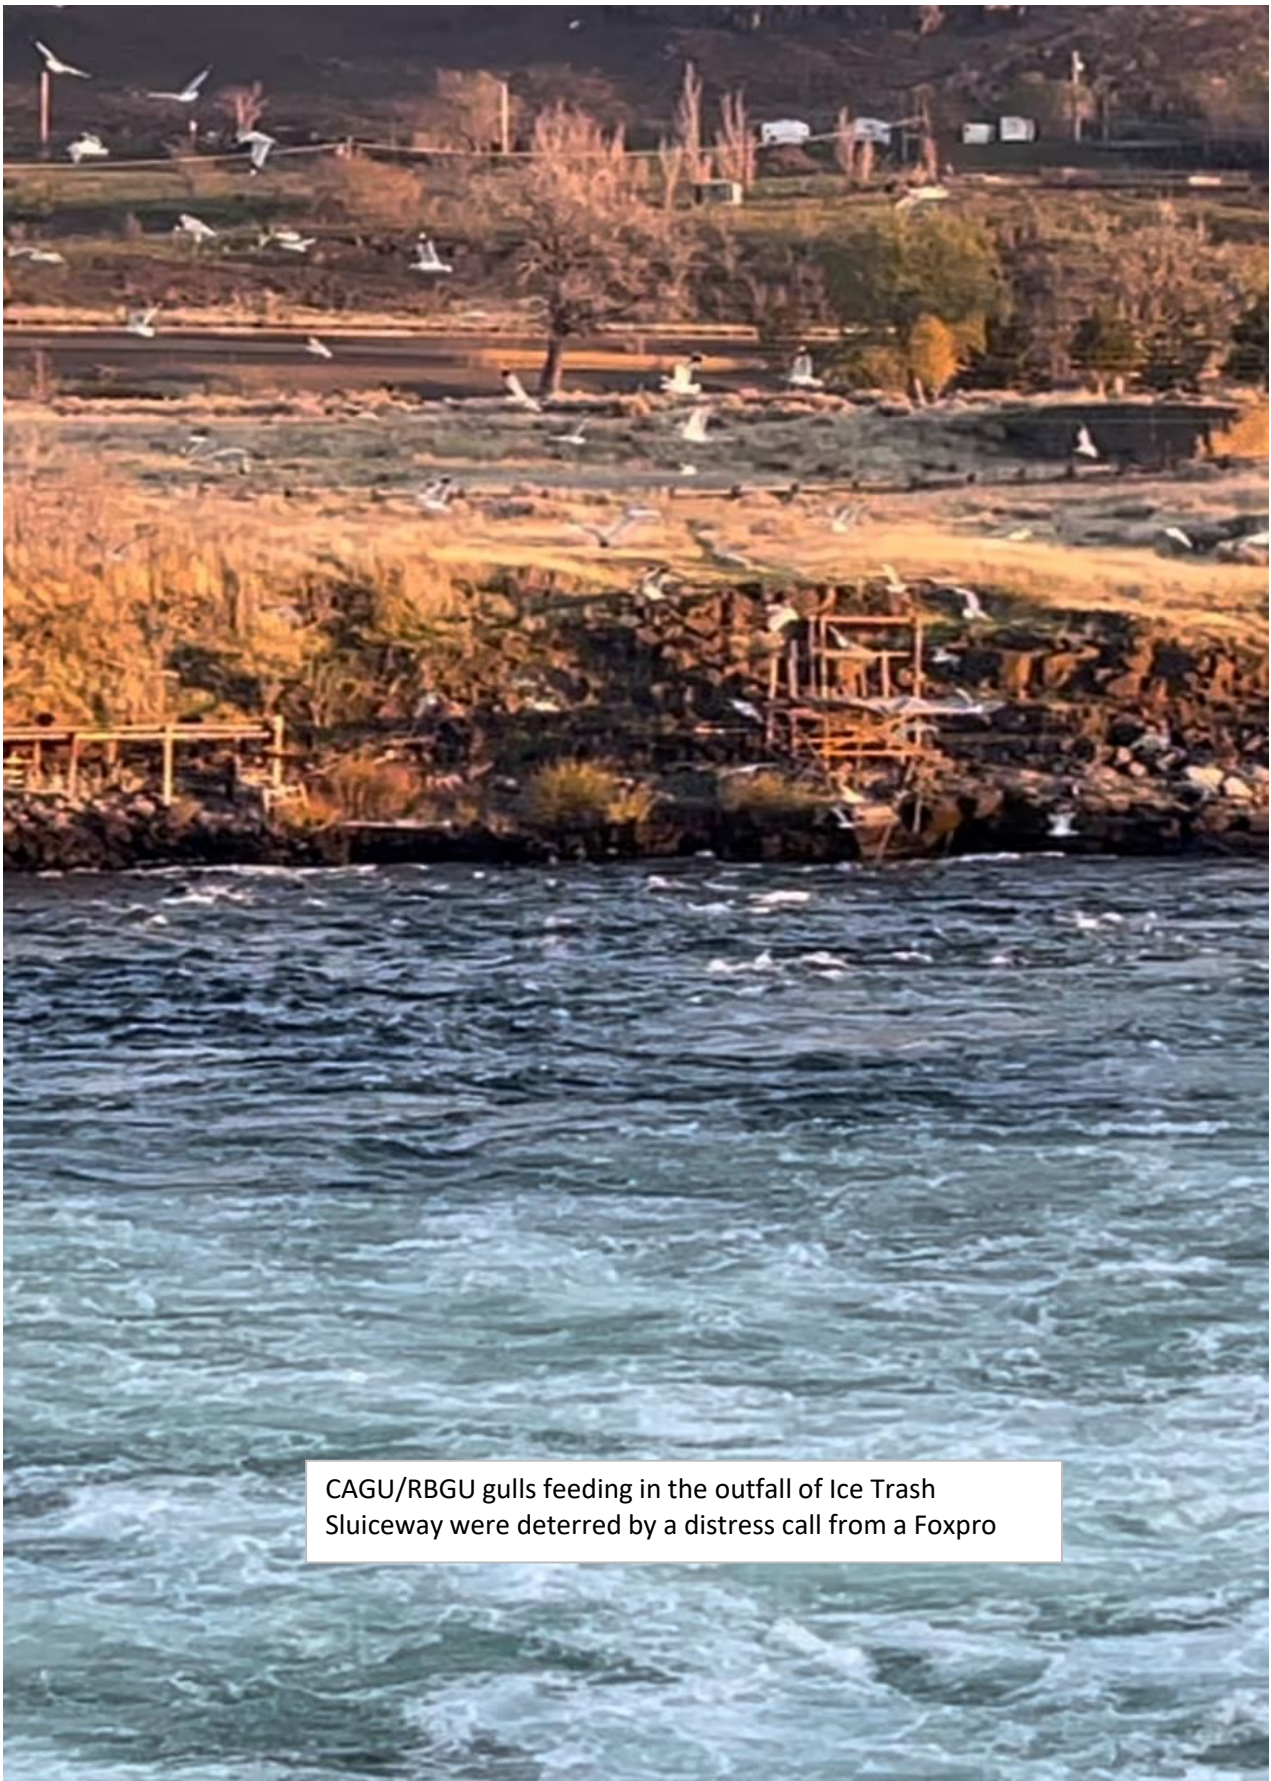
CAGU/RBGU gulls feeding in the outfall of Ice Trash Sluiceway were deterred by a distress call from a Foxpro
