The Dalles Dam Fishway Status Report

11/12/23

Inspection Period 11/05-11/11, 2023

THE DALLES DAM

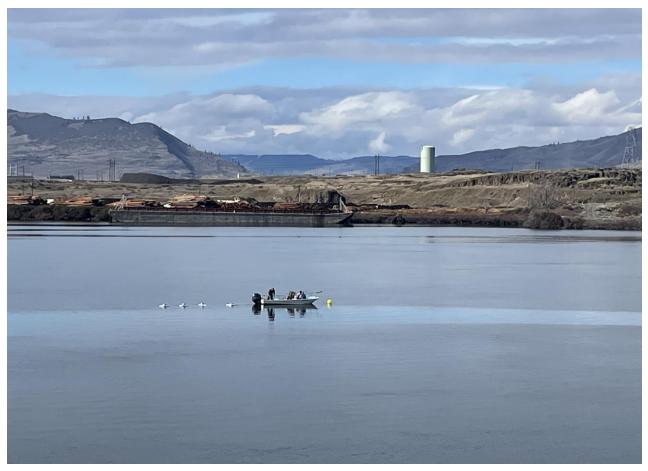
WSU plankton sampling in forebay
