# The Dalles Dam Fishway Status Report

Inspection Period 11/26-12/2, 2023

# THE DALLES DAM

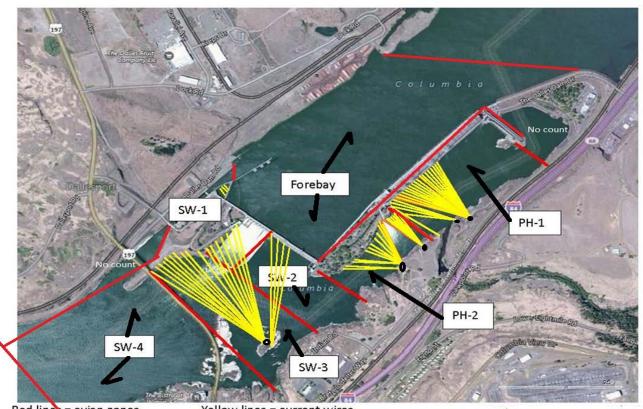
# Bird Count Zones, Avian Lines and Deterrent Sites

Red lines = avian zones

Yellow lines = current wires

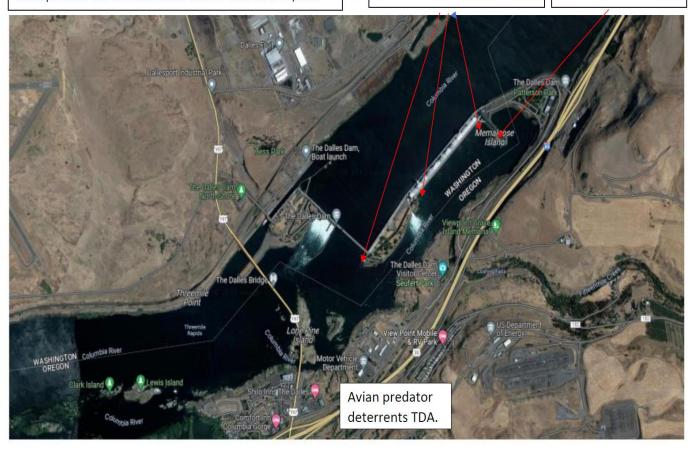
Tori lines at East Ladder entrances.

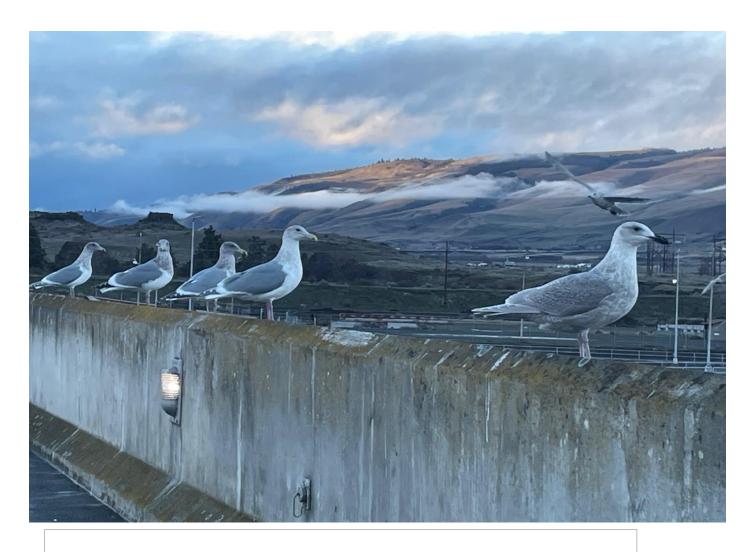
Western hybrid gulls continue to feed near the north navlock 12/3/2023. Not pictured are California and Ring bill gulls
