The Dalles Dam Fishway Status Report

Inspection Period 12/03-12/09, 2023

THE DALLES DAM

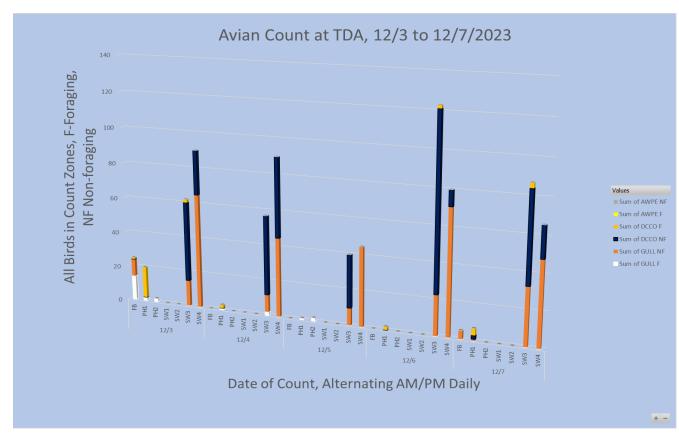
Bird Gard sound system being tested at peninsula and east entrance. Appears effective on cormorants and feeding gulls.

Bird Gard audio deterrent.

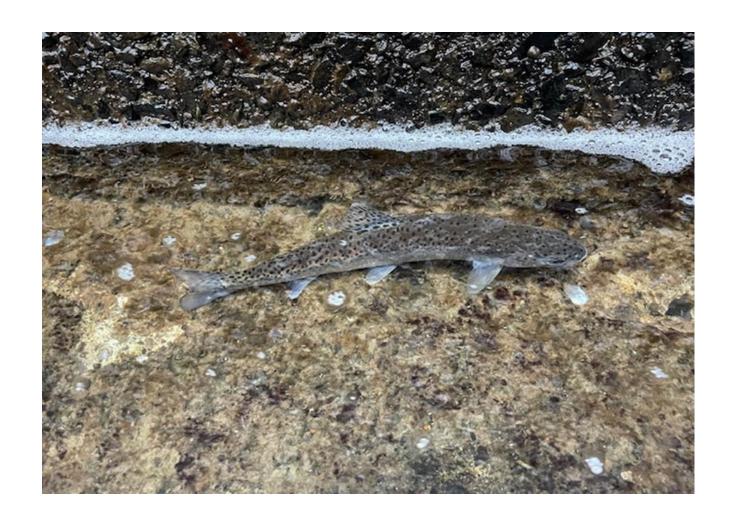
East fishway dewatered Dec 5. Approx 30 juvenile salmonids, 12 lamprey and 3 sturgeon released to river. Sturgeon were scanned by state reps.

One of several dozen steelhead rescued during east ladder dewater on 12/5/2023.
