The Dalles Dam Fishway Status Report

Inspection Period 3/9-3/16, 2024

THE DALLES DAM

US Army Corps
of Engineers
Portland District

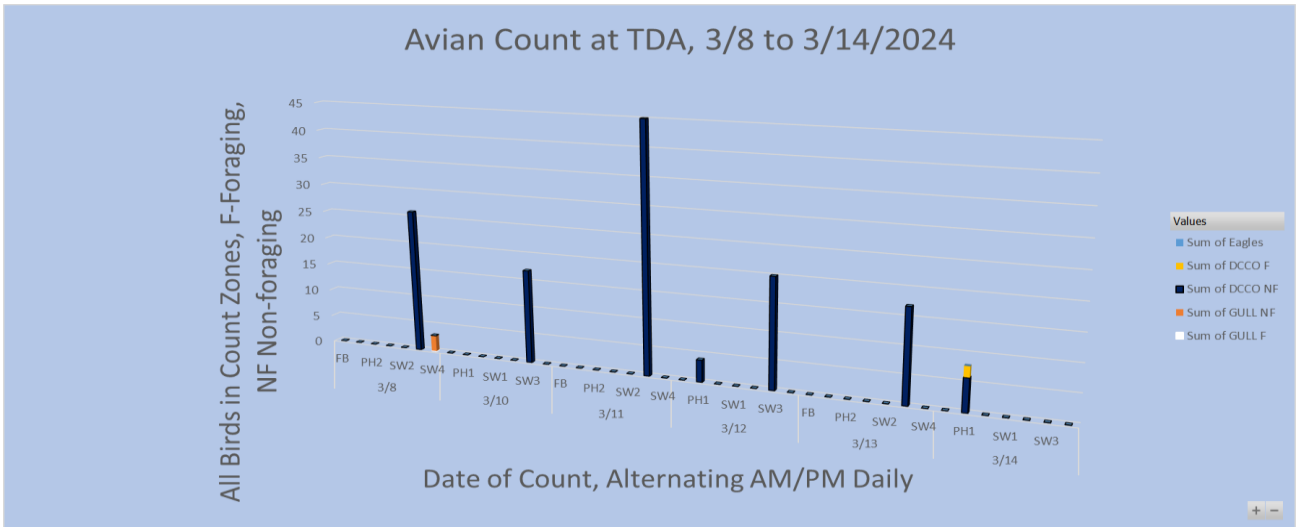
On 3/14 a Bird Gard audio deterrent installed on BPA towers and nest materials removed. No gulls, few eagles

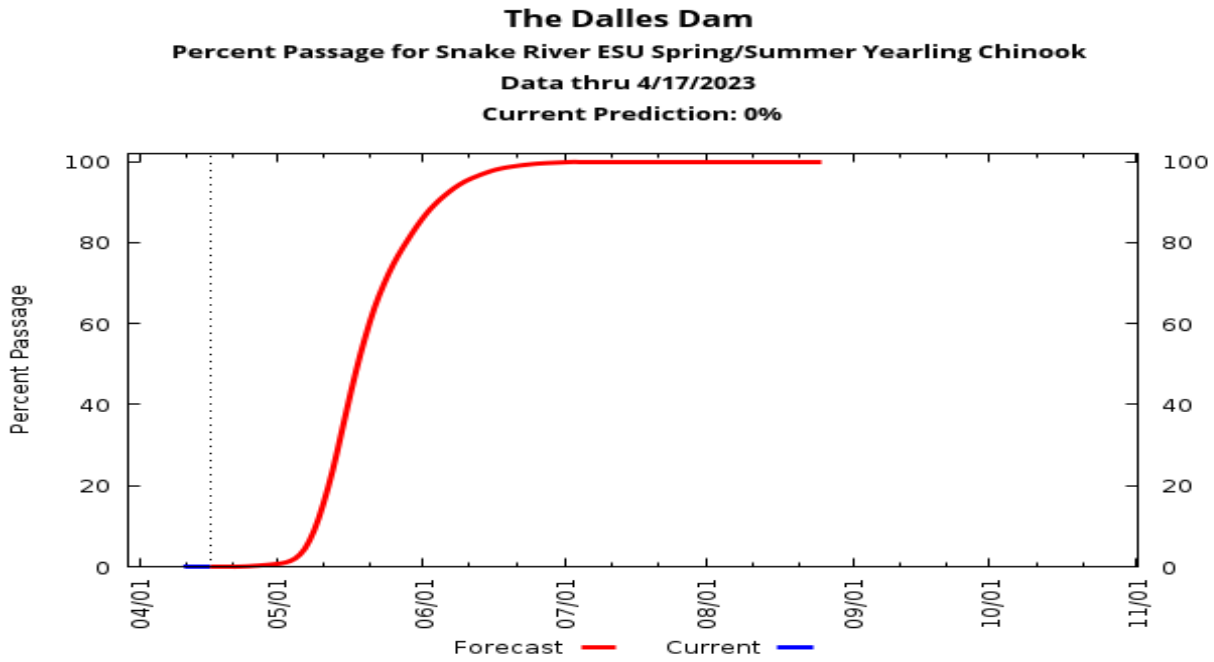
Waiting for fish

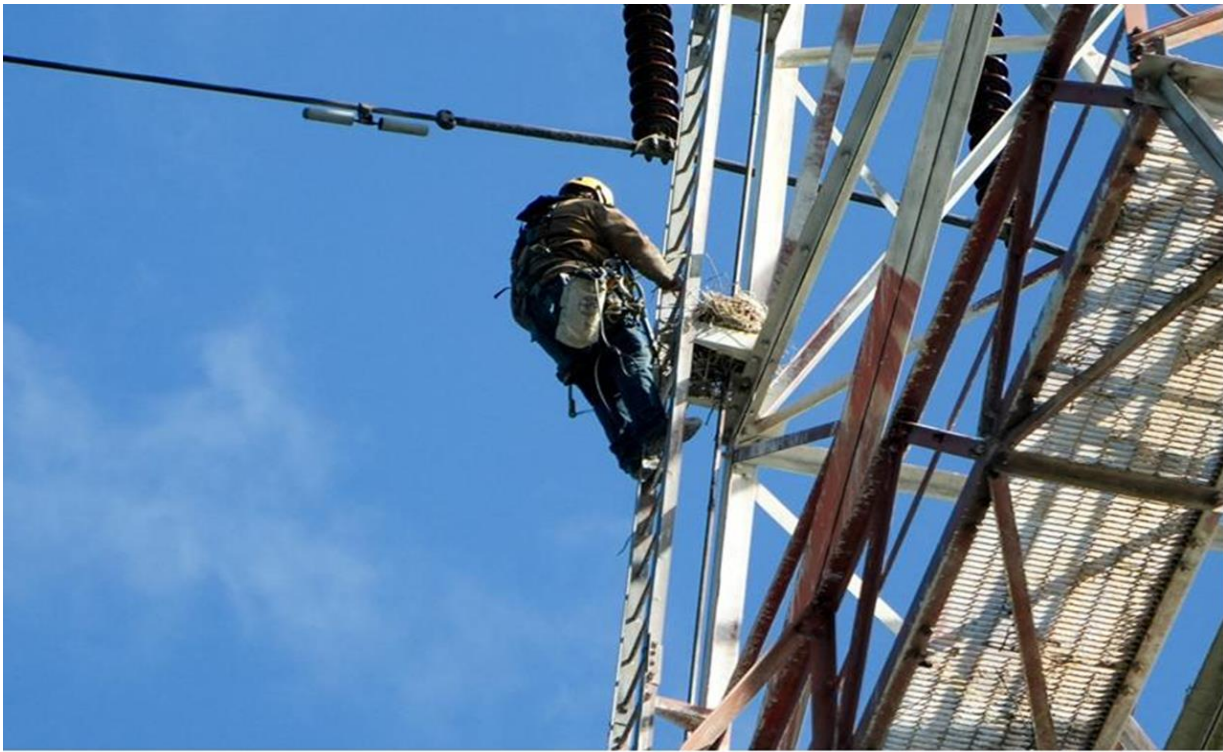
BPA scanning for PIT tags prior to removing nest materials 3/14/24.
