FISHWAY STATUS REPORT

Date: 2/8/2011

Inspection Period: 1/30 - 2/5/2011

THE DALLES DAM

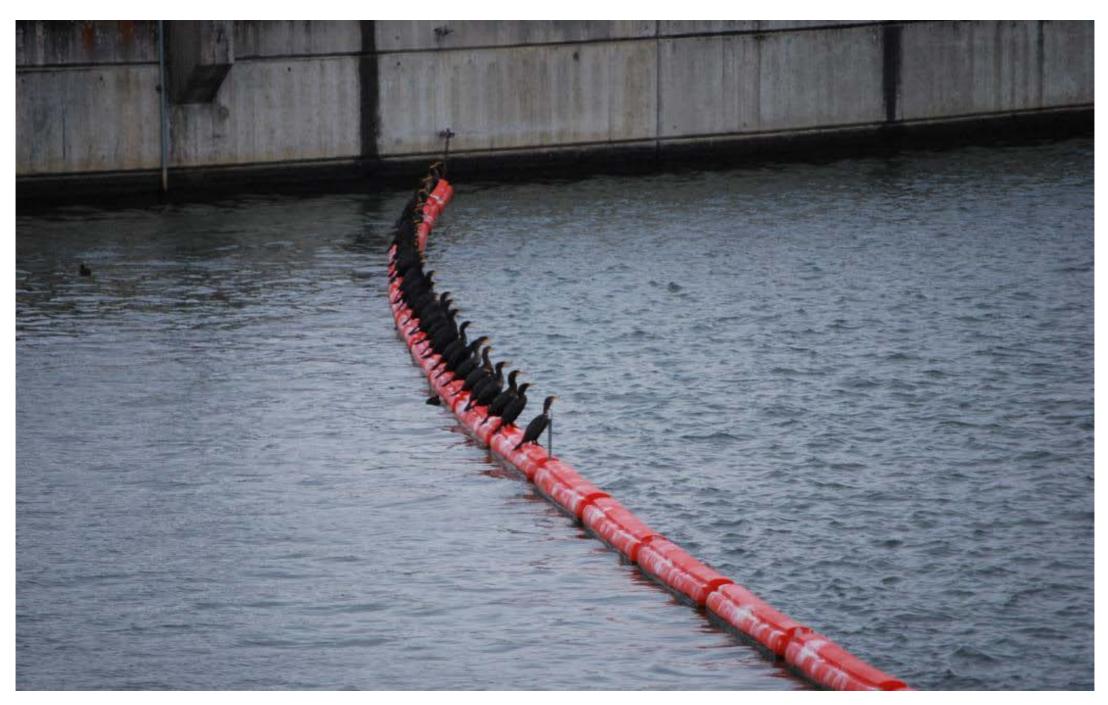
Birds: Eagle numbers decreasing. Cormorant numbers still high. Refer to avian observation map and picture of cormorants roosting on boom north ladder exit.

North exit debris boom/cormorant roosting. Primarily a fall/winter behavior. Not as prevalent during spring/summer passage season.
