FISHWAY STATUS REPORT

Date: 2/13/2012

Inspection Period: 2/5 - 2/11/2012

THE DALLES DAM

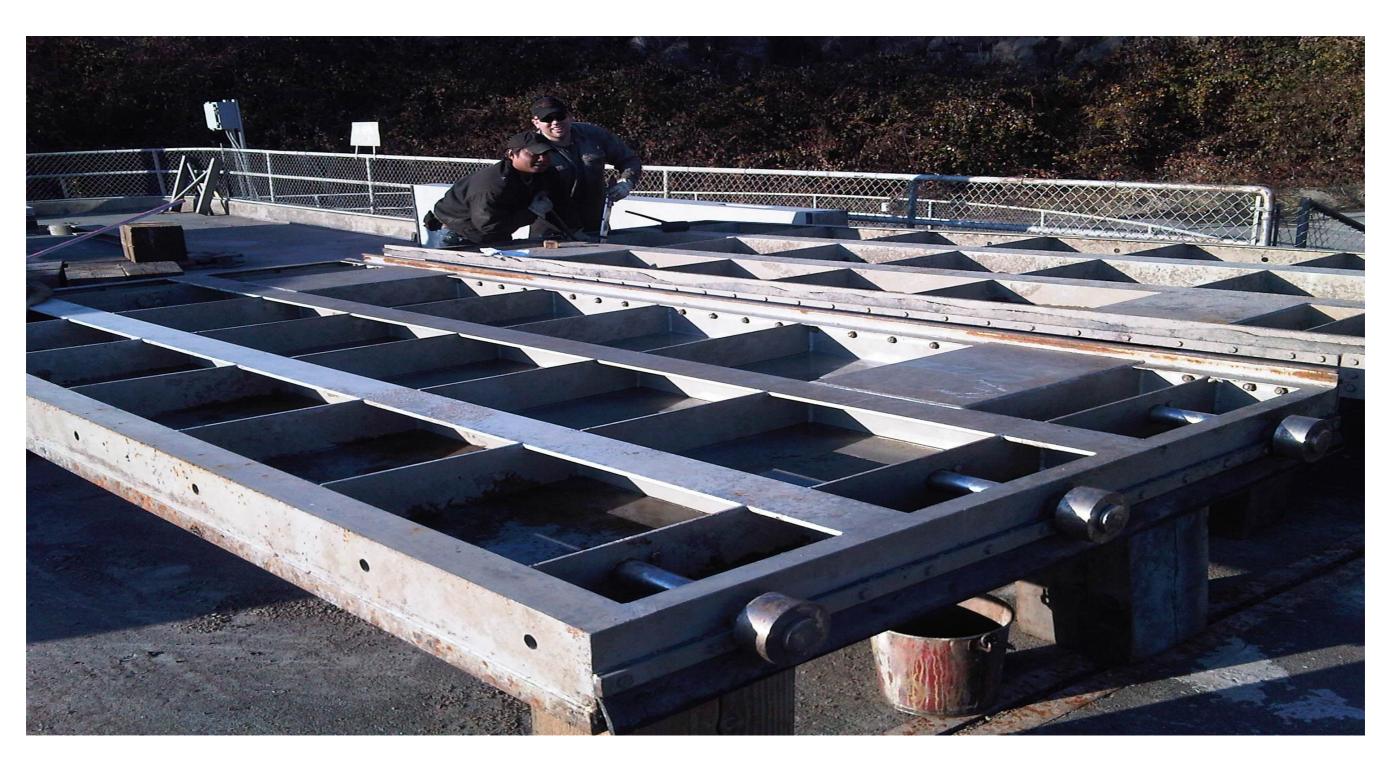
North entrance weir N1 removed for wheel repair. Several of the wheels were seized.
