FISHWAY STATUS REPORT

Date: 5/13/2013
 Inspection Period: 5/12 - 5/18/2013

THE DALLES DAM

**US Army Corps
of Engineers**
Portland District

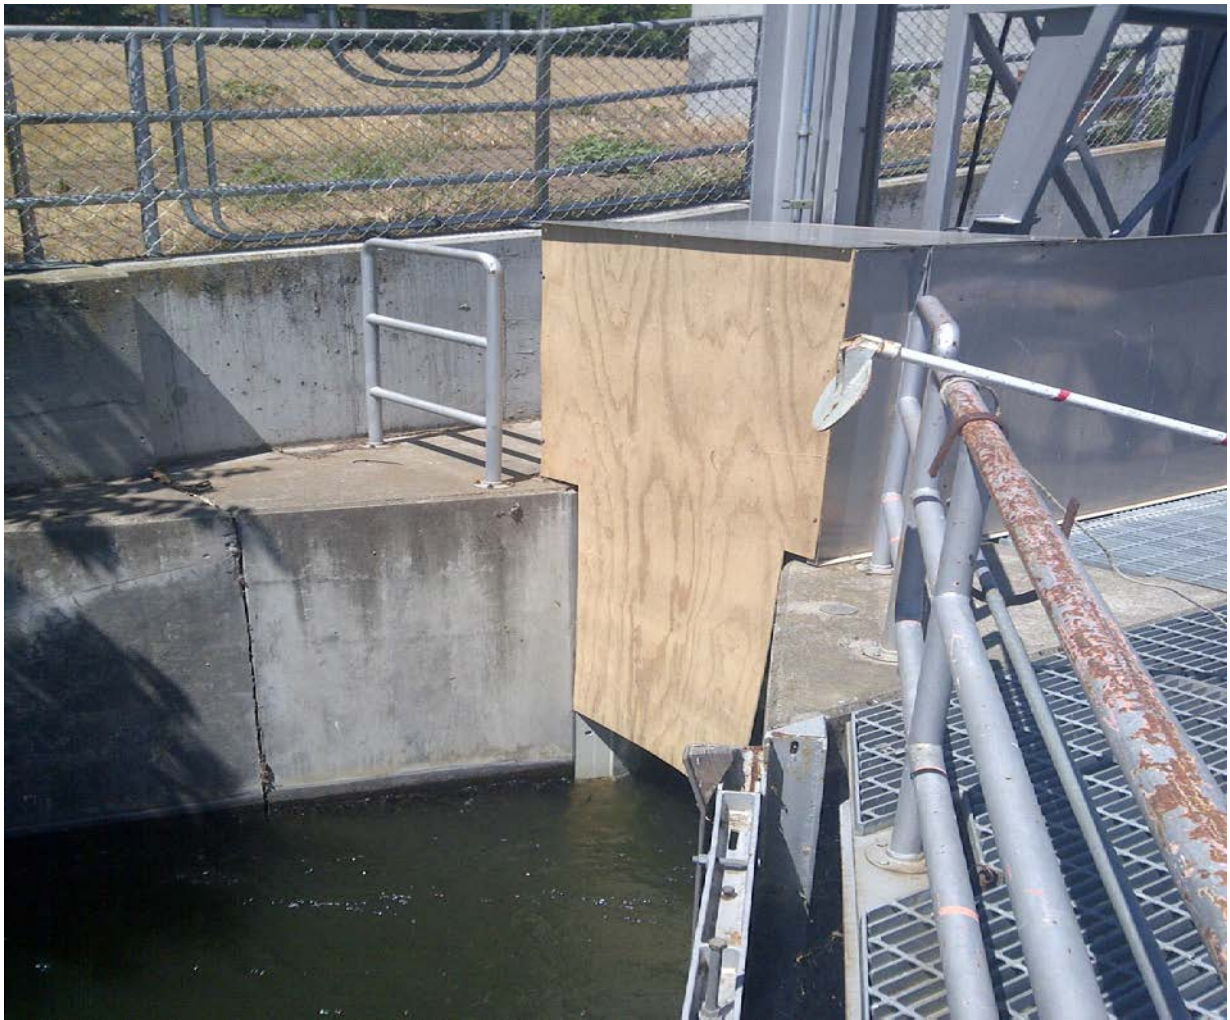
An aluminum shading panel over the count slot was replaced with a wooden one due to an possible interference with PIT antenna.

Wood panel sunshade installed at north count station to replace aluminum in attempts to reduce PIT antenna interference.
