FISHWAY STATUS REPORT

Date: 5/26/2013
Inspection Period: 5/19-25/2013

THE DALLES DAM

**US Army Corps
of Engineers**
Portland District

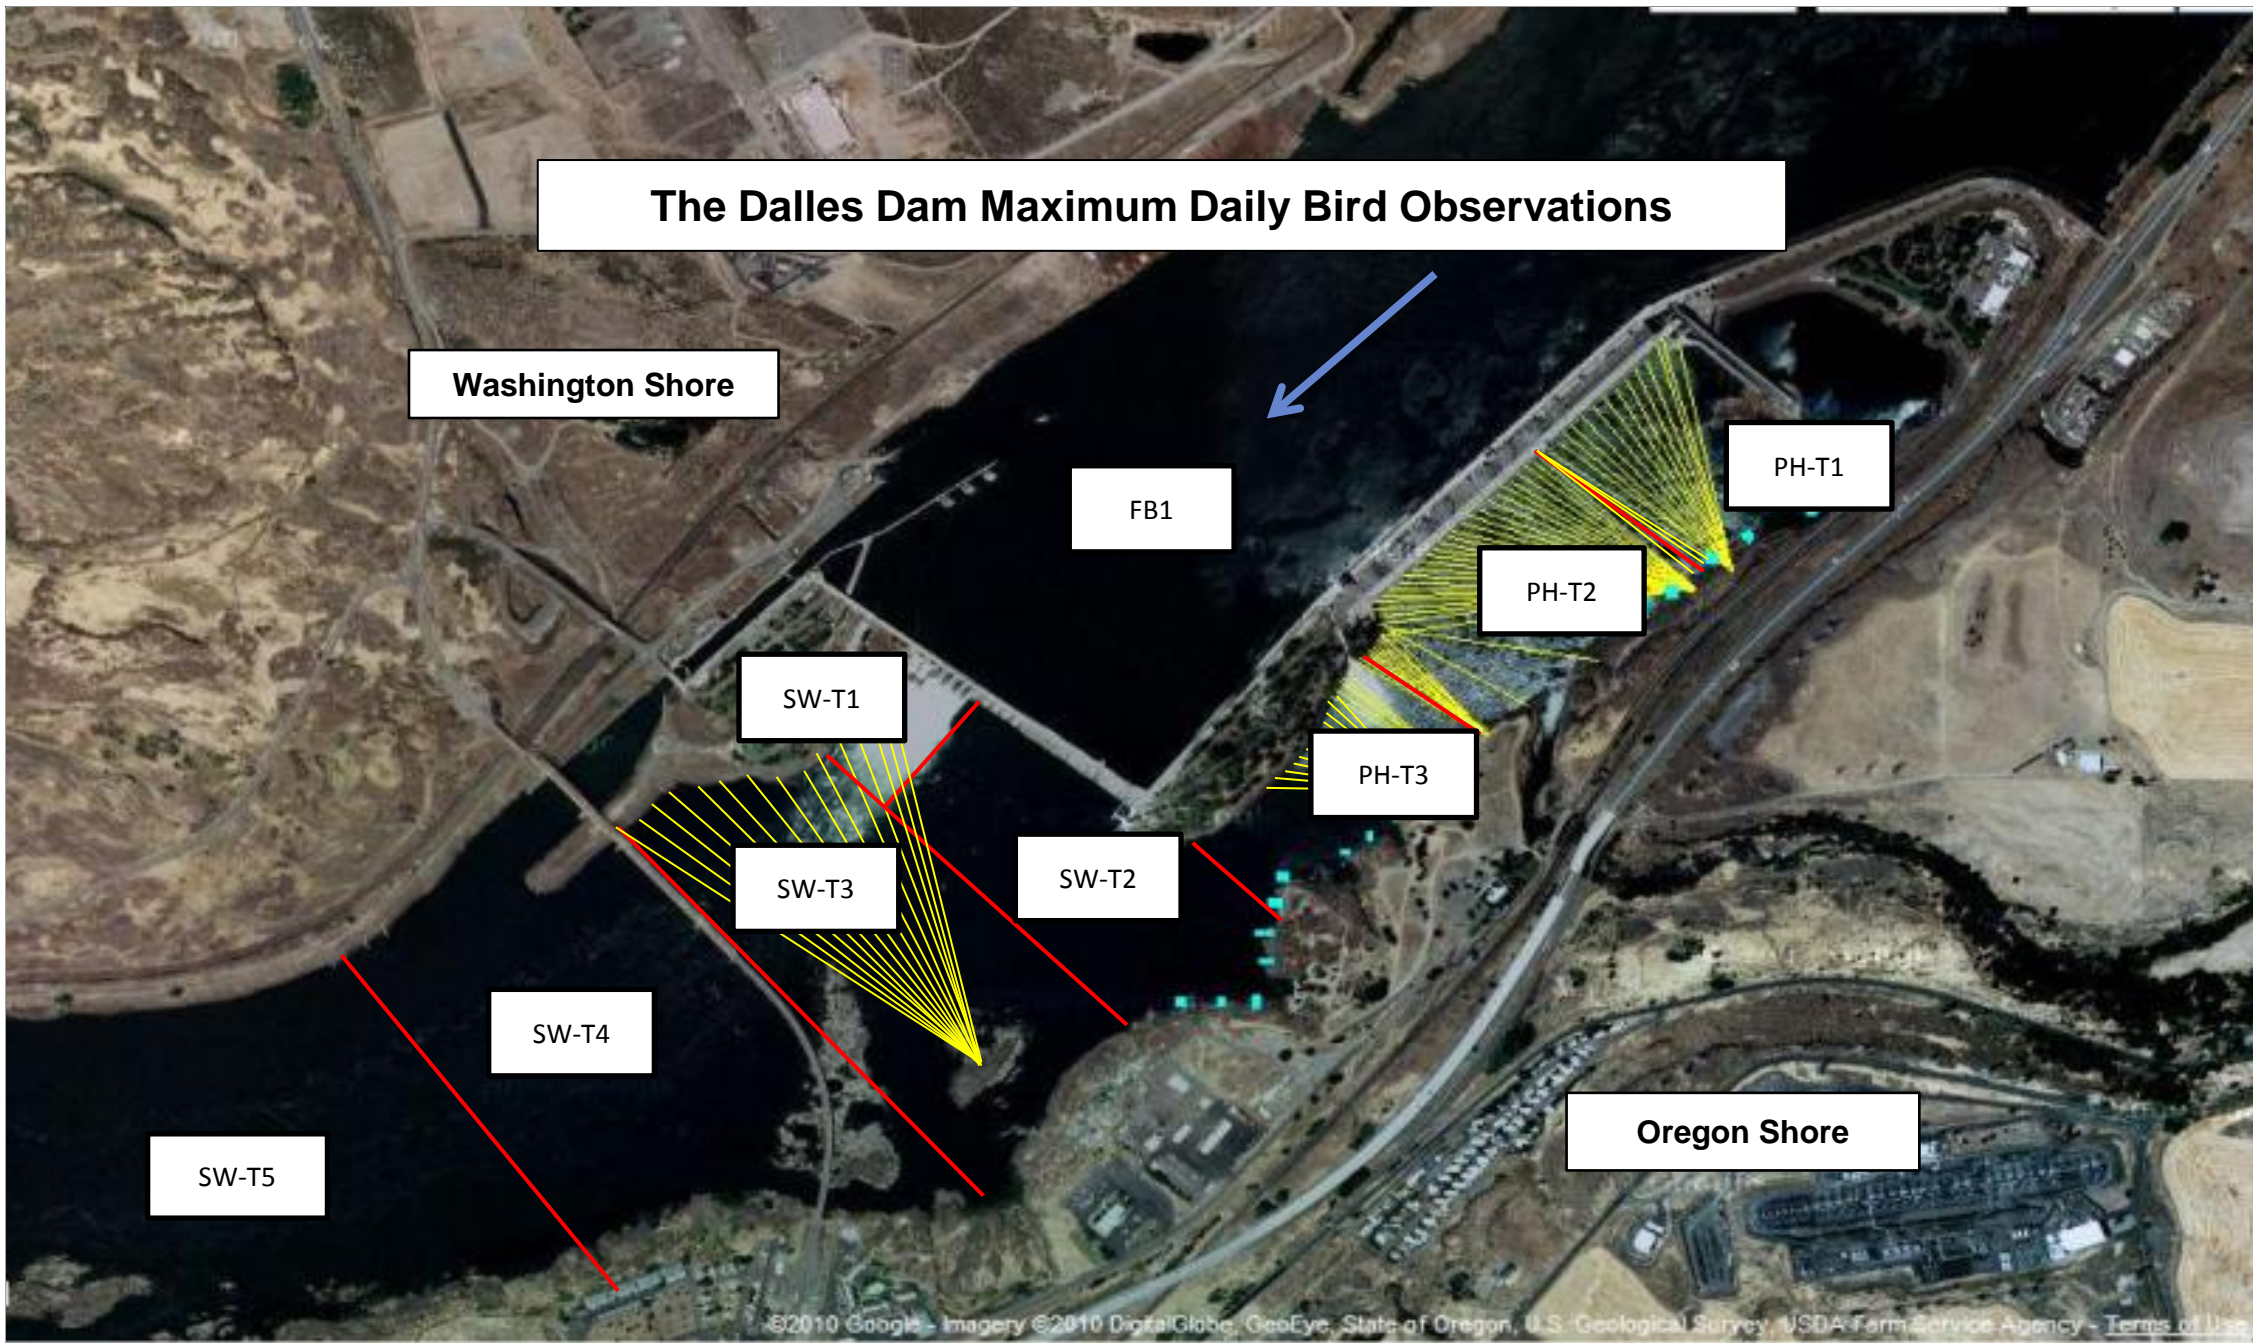
The Dalles Dam Maximum Daily Bird Observations

Bird observation data collected twice daily. Gull numbers high downstream of bridge. New avian zone (SW-T5) created due to high numbers of gulls resting, flyby, and foraging below SW-T4, downstream from the green coast guard marker to the islands. See avian zones map and distribution tabs. Boat hazer's from John Day were borrowed for two days due to high numbers of gulls downstream of bridge, but there was a noticeable increase at John Day immediately afterwards. There was one sea lion sightings during this week.
