The Dalles Dam Fishway Status Report

Inspection Period: 05/01 - 05/07/2016

THE DALLES DAM

US Army Corps
of Engineers
Portland District

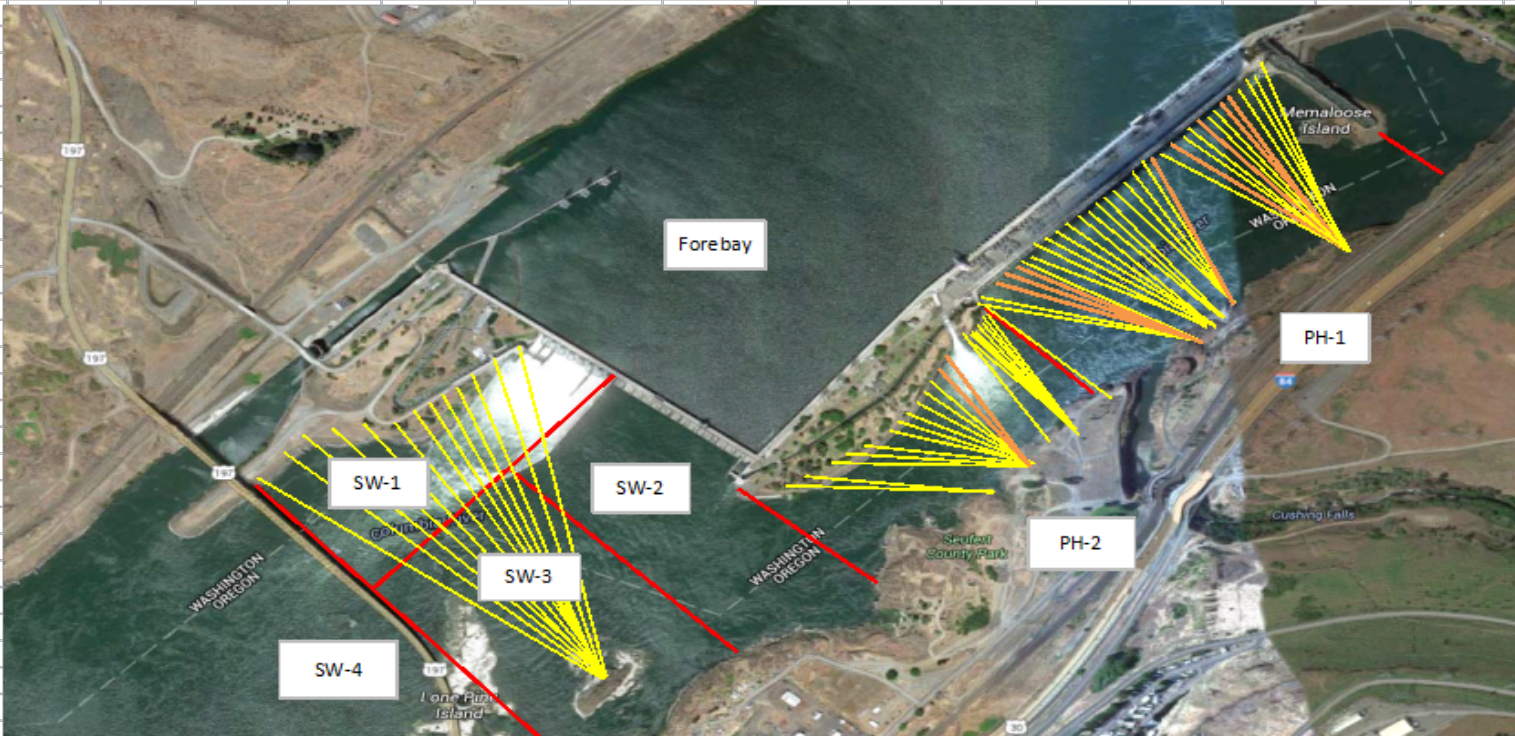
Bird observation data collected once daily. Refer to Avian Zone map. USDA hazers started May 7 after 2 week delay due to late approvals.

Bird predation extremely high downstream of spillway. No bird activity at powerhouse.

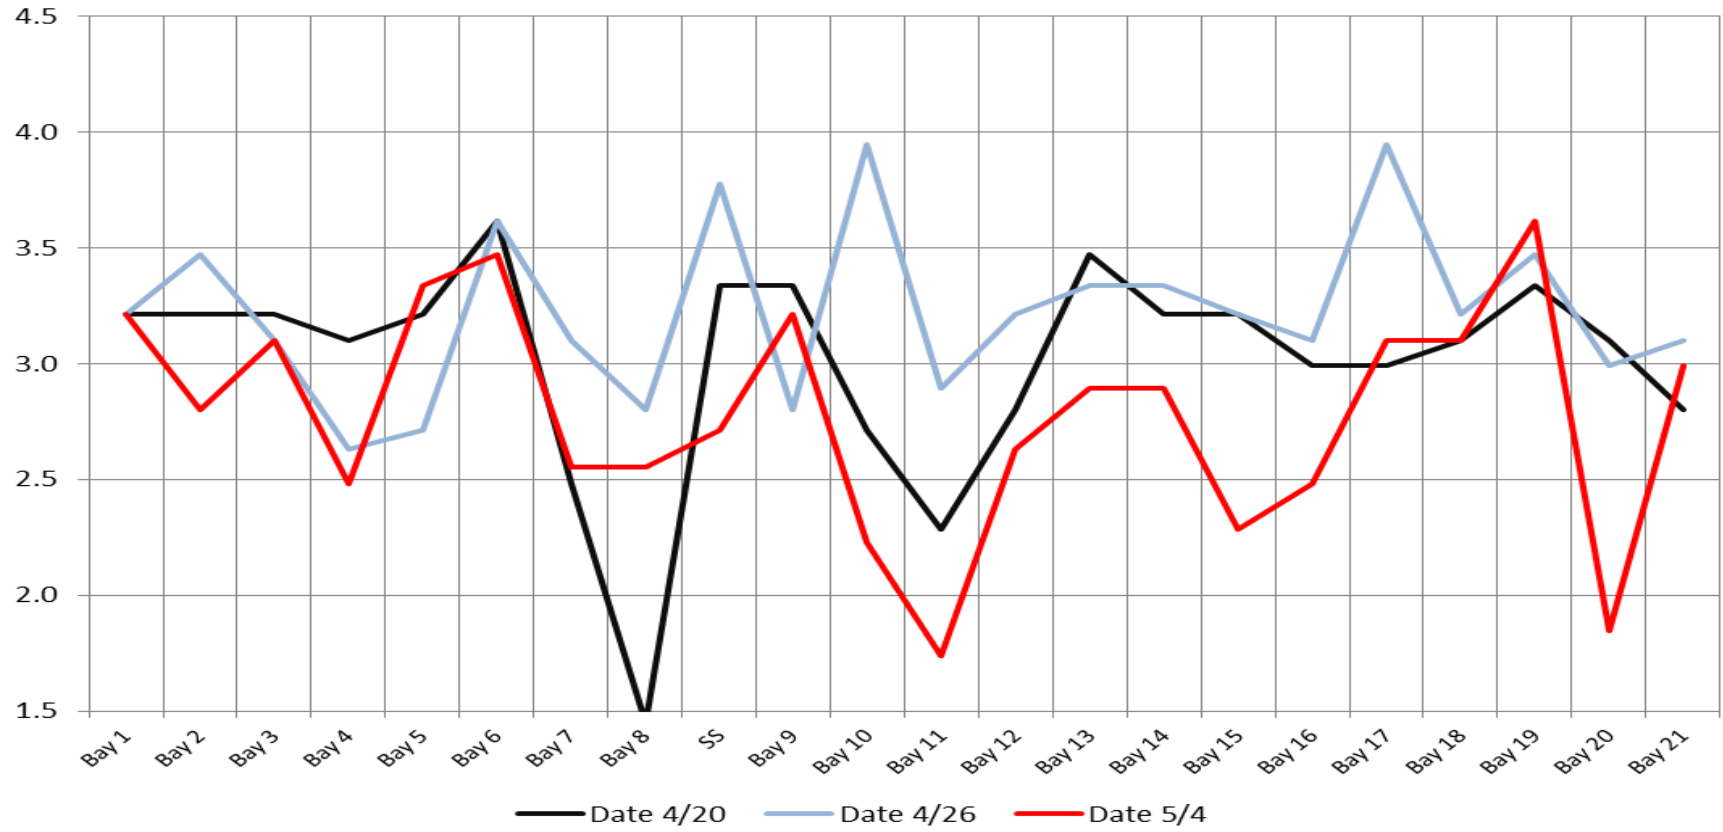
The Dalles Dam Collection Channel Velocites (In criteria 1.5 - 4.0 fps)

| The Dalles Dam | Inspections Out of Criteria | Criteria Limit | Total Number of Inspections: 21 | | Temperature: 55.6 °F | |
|---|---|---|---|--|---|--|
| Collection channel velocity | 0 | 1.5 - 4 fps | 3.2 | | | |
| North channel velocity | 0 | 1.5 - 4 fps | 2.0 | | | |
| South channel velocity | 0 | 1.5 - 4 fps | 2.5 | | | |
