THE DALLES DAM

The Dalles Dam Fishway Status Report

12/17/2016

Inspection Period: 12/11/2016 - 12/17/2016

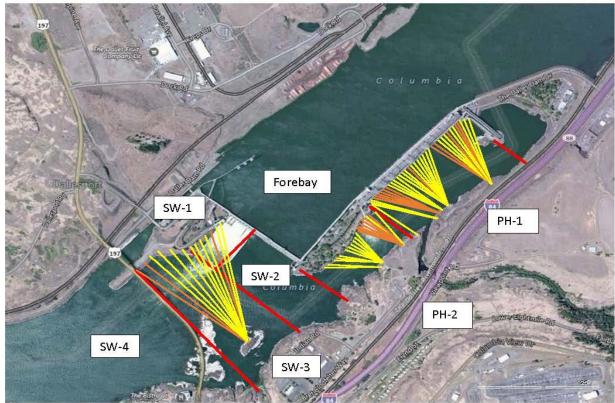
No sea lions observed. High numbers of Cormorants. Bald Eagles starting to arrive in westrick park; Bird observation data collected once daily. Refer to Avian Zone map and bird count. Two of 13 spillway avian lines broke closest to bridge. Preparing work plan for USDA contract.

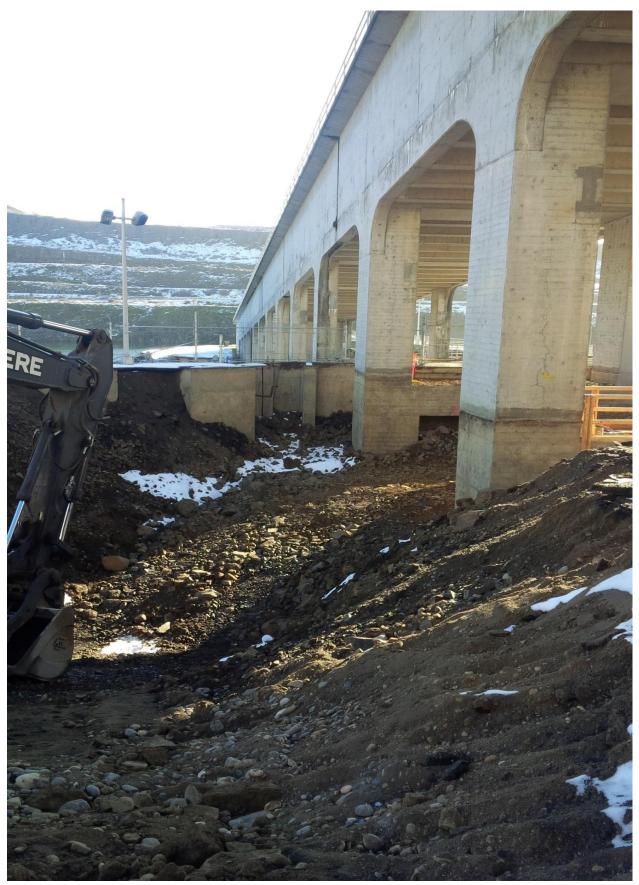
Excavation of valve place under east fishladder. Ready to cut junction pool wall.

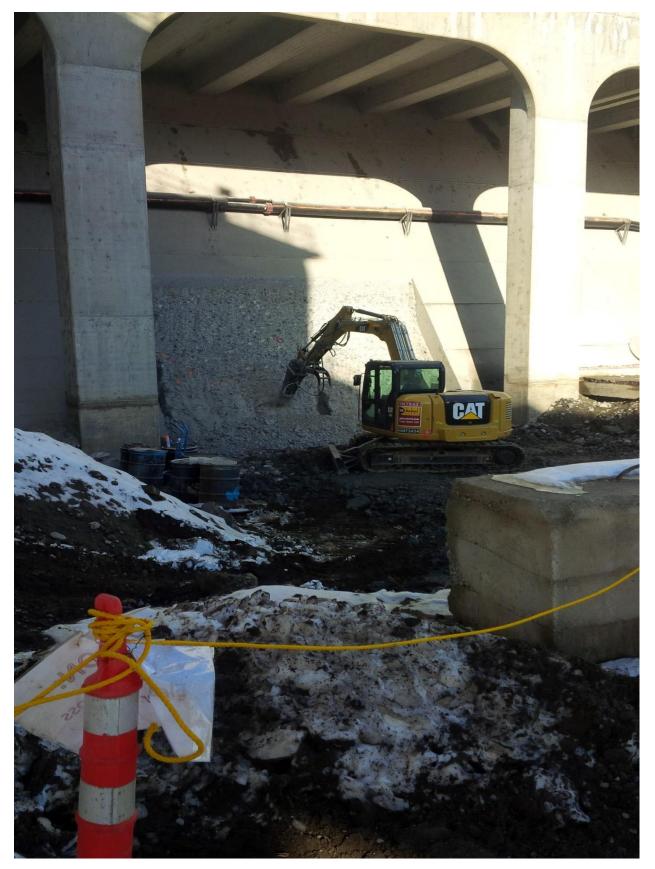
Rock hammering of dam face near complete. Prep for drilling hole.

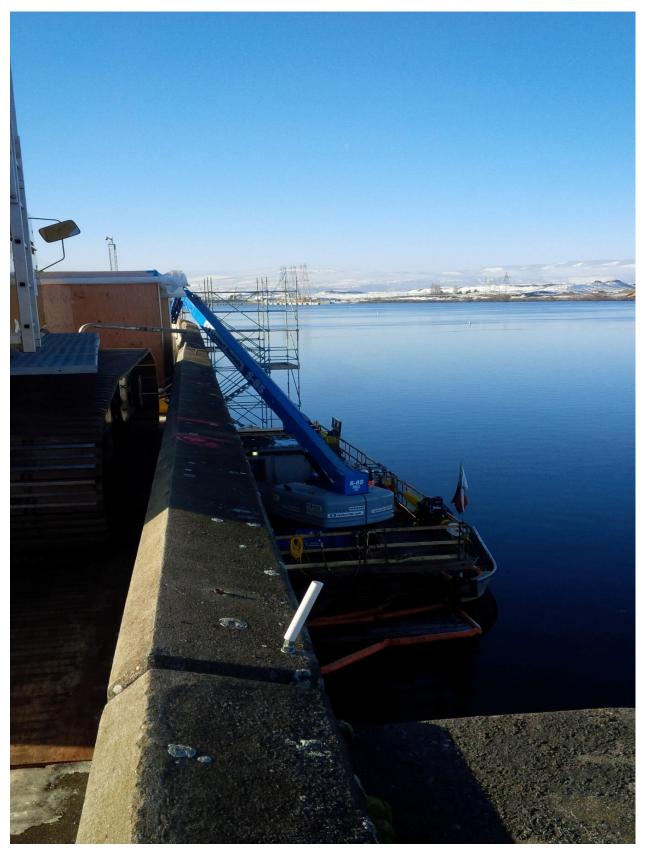
Forebay platform continues with intermittent dive work and clamshell dredging.
