# The Dalles Dam Fishway Status Report

## 1/8/2017

Inspection Period: 01/07/2017 - 01/07/2017

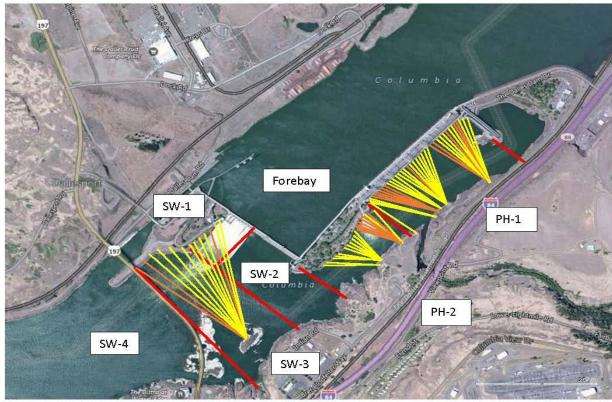
Two of 13 spillway avian lines broke closest to bridge. Work plan and hazing contract routed for approvals.

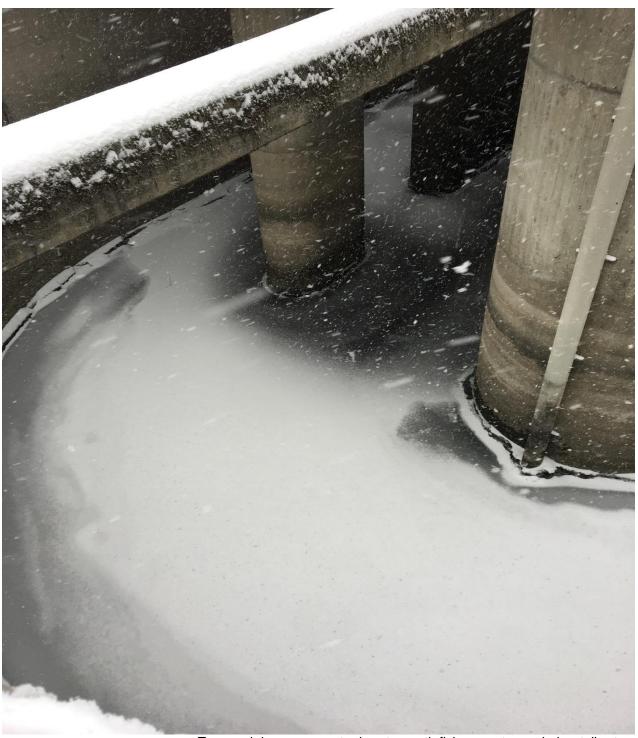
North fishladder dewatered Jan 4. Entrance below tailwater attempted Jan 5 but postponed due to low temperatures and ice coverage. (refer to pic tab)

Too much ice coverage to dewater north fishway entrance below tailwater. Postponed. Would require ice fishing tactics for fish salvage.

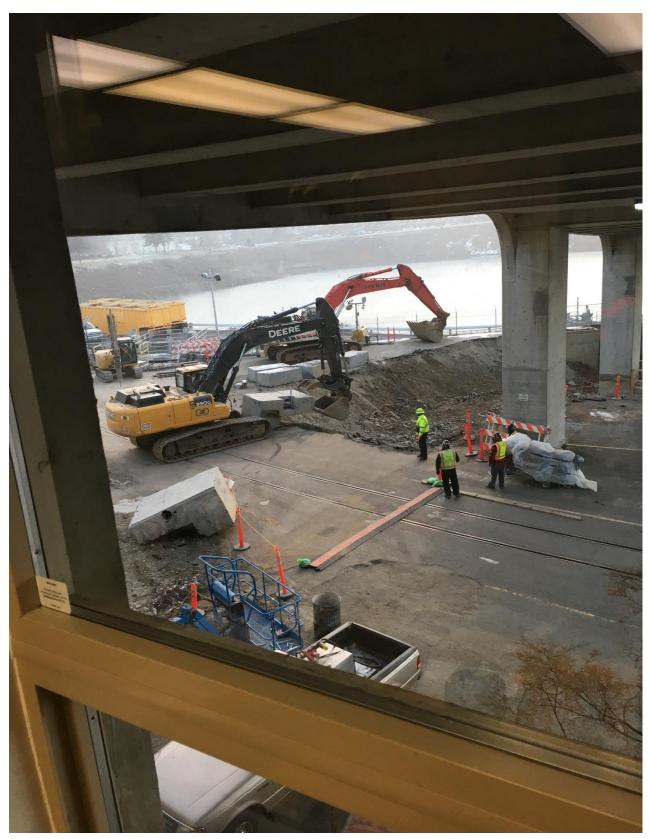
East fishladder AWS emergency backup - Forebay diving underway. Scaffold and work platform in junction pool. Junction pool concrete east side removed. Jackhammering of hole resumed. Forebay slot cutting via dive for peirs underway.

Concrete sections removed from junction pool wall
