# The Dalles Dam Fishway Status Report

1/18/2017

Inspection Period: 01/08/2017 - 01/14/2017

US Army Corps  
of Engineers  
Portland District

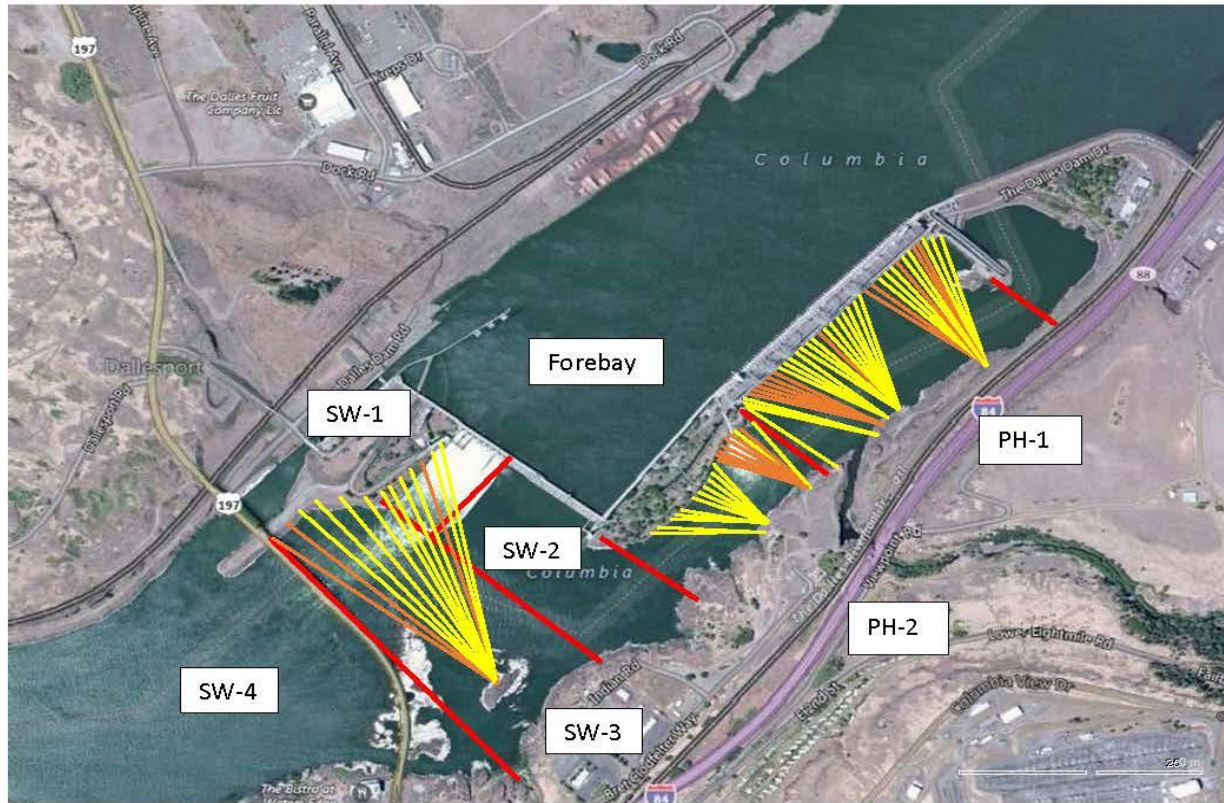
No sea lions observed. High numbers of Cormorants. High Bald Eagle numbers in westrick park.  
Bird observation data collected once daily. Refer to Avian Zone map and bird count.  
Two of 13 spillway avian lines broke closest to bridge. Work plan and hazing plan being routed for approvals.

Orange lines = down or missing wires

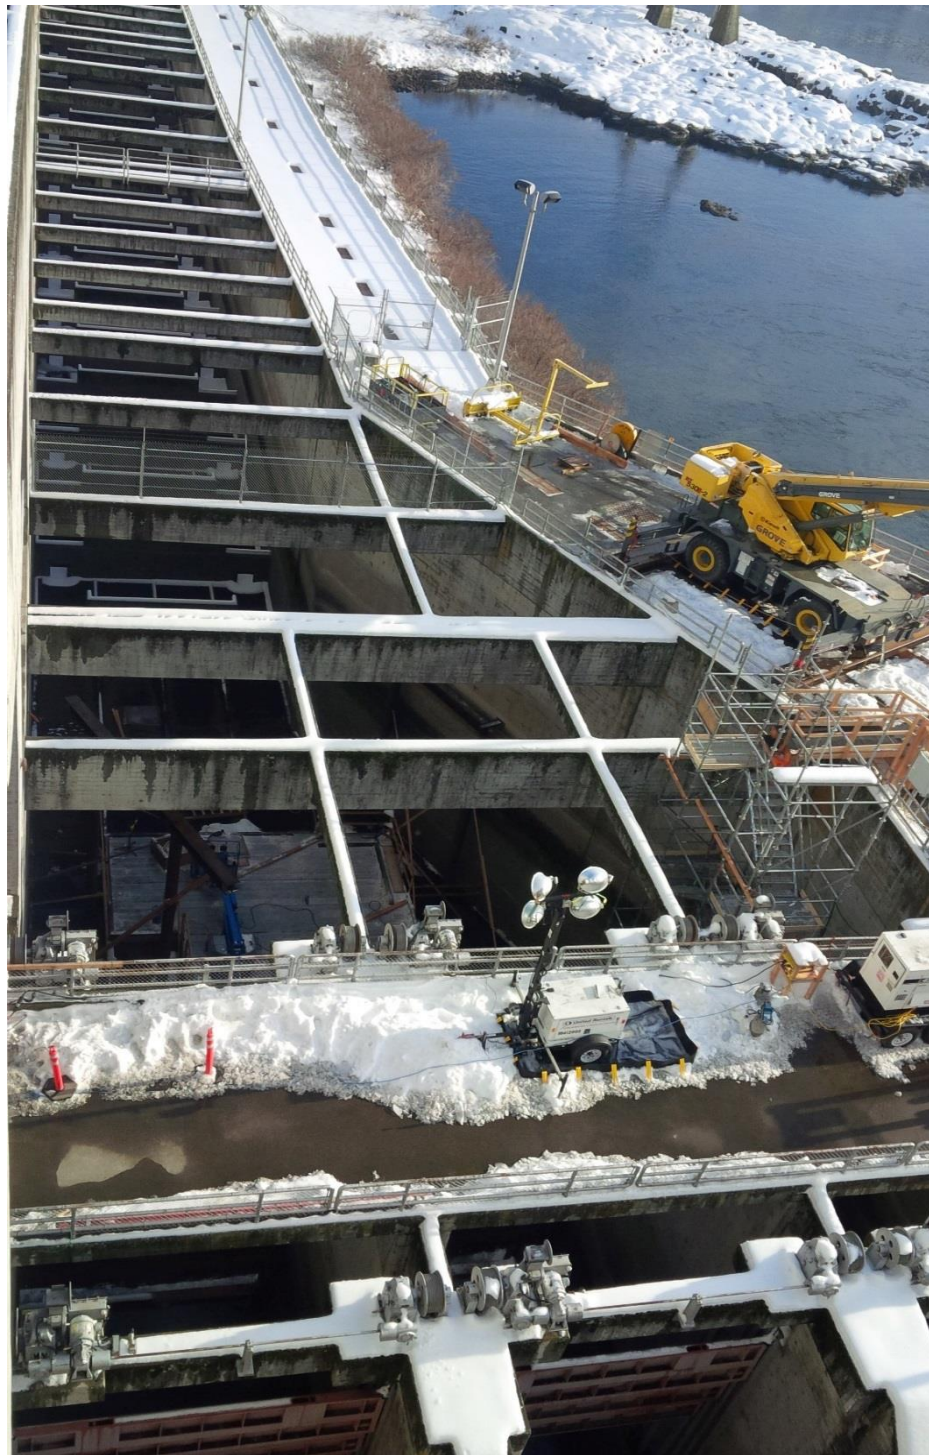
Work area in junction pool. Prep for aux water pipe crossing.

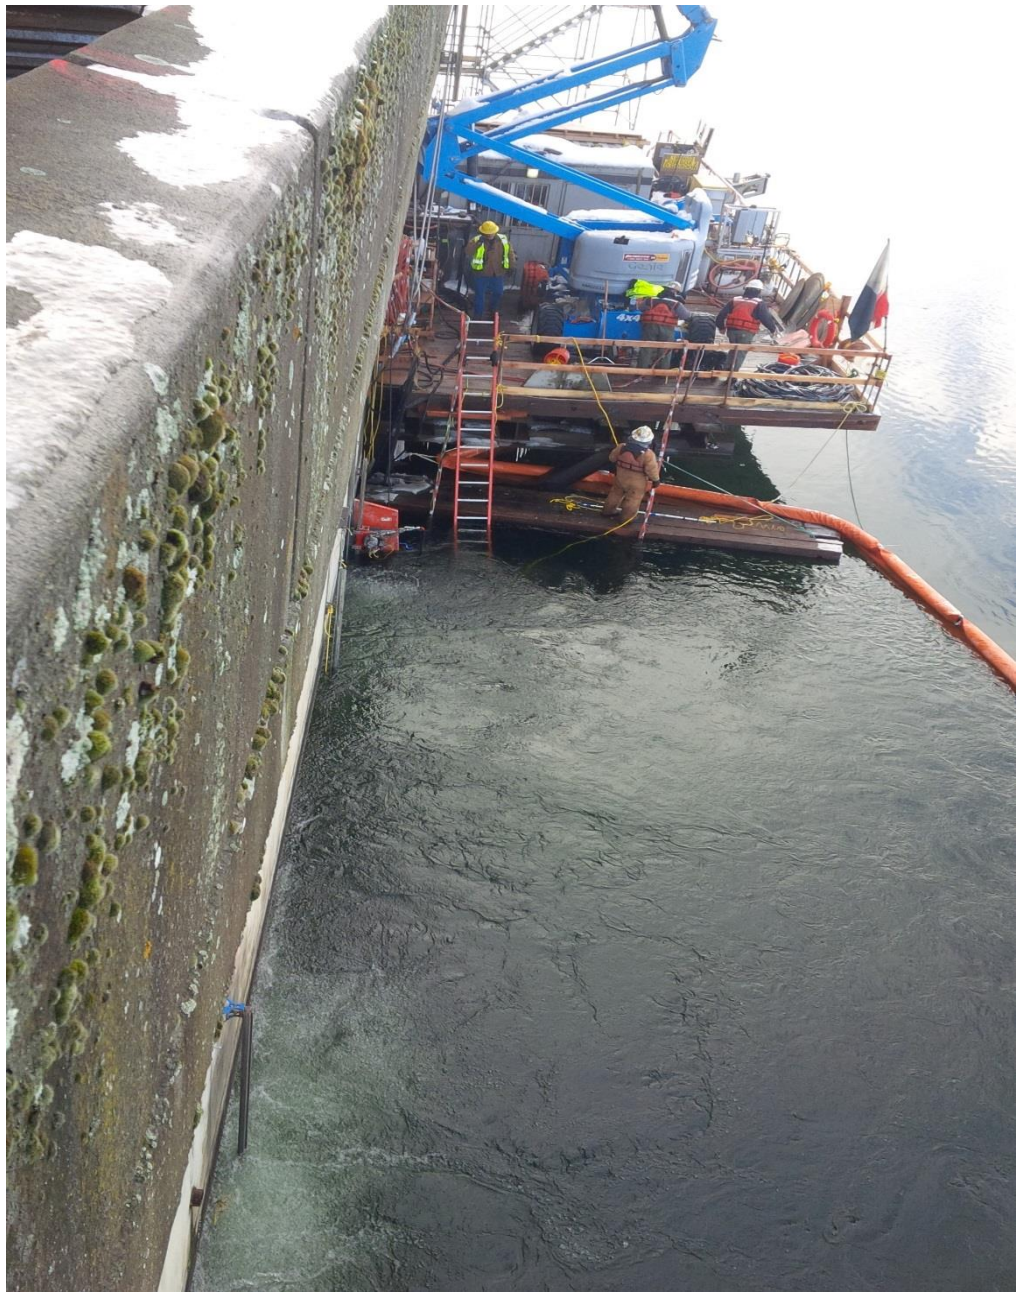
Dive operations in forebay. Slot cutting for piernose anchors.
