The Dalles Dam Fishway Status Report

2/11/2017

Inspection Period: 02/05/2017 - 02/11/2017

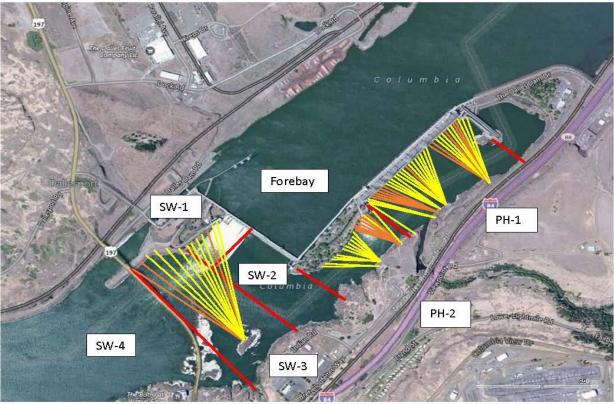
Spillway avian lines repair plan in progress. Work plan and hazing plan routed for approvals. USDA prework site tour Mar1.

Red lines = avian zones

Yellow lines = current wires

Orange lines = down or missing wires

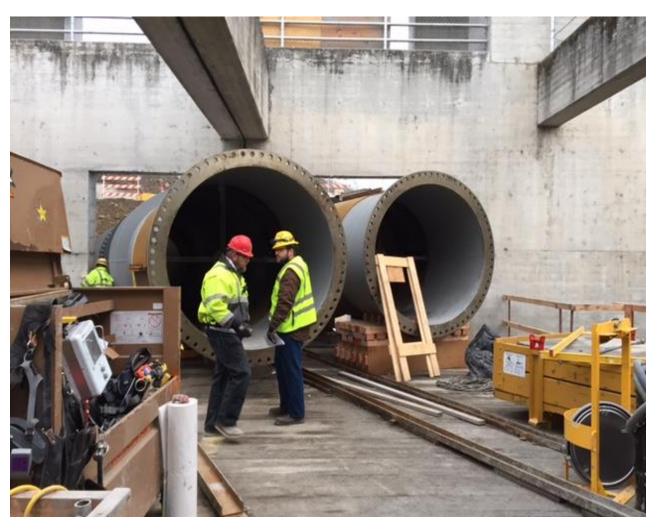
AWS 7' pipes half way across junction pool span.

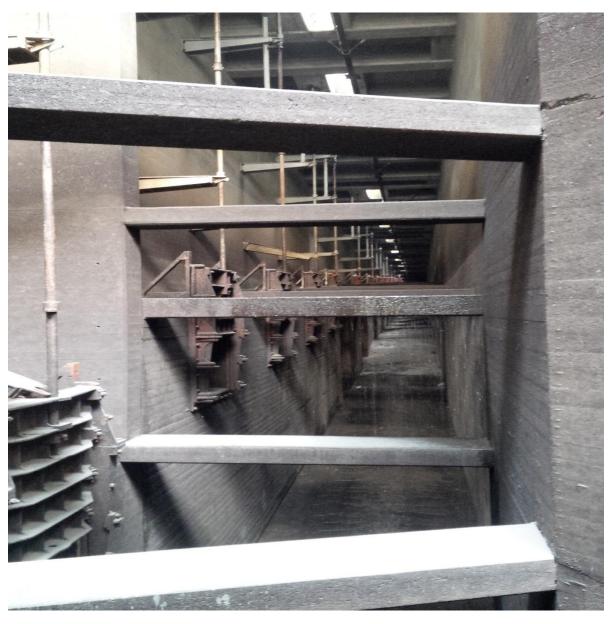
Broke diffuser stems on 5 junction pool diffusers. Will not impede flow. These valves will be removed in future. No repair planned.

Failed support bracket for diffuser valve (slanted one). 4 others found with same failure.

Long Term repair maintenance plans; 154 -157 rehab/weir wheel replace, collection channel diffusers decommission, repair failed diffusers.
