The Dalles Dam Fishway Status Report

2/19/2017

Inspection Period: 02/12/2017 - 02/18/2017

US Army Corps
of Engineers
Portland District

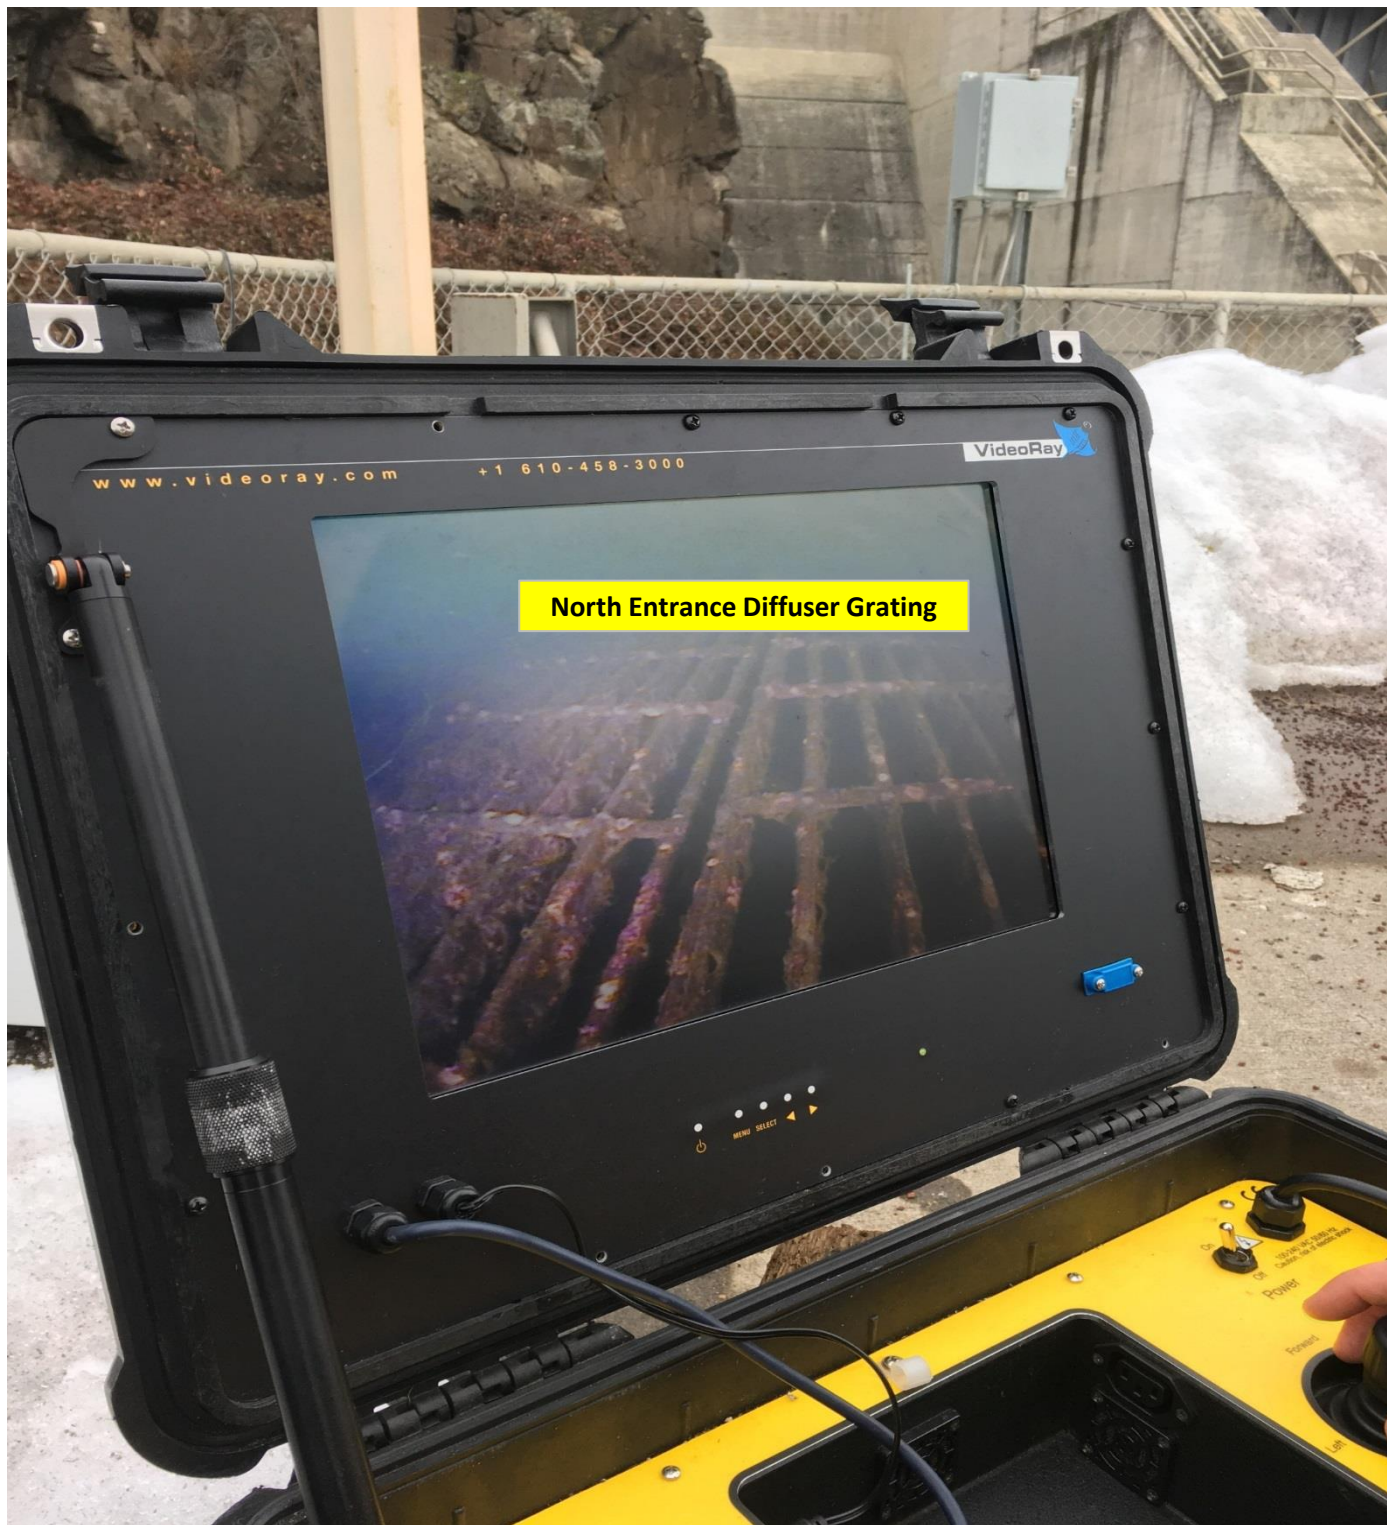
North Entrance Diffuser Grating

North fishway entrance diffuser grating ROV inspected 2/15. No problems found.

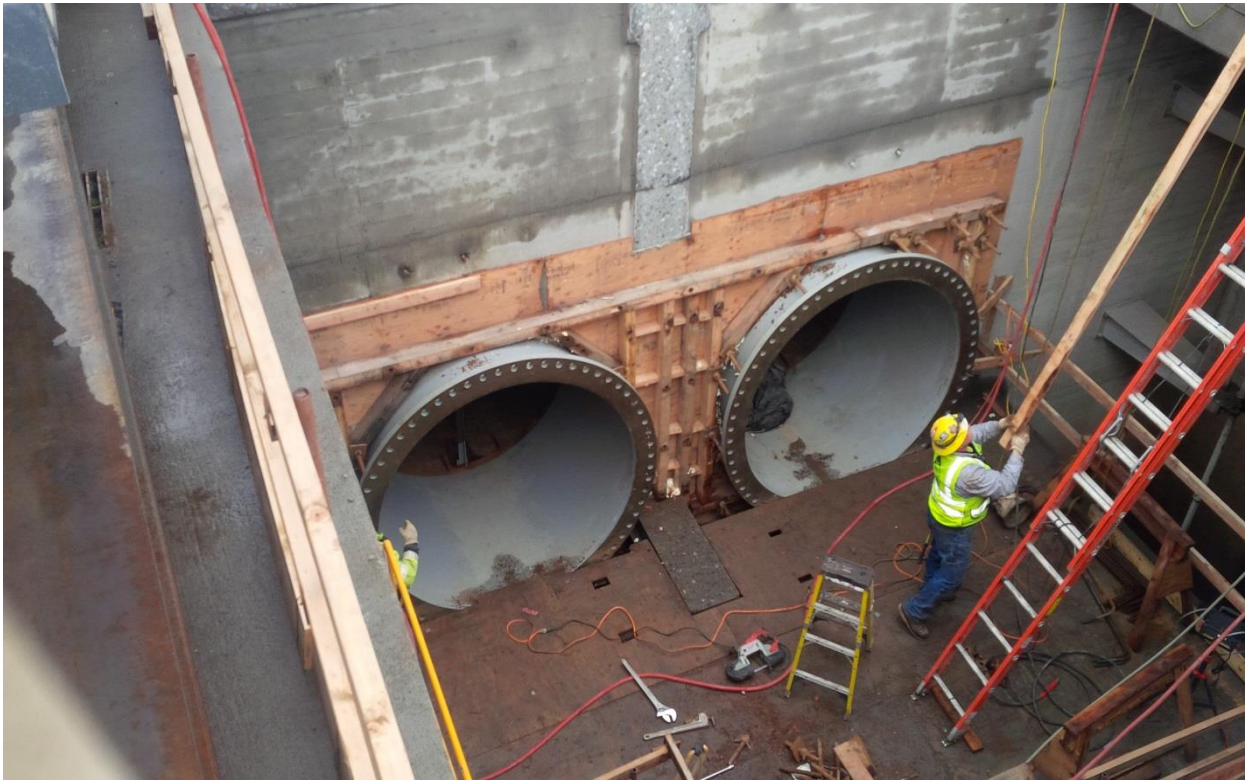
East fishladder AWS emergency backup - Forebay diving saw cutting continues. Junction pool 7' pipes span complete. Excavation 7' valve room continues.

AWS 7' pipes entering AWS chamber west of junction pool
