The Dalles Dam Fishway Status Report

2/25/2017

Inspection Period: 02/19/2017 - 02/25/2017

THE DALLES DAM

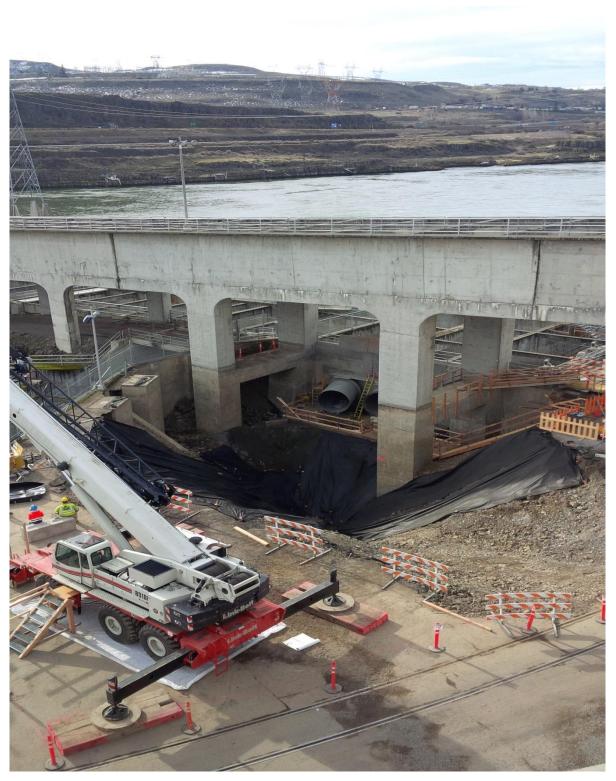
Excavation completed for 7' valve room and thrust block construction

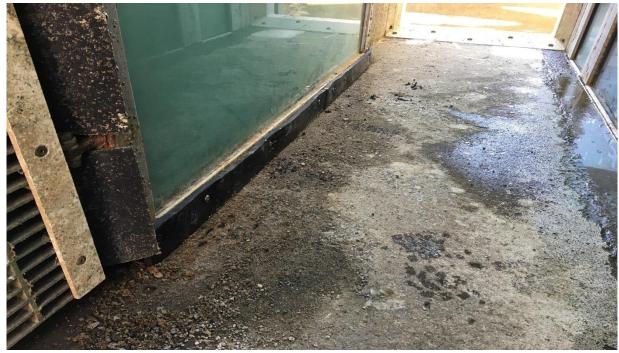
Installing rubber seal to bottom of east count station crowder to keep lamprey out from entering crowder. FPOM approved.

Rubber seal installed to prevent lamprey entry under east count station crowder.
