The Dalles Dam Fishway Status Report

Inspection Period: 02/26/2017 - 03/04/2017

THE DALLES DAM

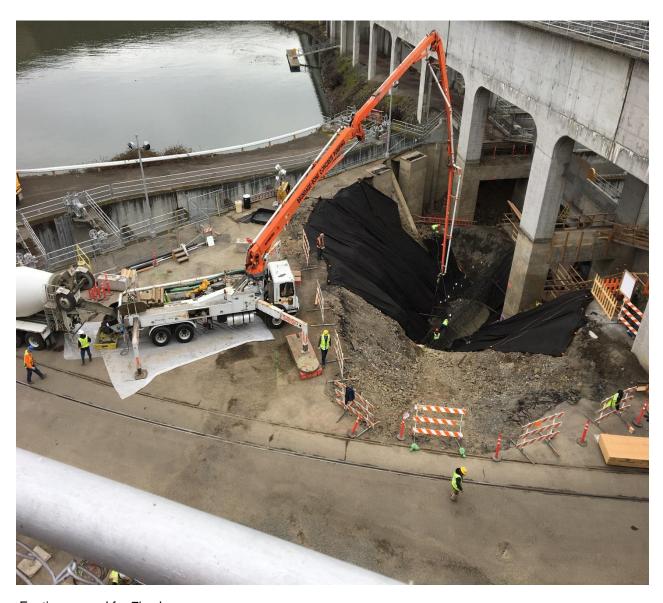
Footing poured for 7' valve room

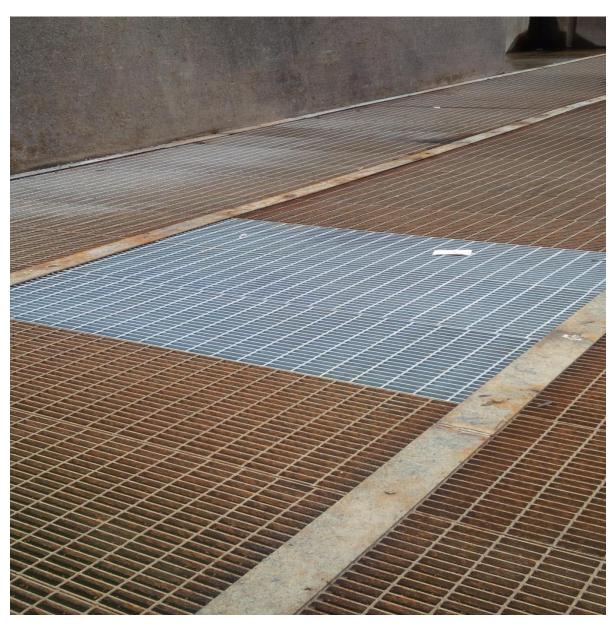
Damaged diffuser grating from contractor work platform replaced
