# The Dalles Dam Fishway Status Report

3/11/2017

Inspection Period: 03/05/2017 - 03/11/2017

US Army Corps  
of Engineers  
Portland District

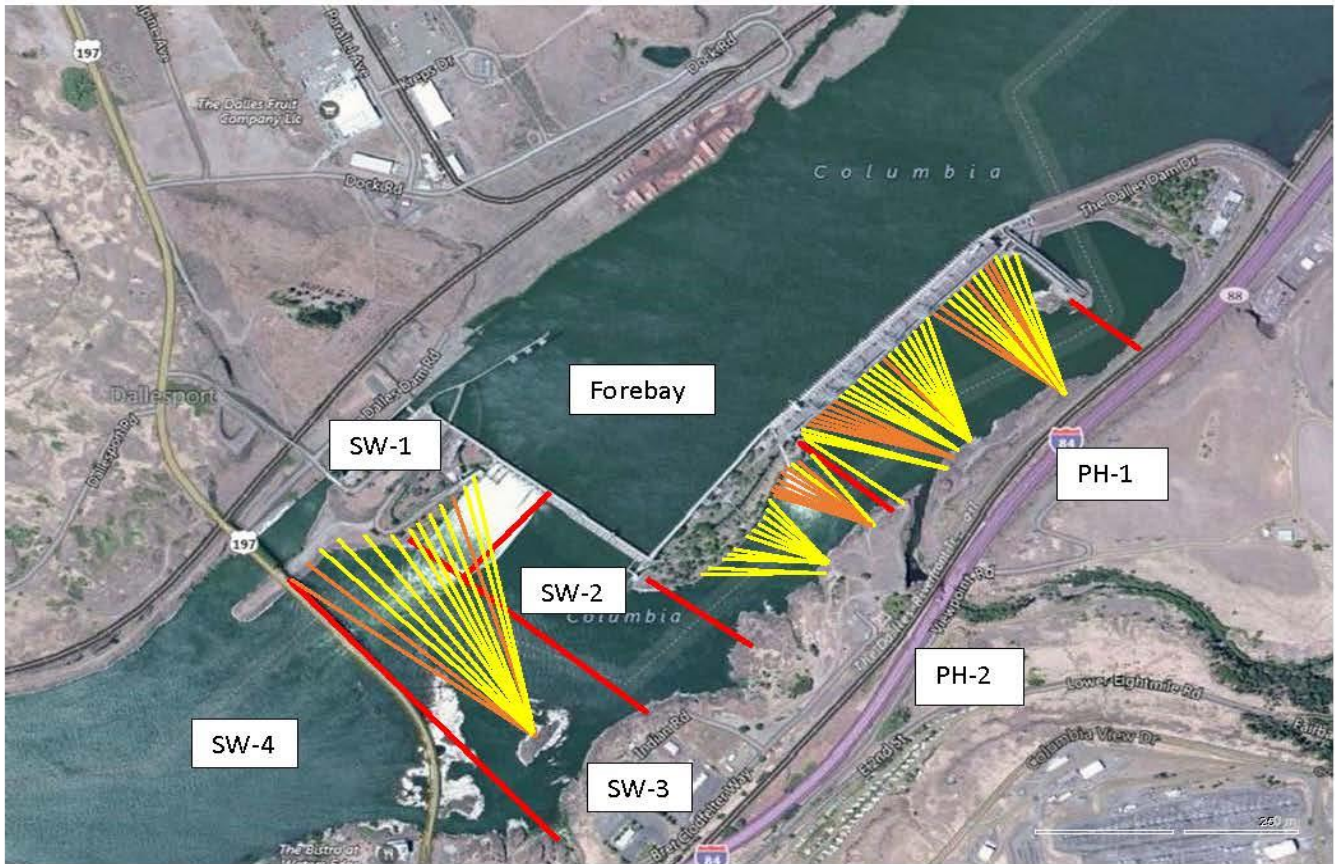
Bird observation data collected once daily. Refer to Avian Zone map and bird count. Bird numbers low.

Spillway avian lines repair plan approved. Spillway closure needed for installation. High river flows may jeopardize this action.

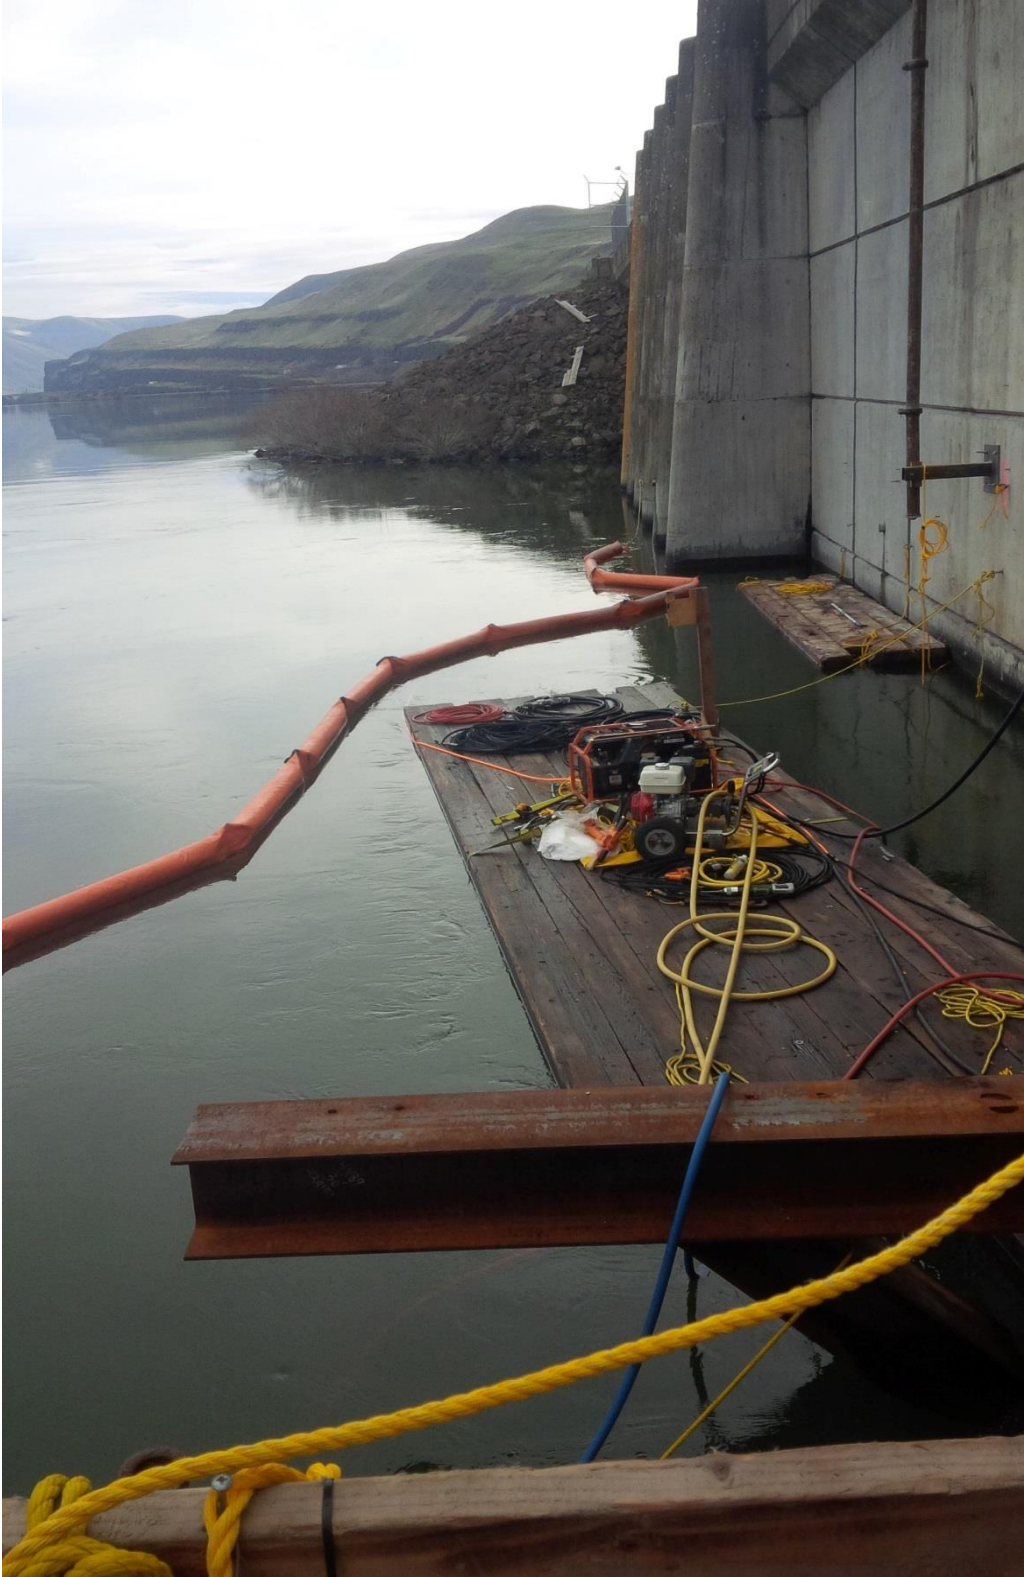
East fishladder AWS emergency backup - Forebay diving night work continues through March. Junction pool 7' pipe valve room concrete pouring underway.

View towards east fishway exit from dive work platform. Requested boom gap correction.

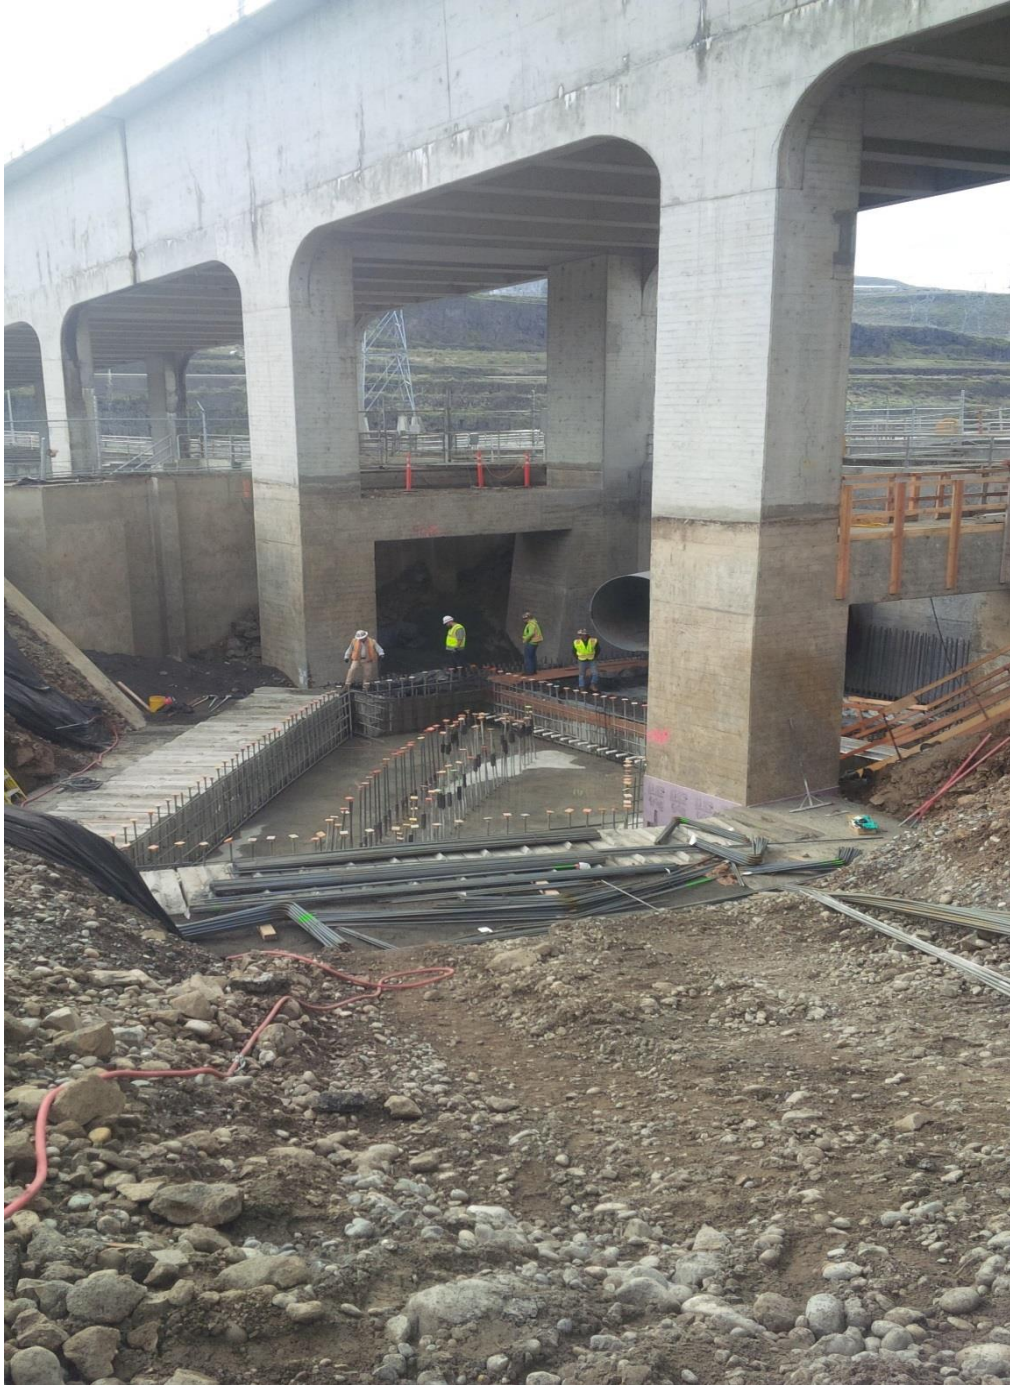
Concrete placement for 7' valve room.
