**U.S. ARMY CORPS OF ENGINEERS
WALLA WALLA DISTRICT
FISH FACILITIES WEEKLY REPORT
#18-2022**

Project: McNary

Dates: July 1 – July 7, 2022

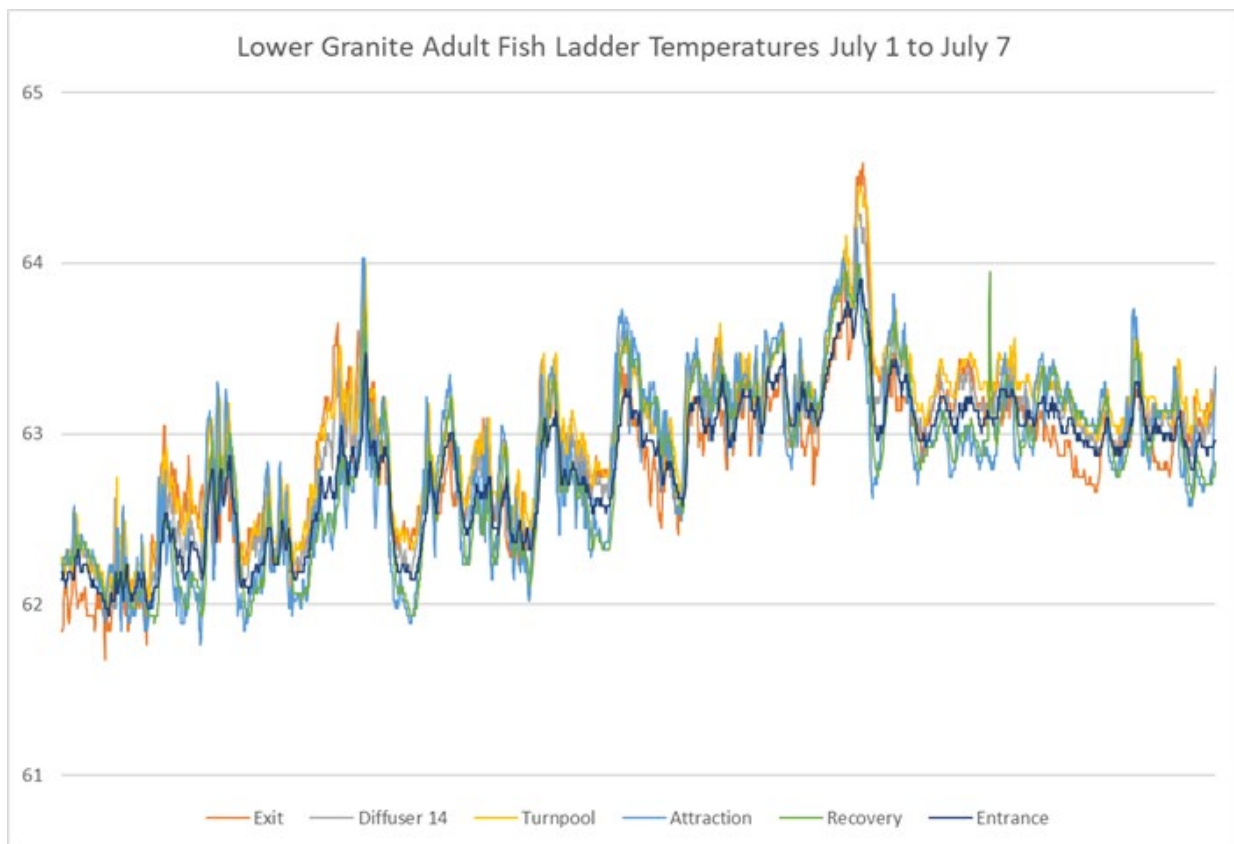
Figure 1. Lower Granite Dam adult fish ladder temperatures July 1 to July 7, 2022.
